WINTER RIVER - TRACADIE BAY WATERSHED ASSOCIATION

Work Report for 2019-20

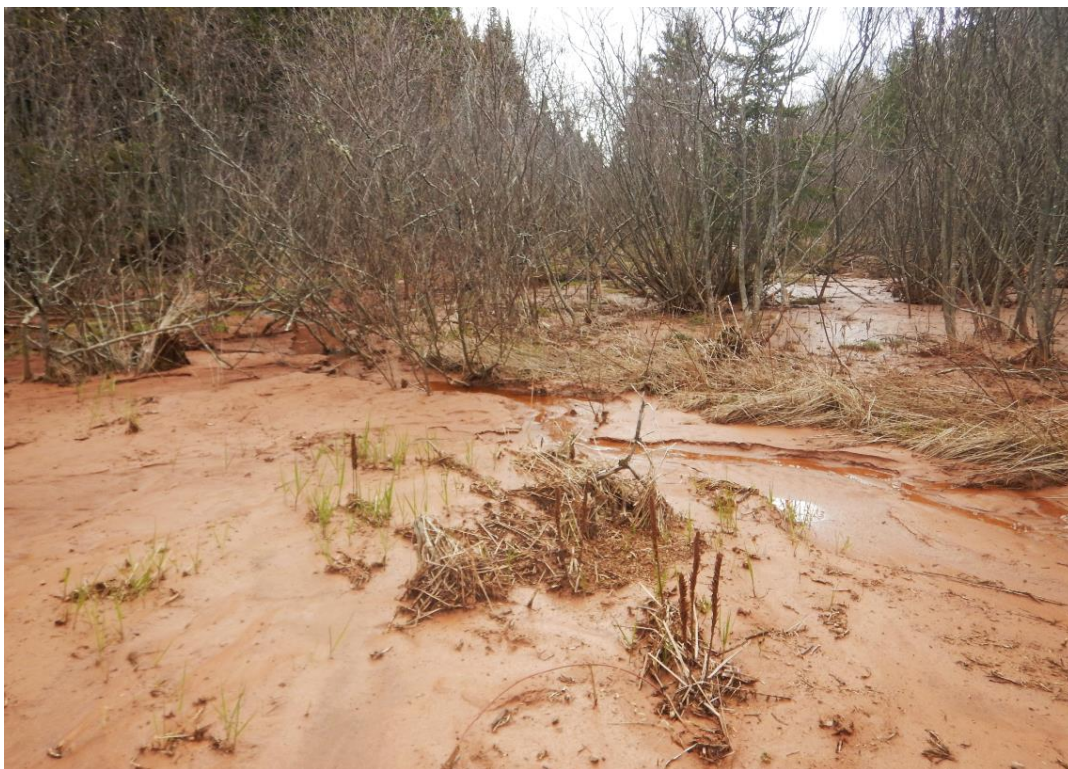
Upon checking the site in spring 2019, it was found that a large section of the riparian zone on either side of the stream had been covered in silt. There were several trenches formed and sediment was running directly into the stream. The straw bales had been pushed out of place from the force of the water coming off the field, and silt completely covered the straw bales in some areas. The stream in this section (approximately 50 m) looked more like a wetland covered in silt than a stream.

Figure 31. Silt covering the riparian zone at the soil erosion site.

Mary Finch, the Watershed Ecologist with the PEI Watershed Alliance, did a stream walk with Sarah to give us some guidance on how to restore the stream. Following these instructions, we located where the stream was trying to make its new path and helped shape it into a narrower channel. To achieve this, we placed logs on either side of the stream and dug out some of the silt to keep them in place. We removed all blockages from downstream and felled all of the dead trees. After the stream started to take on a better shape, we planted the riparian zone with trees and shrubs to help build the area back up. The Watershed has been working with the landowner to prevent any further damage to the stream.

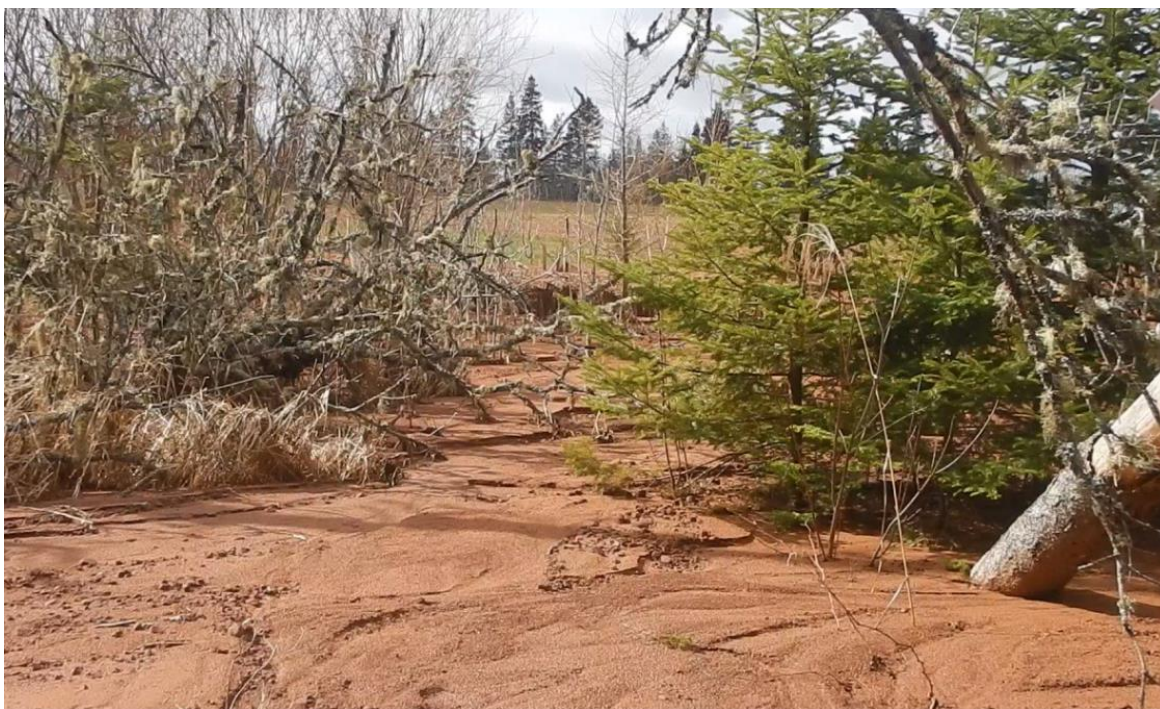
Figure 32. Silt runoff from the field, covering the riparian zone at the soil erosion site.

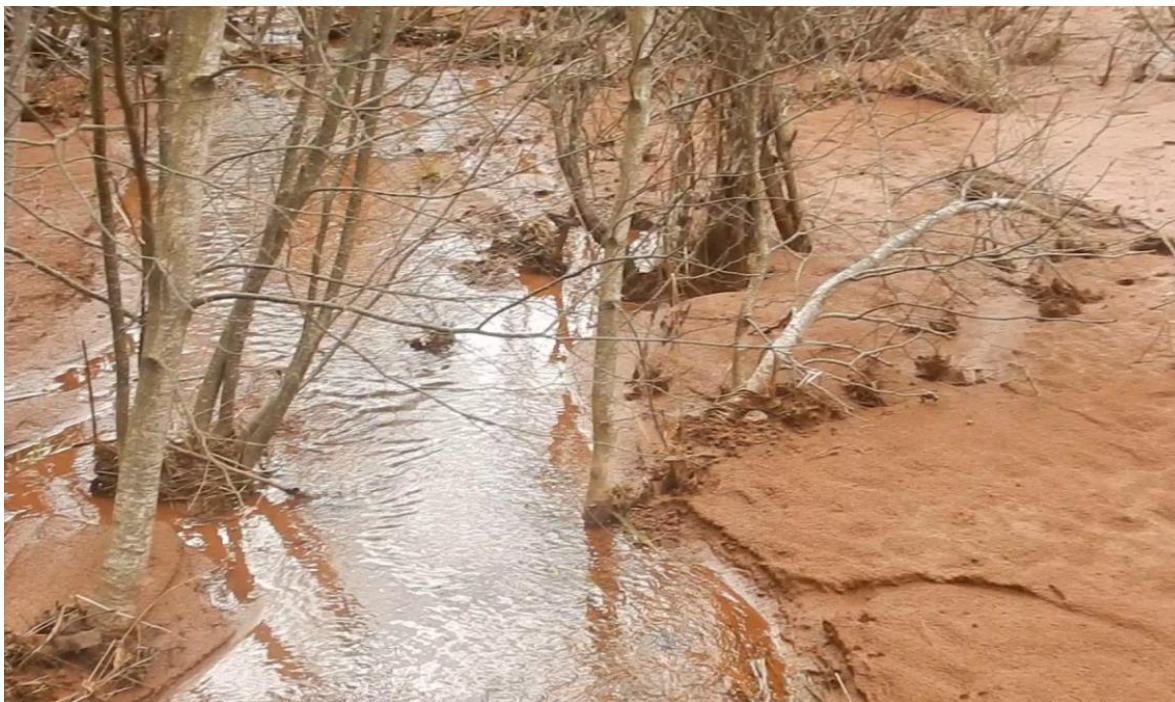
Figure 33. Silt in the stream at the soil erosion site.

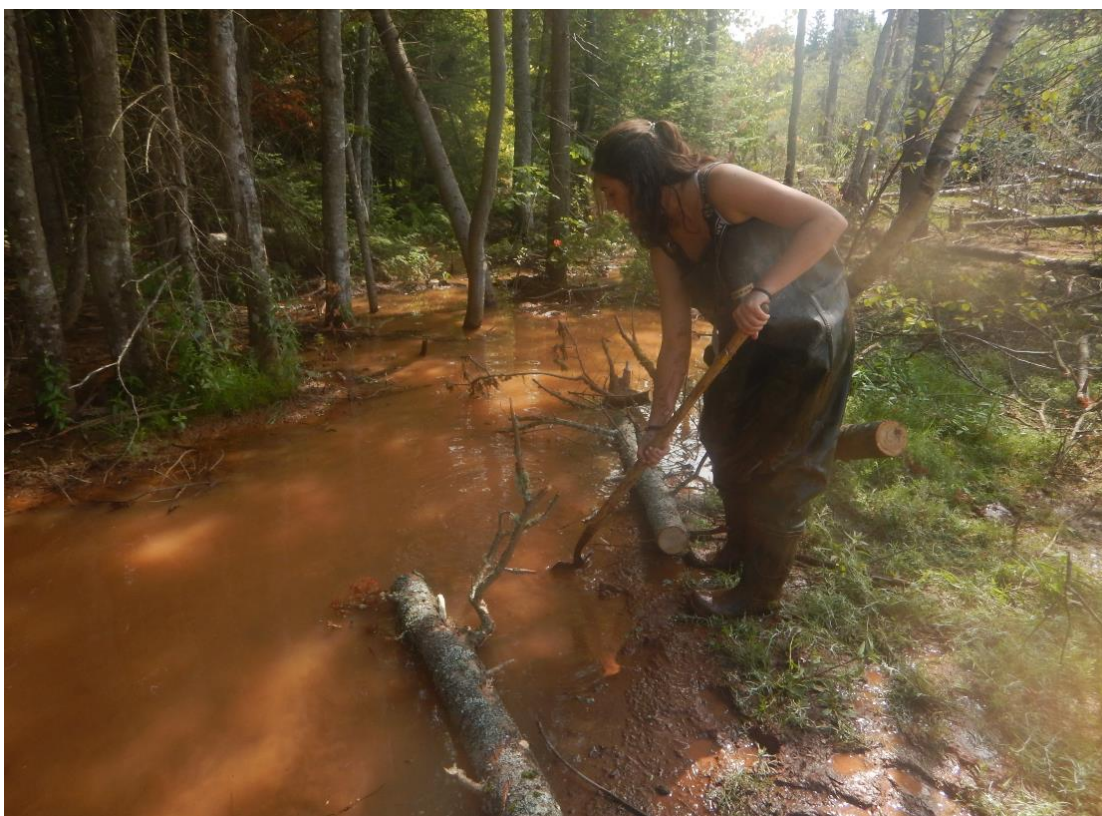
Figure 34. Staff member Sam digging out silt from the stream at the soil erosion site. The logs pictured here were used to help redirect flow and shape the stream channel.

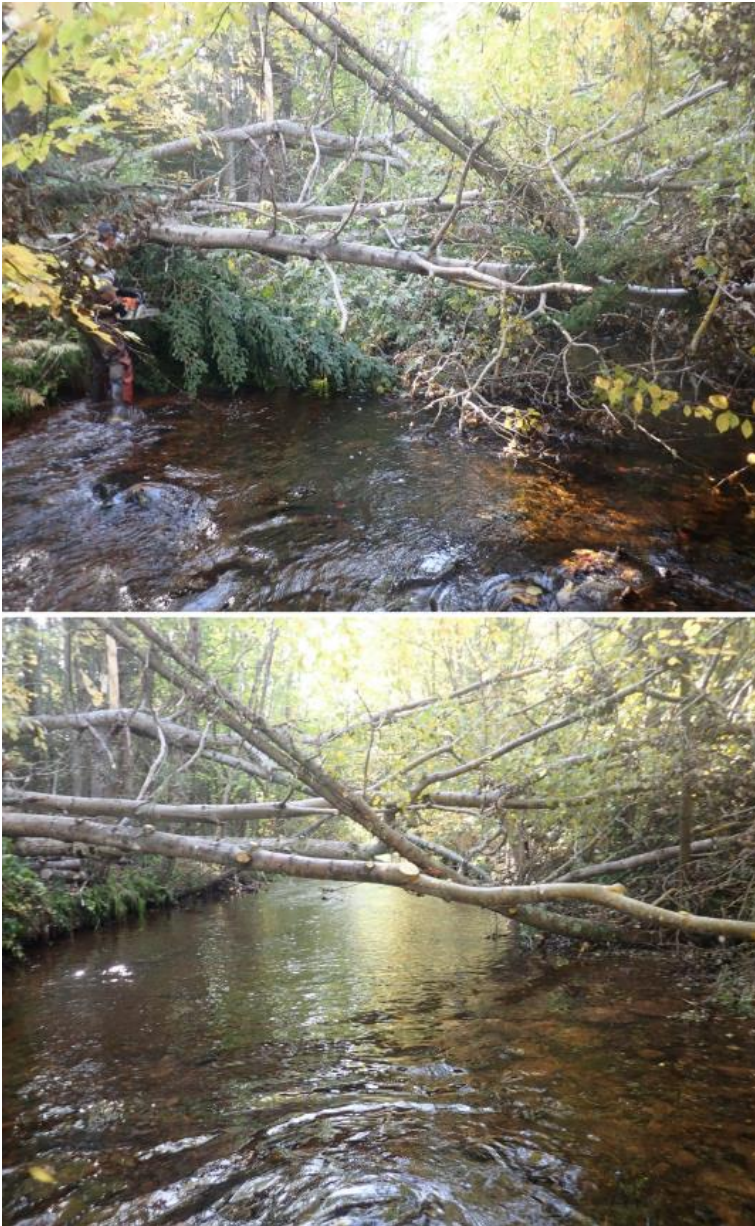
Figure 36. Above: blockage before removal work. Below: after the blockage was cleared. This site was along the main branch of the Winter River, off Suffolk Rd.

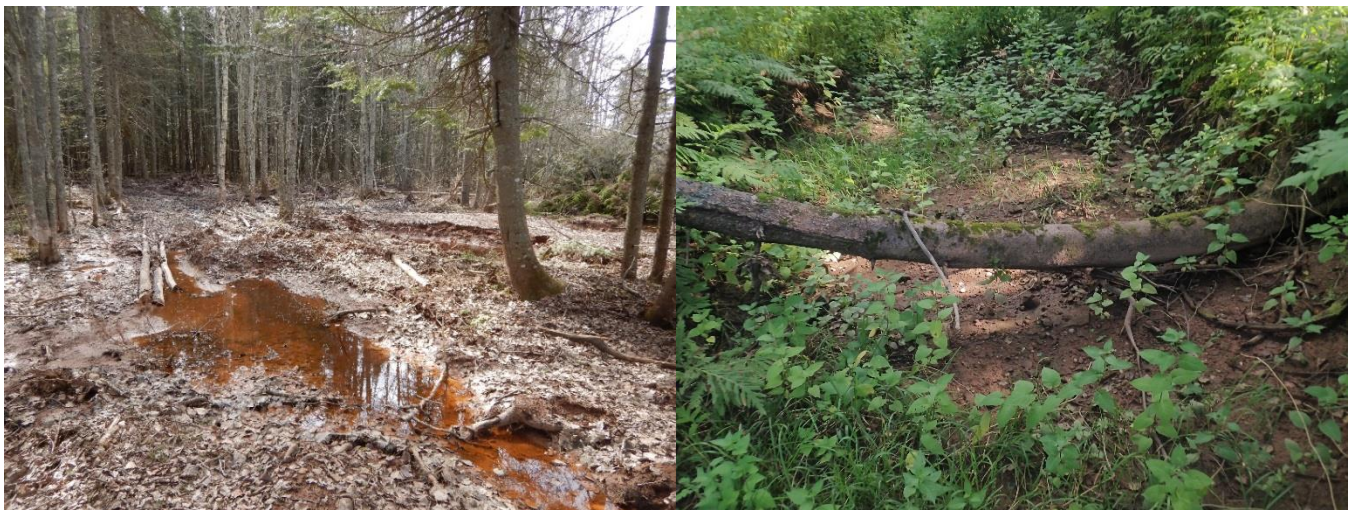
Figure 46. Left: May headwater survey along Brackley branch. This is an example of a Category 1. Right: September headwater survey along Brackley branch. This is an example of a Category 0, where the headwater dries up.

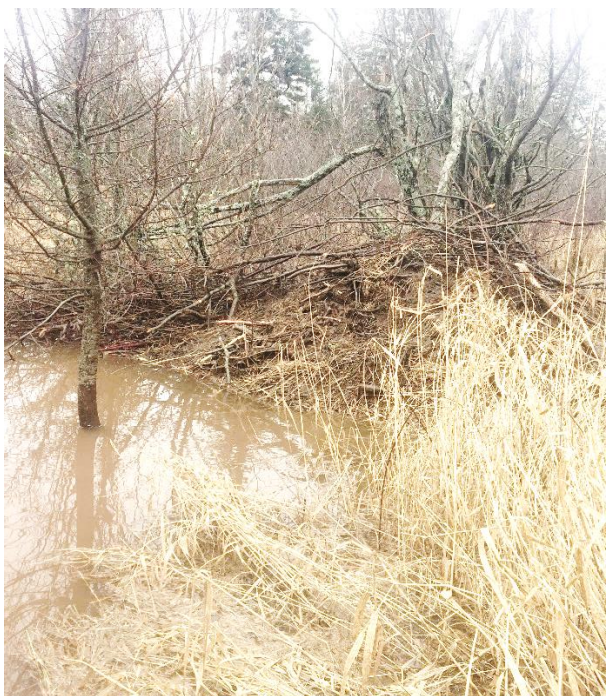
Figure 56. Beaver lodge below Hardy Mill Pond and flooding of the area in November 2019.

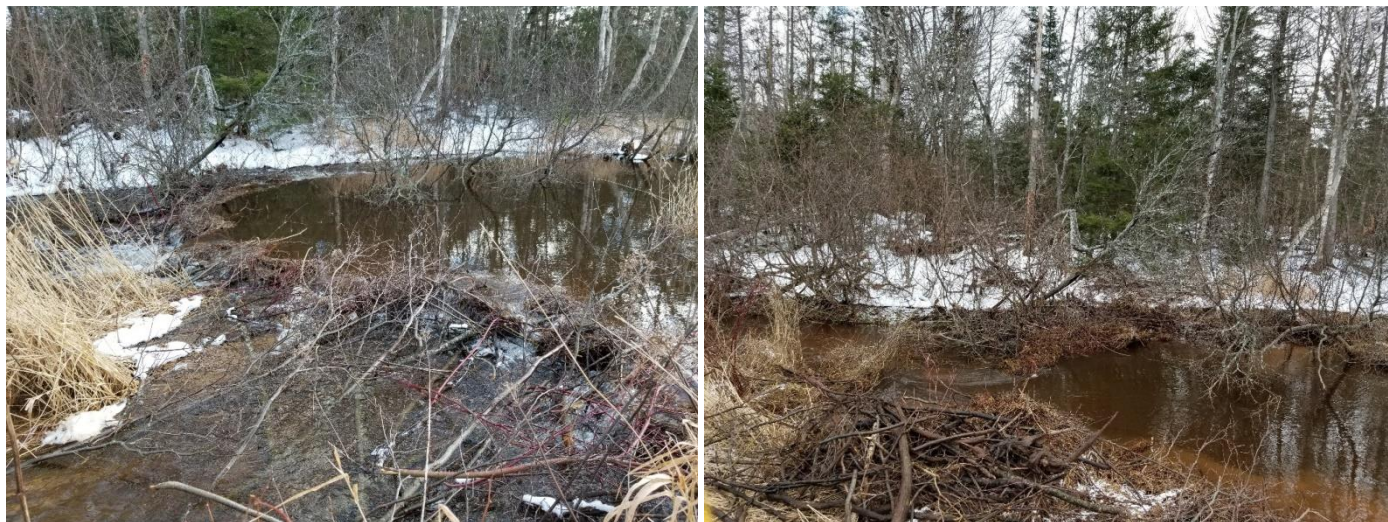
Figure 57. Left: Beaver dam on main branch of Winter River below Hardy Mill Pond before work. Right: the dam after opening it up for fish passage, December 2019.
