Winter River – Tracadie Bay Watershed Association

2016 Field Report

Hilary Shea
2017-01-09

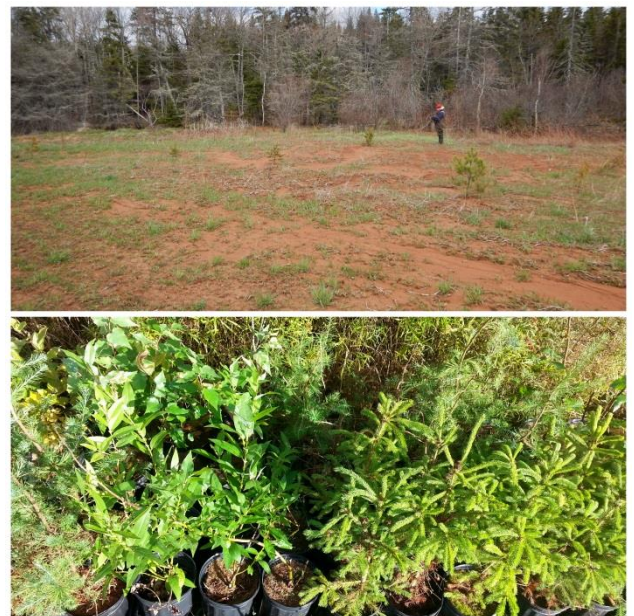
The native planting site is adjacent to the headwaters springs of the Pater Branch on Winter River and below an active agricultural field. In the spring, this area was surveyed and found a large amount of sediment runoff within the buffer zone. This summer, approximately 60 trees and shrubs were planted within the buffer zone including: Green Ash, Blue leaf Birch, Red Maple, Larch, Black Spruce, White Spruce, Bayberry, Pussy Willow, and Winterberry. In addition, the watershed group installed a 200m long sediment fence to mitigate the sediment runoff for an effective short-term solution.

Figure 2: (top) riparian zone full of silt from spring runoff; (bottom) trays of trees to be planted below the silt fence

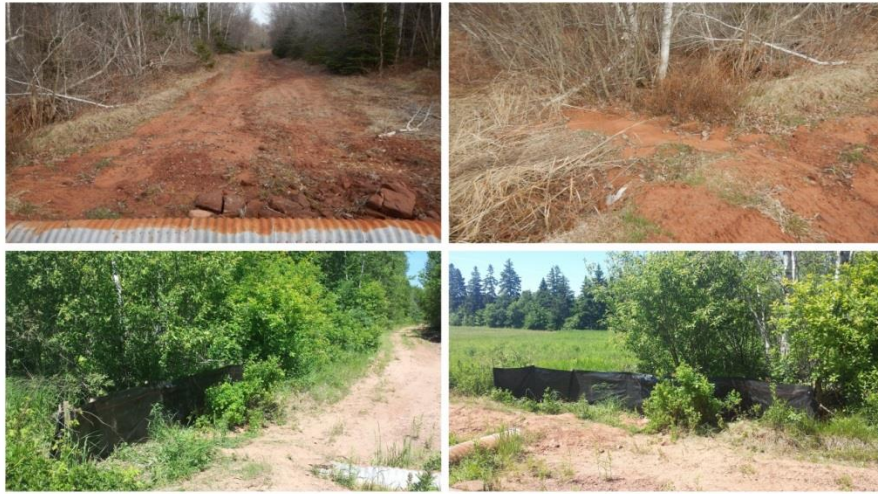
Figure 34: Headwaters of the Wheatley Branch, Winter River – showing silt issues at road crossing, and silt fence that was installed to deal with silt.

In the spring, key locations for sediment runoff were identified by Hilary and Jill during the stream assessments. In the summer the crew installed 3 silt fences to mitigate this problem. A small silt fence was installed at an abandoned pit road that was a source of silt during snow melt above the headwaters of the Wheatley Branch in Winter River. In addition, a second small silt fence was installed along the pit road of the Vanco Branch. The berm on the pit road beside the culvert had begun eroding away in the spring and was a direct source of silt runoff into the tributary. This silt fence was fixed during the summer after a heavy rainfall event, as leaks were found and plugged up with hay bales. This fence was accompanied with native shrub plantings. A large, 200 m long silt fence was installed adjacent to the headwaters of the Pater Branch in Winter River. This area is adjacent to a large active field that is the direct source of the sediment runoff during snow melt or precipitation events. A large effort was made here to mitigate the agricultural runoff and was accompanied with native tree and shrub species.

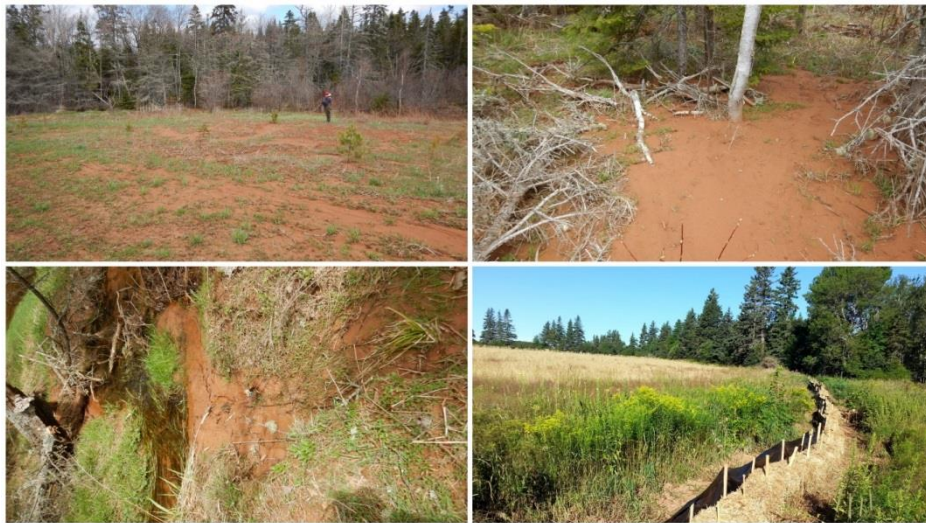
Figure 35: Sediment moving between an agricultural field and the headwaters of Pater Branch, Winter River; silt fence installed to deal with silt.

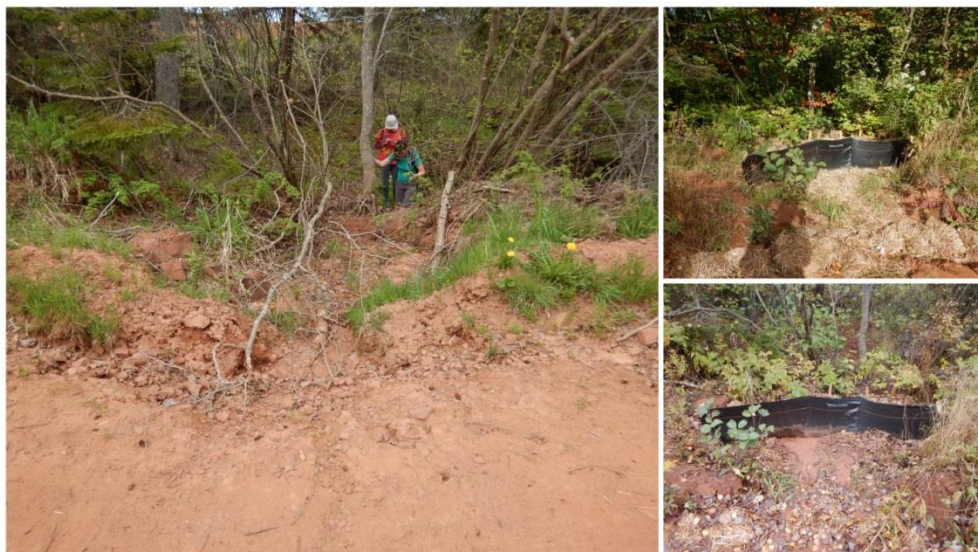
Figure 36: Sediment fencing below a pit road, adjacent to the stream of Vanco Branch, Winter River

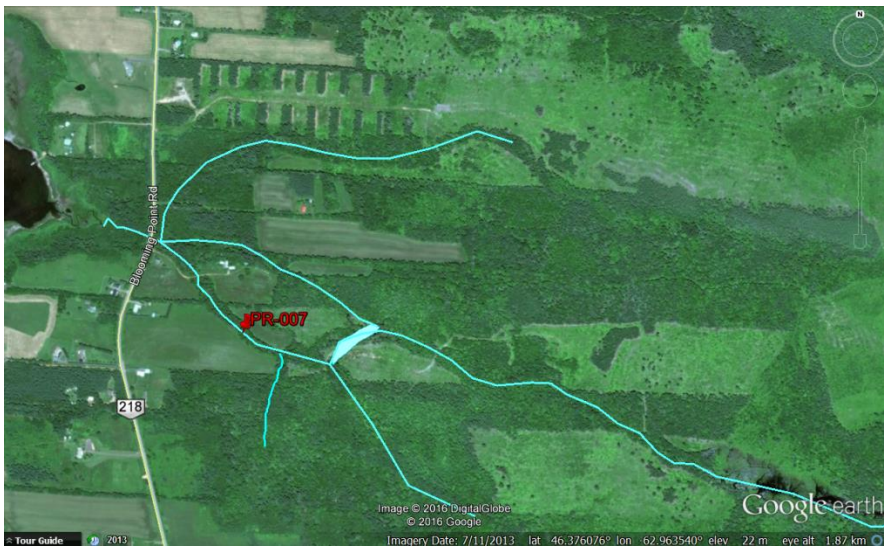
The crew removed two private culverts that were side by side at a road crossing located along Pipers Creek. These culverts were located at an old crossing and were impeding proper flow and fish passage. The metal culverts were removed with hand tools by the summer crew. In addition, geotextile fabric and shrubs were planted adjacent to the stream to increase bank stability.

Figure 38: Culvert removal at Piper's Creek

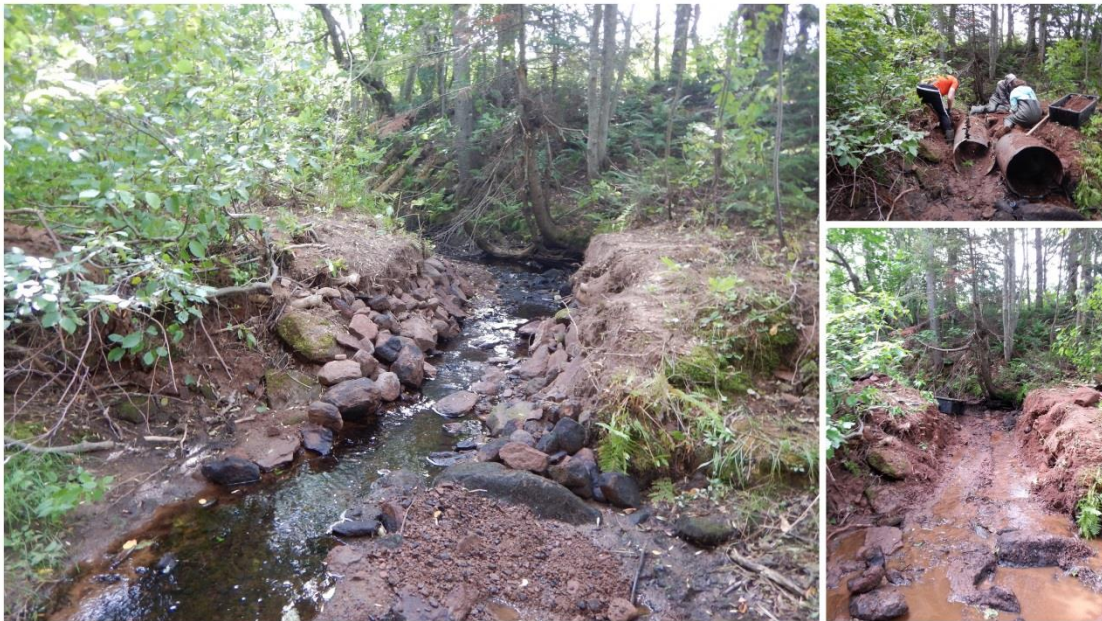
Figure 39: Culvert removal at Pipers Creek, check up on the "toe" rock to ensure it block passage

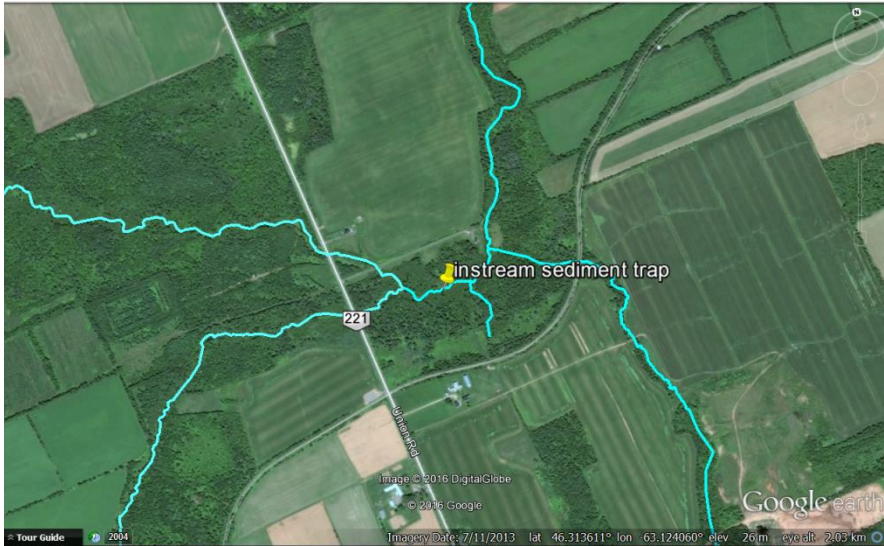
In early September, the instream sediment trap near the Union Road pumping station was excavated. This in-stream sediment trap acts as a collection area for silt flowing down from the headwaters, to prevent the silt from moving further downstream into important fish habitat. Silt is removed every 3-4 years as material accumulates. The rate of deposition of silt depends on the land use practices in upstream areas, and is mostly heavily influenced by potato farming.

Figure 42: Silt trap location.

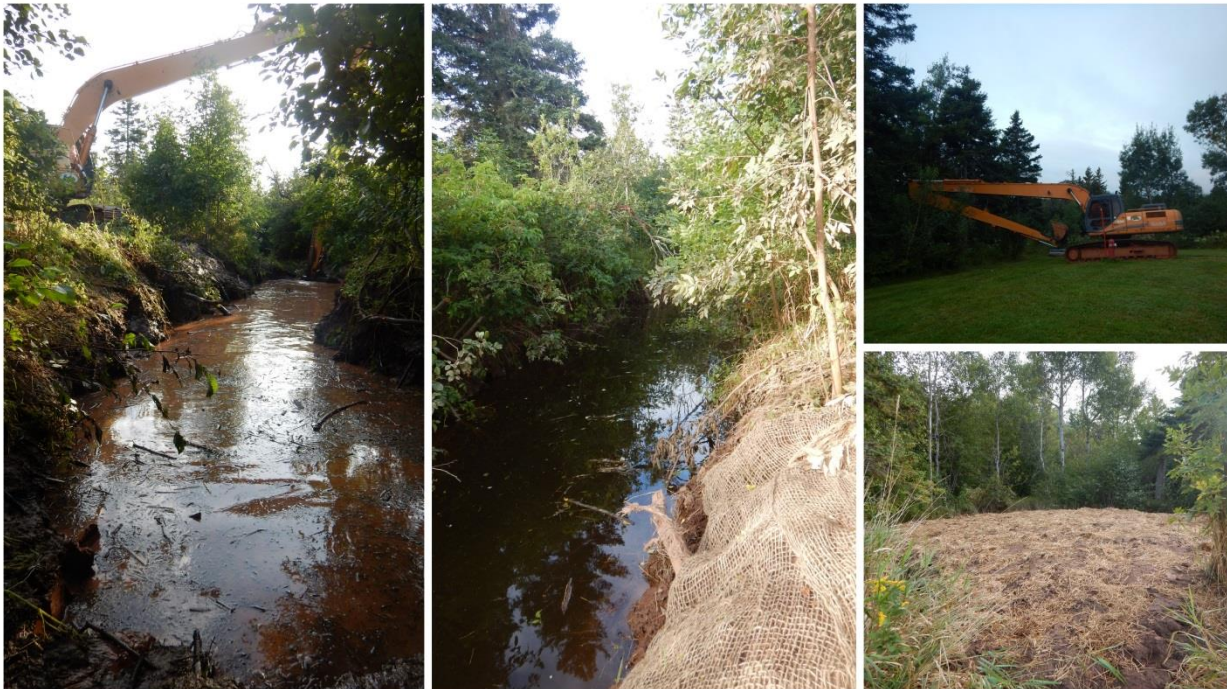
Figure 43: Long reach excavator at work, site after banks were stabilized with geo-jute.

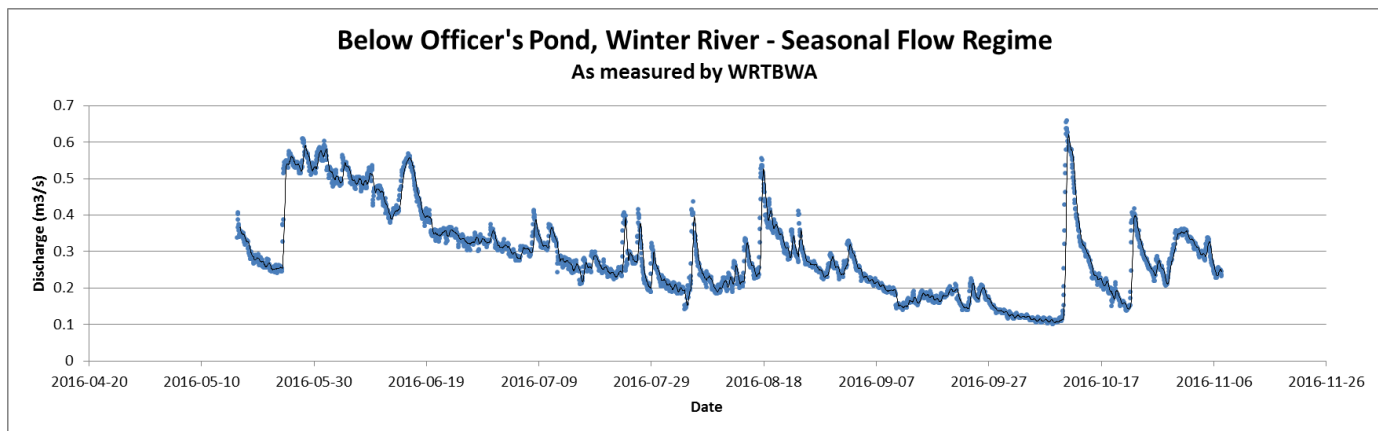
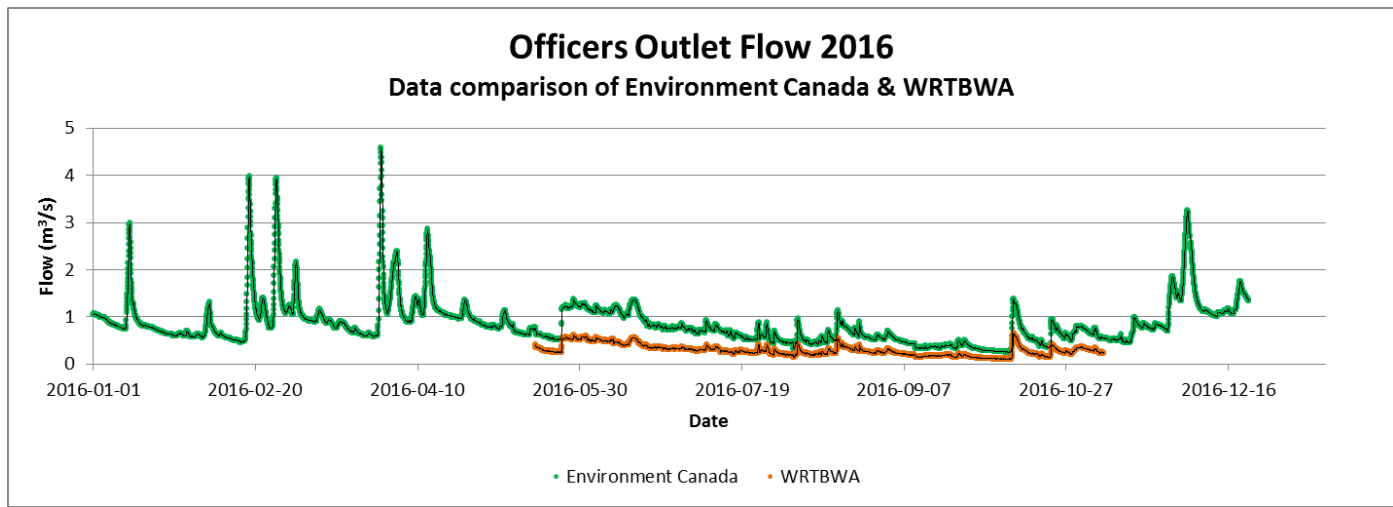
Figure 46: The depth logger at this site measures less flow than the Environment Canada Station. Possible cause: the infield measurements did not capture the full cross section. Since using the orange, it is hard to capture the discharge near the banks due to alder vegetation in the stream.

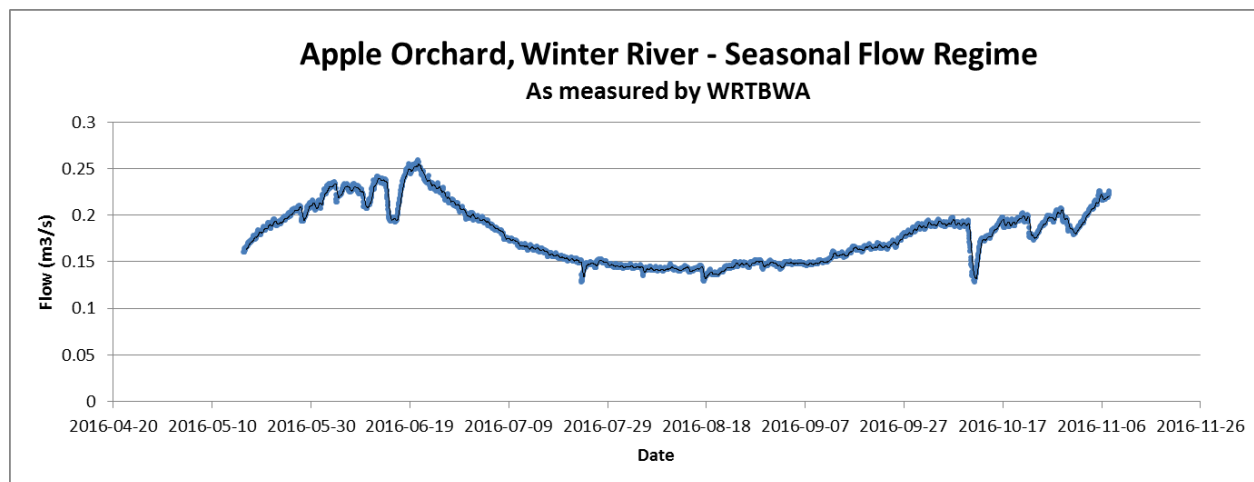
During the monitoring season, several factors have influenced the discharge readings at this location. This data will not be used to compare flows, but shows some interesting trends due to external factors.

1. York Bridge Replacement Upstream - the construction of the York Bridge ensued during the late summer and up until December.
2. Beaver Dam Downstream – a beaver dam was found downstream in the early fall. This explains the "stagnant" river effect, as measurements even with the orange were quite difficult to measure all season.
October 10 to 11, 2016 – water level/discharge drops significantly and rises back up again in a few days. Only explanation I thought of, the landowners removed the beaver dam and beavers proceeded to rebuild it??

3. Large Blockage Downstream – this blockage consisted of a few large trees with vines and other vegetation beginning to grow over top. This blockage back pooled the water behind it, and when it was partially removed, released the water with it, decreasing the depth of the river upstream.

4. Hardy Dam Vandals – there is a small drop in flow discharge around the time the hardy outlet was released and fixed.

My suggestion is to move the logger upstream, since the data is unusable for flow comparison because of the beaver since the landowners are not willing to take them out. The logger needs to be far enough downstream from the "MacLauchlan Branch" so it does not influence the logger like it did in 2015. In addition, the landowner was cooperative to let us through the Apple Orchard to take measurements, but one of the dogs tied outside on the property could be of danger to the staff if it ever got loose as it is very protective of its property. Ask Hilary for further details.
