WINTER RIVER - TRACADIE BAY  
WATERSHED ASSOCIATION

## **2018-19 Work Year Report**

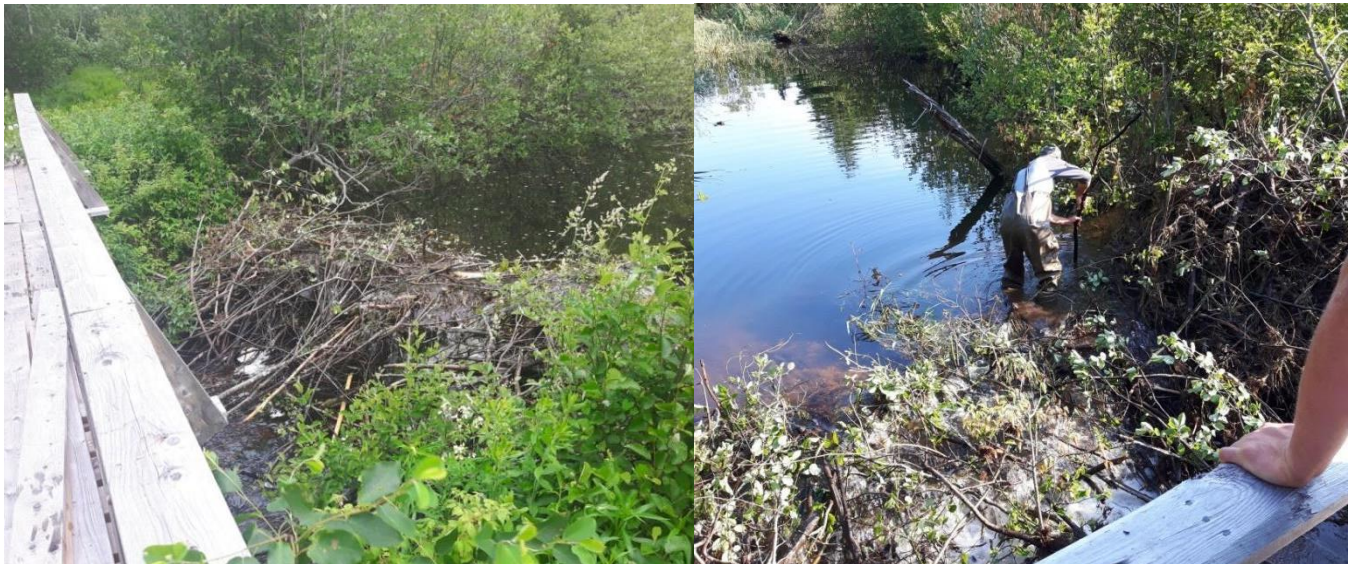
It is important to monitor for beaver activity in the Watershed, as they can cause a lot of problems in a short time. The biggest problem they cause is the construction of dams, which impede fish passage. They also cause flooding and fell a lot

Figure 39. Large beaver dam at bridge by Spike's Paintball. Carl Balsar, trapper, setting foot-hold trap by the beaver dam.

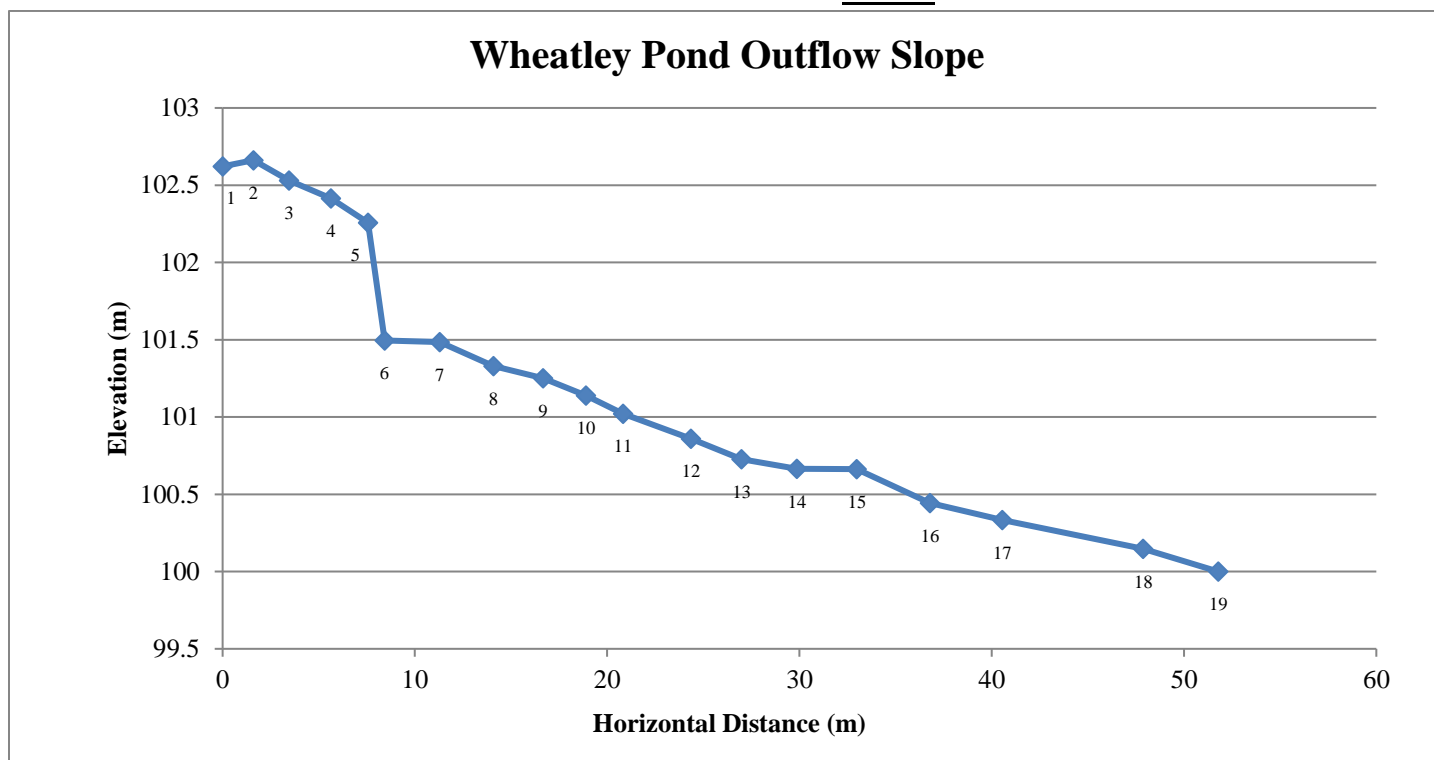
Figure 49. Slope of Wheatley Pond outflow, beginning in the pond just before the dam.

It has been shown that Brook Trout of any size struggle to make it past a jump greater than 43.5 cm in height when coming from a pool with a depth of 10 cm or less (Kondratieff and Myrick, 2006). Most of the outflows that were surveyed in 2018 did not have many pools deeper than 10 cm, and there were jumps greater than 43.5 cm found in Wheatley and Mazer.

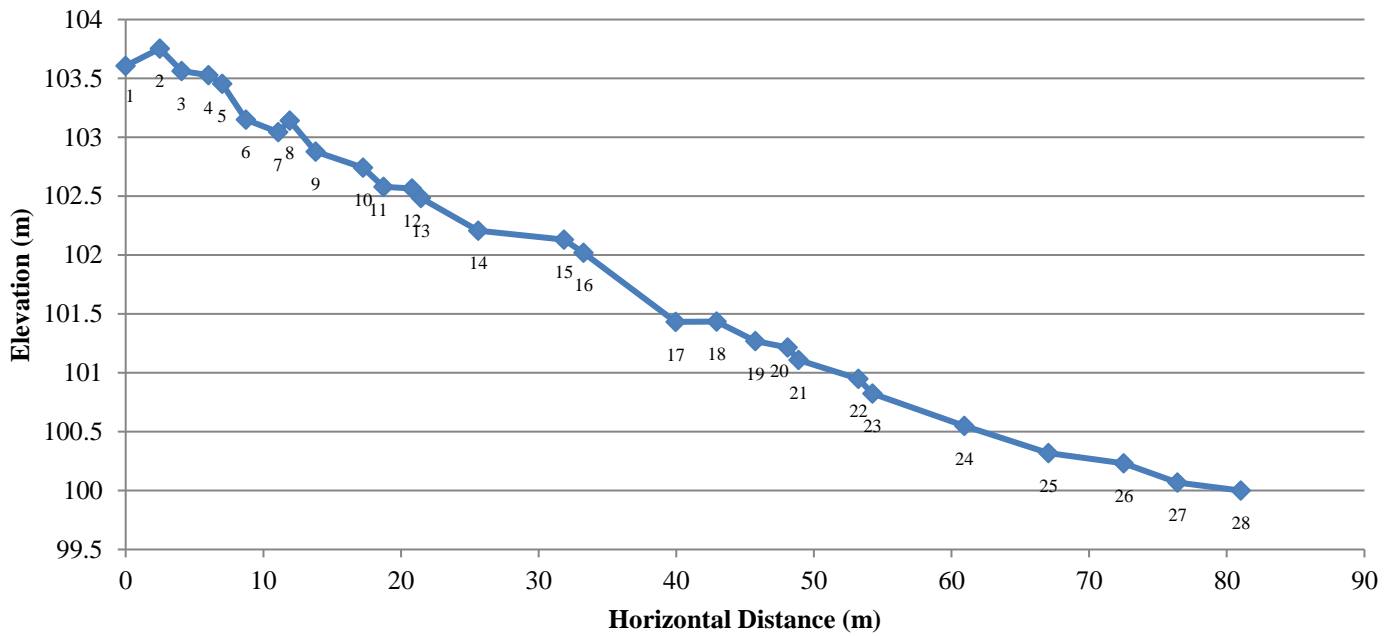
Figure 50. Slope of Van Westerneng Pond outflow, beginning in the pond just before the dam.

jumps below where the dam was created. Van Westerneng appears to be in relatively good condition compared to the other 2 outflows. However, given the available habitat upstream, it is a relatively high priority location, where a small improvement could result in great increases in fish habitat connectivity.

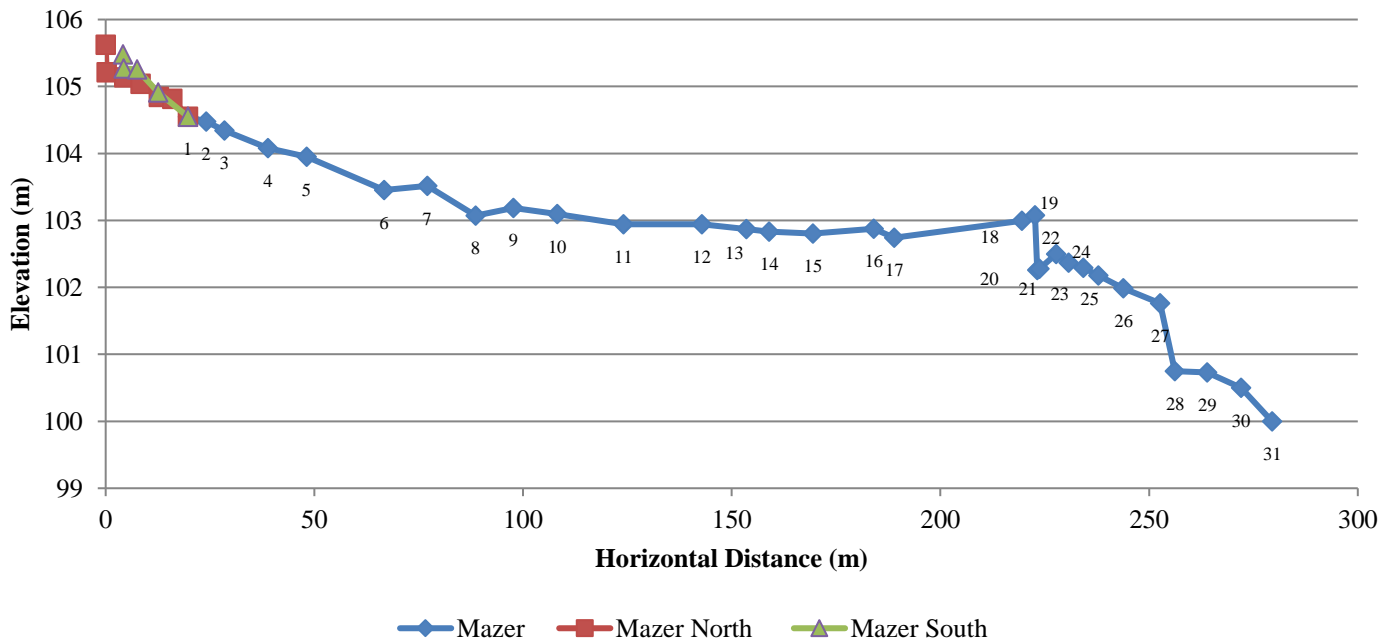
Figure 51. Slope of Mazer Pond, beginning with both culvert outlets at East Suffolk Road and ending at Winter River (main).

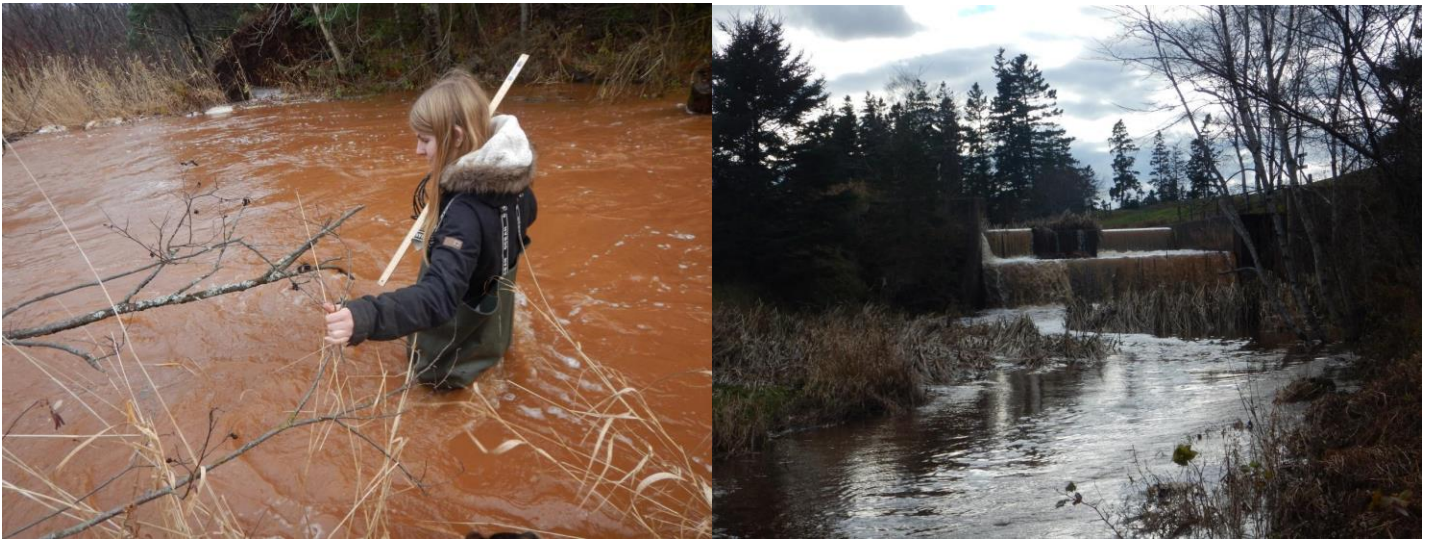
Very-high-water events occurred twice this season, once mainly affecting the Union Pumping Station and Hardy Mill Pond sites, and the second time affecting all sites except Beaton's Creek. The first high flow event was on 2018-06-29 and was likely caused by the heavy rain events many consecutive days prior. The Union Pumping Station logger was about 1.2 m deep, while it is usually around 0.2-0.3 m. The velocity was also over 3 times its usual numbers, about 0.3 m/s compared to the usual 0.1 m/s. This gave a  $1.601 \text{ m}^3/\text{s}$  discharge with usual discharge values being recorded around the 0.05-0.15  $\text{m}^3/\text{s}$  range. The water depth at Hardy Mill was also triple its usual depth and twice the typical velocity. The Apple Orchard site's depth values doubled 2018-06-29, but the velocity was not largely affected. Officer's Pond Outlet had double the normal velocity values that day, but only minor increases in water depth. The effects of the heavy rains may have been dampened by the presence of the dam. The other sites did not appear to have many depth or velocity changes that day.

*Figure 70. Hardy Mill during the high flow event in November (left) and Officer's Pond during the June high flow event (right).*

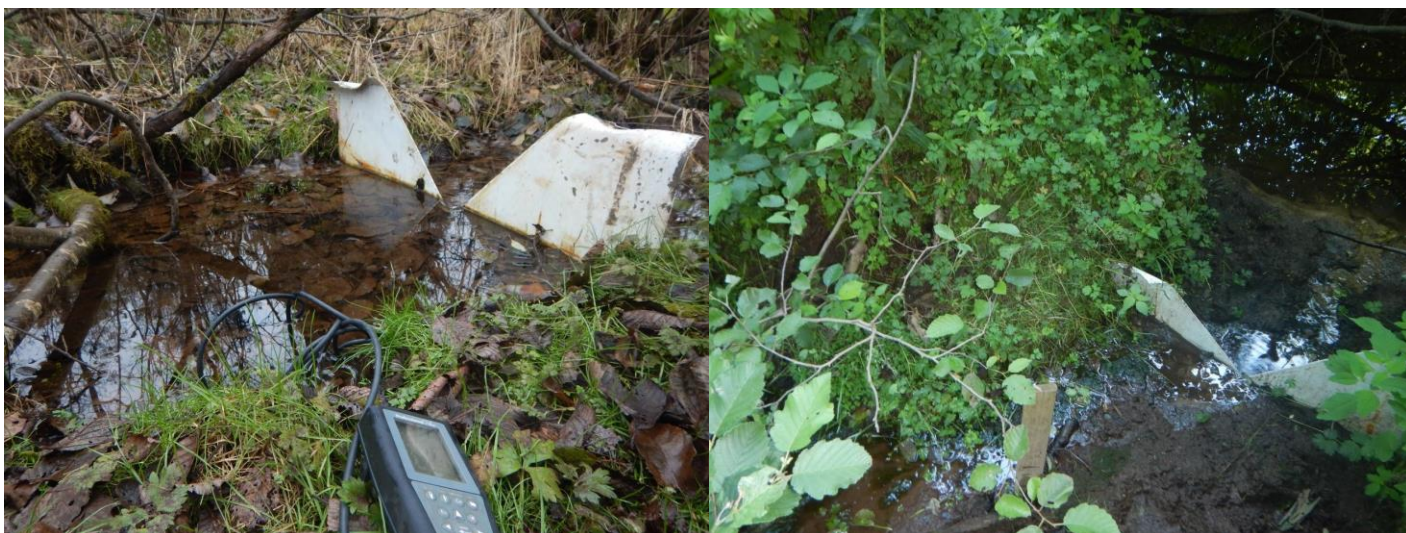
Figure 88. Brackley Weir #8 (left) and Brackley Weir #7 when nearly dry.

The following graphs have a degree of error due to weather conditions, beaver activity and daily evaporation. The unnatural drying up of the Brackley springs directly match up with the time periods of highest water extraction via the Union Pumping Station. The summer months are always the times of highest extraction. The springs began to go dry on 2018-07-07 and all Brackley branch springs were dry by 2018-08-15. The Brackley springs began to recharge in mid-November.
