Winter River-Tracadie Bay Watershed Association
2014 Summer Field Work Report

Submitted by Luke Peters

January 2015

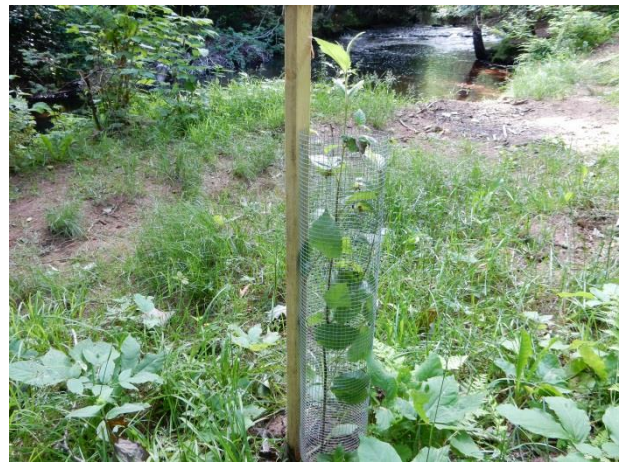
A wide variety of native trees and shrubs of the Acadian Forest were planted in the riparian zone of the Winter River. Although the areas planted in 2014 were mostly healthy with quite a bit of mature trees, we planted to add to the diversity of the area, paying particular focus to add long lived species and ones that are of great benefit to wildlife. In total, there were 2300 trees and shrubs planted during 2014. Species of trees and shrubs included but were not limited to; yellow birch (*Betula alleghaniensis*), red maple (*Acer rubrum*), sugar maple (*Acer saccharum*), white pine (*Pinus glaucis*), red oak (*Quercus rubra*), service berry (*Amelanchier spp.*), and red osier dogwood (*Cornus sericea*).

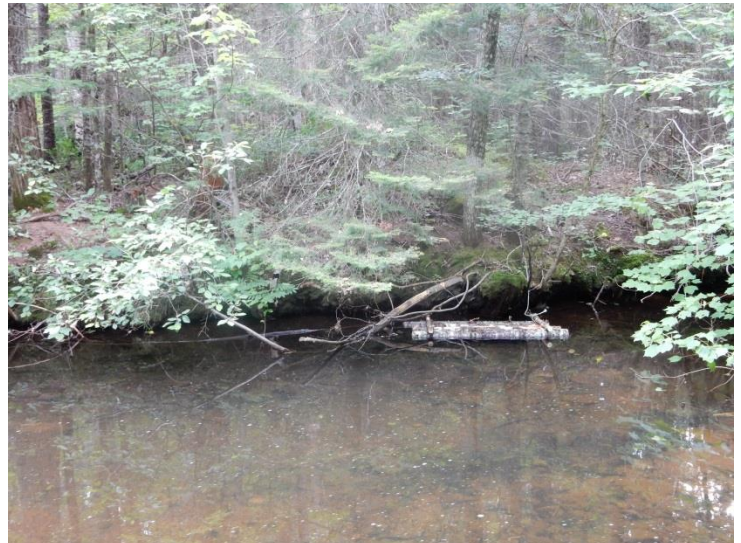
In areas where the substrate was too hard to affix slab logs to the river bed, cover rafts were installed instead. A cover raft consists of 3-5 logs approximately 3.5 feet in length, held together with two cross logs. The raft is then anchored to a solid structure (e.g. tree trunk) on the river bank with a length of steel wire or rope. Rafts provide a larger area for fish to hide under, but due to the rafts distance from the river bed, it is normally only larger fish that use them for cover (smaller fish find it too open below the surface of the water to act as adequate cover). Cover rafts were a less

favourable alternative to slab logs because they do not blend in to the natural environment, they are more difficult to install and they do not last as long in the river as do slab logs (roughly two to three years). It is also recommended that cover rafts be removed in the fall of the year when water levels begin to rise to avoid them being ripped off of their anchor point.

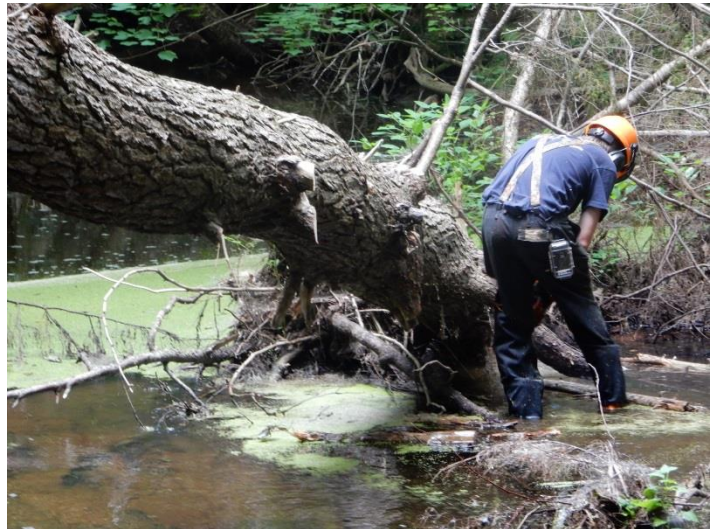
There were several major blockages that were addressed during the 2014 field season. In previous years, major blockages were cut out and completely removed from the river. This year we decided to leave as much of the blockage in the river as possible, to act as fish cover. Small portions of the blockages were cut out to allow water to flow freely and fish to pass. Any part of a blockage that was cut out would be moved downstream and fastened to a strong structure on the riverbank (e.g. tree trunk) so that it and the rest of the blockage that remained upstream could serve as cover for fish. This is an effective and low effort way to add fish cover to a river.

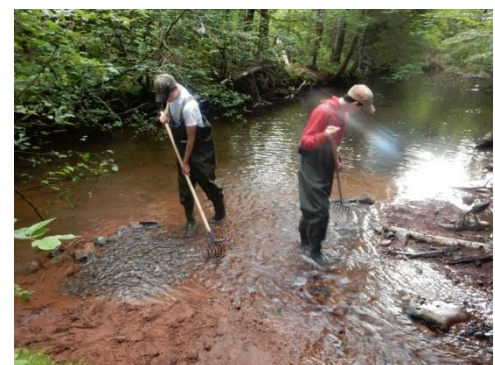
The latter portion of the summer saw the crew focus on enhancing available fish spawning habitat throughout the lower portion of the main branch of the Winter River. Due to the lack of water in the upper tributaries where salmonids would normally spawn, it was of great importance to ensure that there would be adequate spawning areas on the main branch. This was done using two methods. In areas where there was semi-suitable gravel and cobble for spawning, rakes were used to agitate the substrate and dislodge any fine sediment that would impede the development of salmonid eggs. The second method was the installation of artificial spawning beds. This technique was used in areas where the substrate may have not been as favourable for spawning but the water properties were (i.e. spring outflows). This method involved digging a hole roughly one by two

meters in length and about six inches deep (this was the size used for salmon spawning beds, smaller holes were dug for trout spawning beds) in the bottom of the river. This hole was then filled in with appropriate sized rock (gravel for trout and cobble for salmon) which fish could then spawn in.

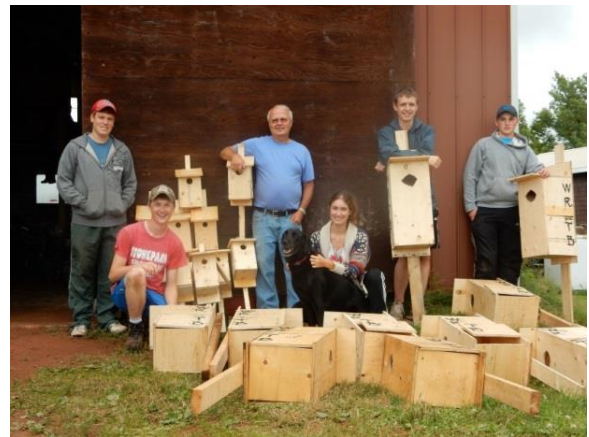
2014 was a big year for nest box construction and placement. 125 nest boxes were built over the course of the summer. Boxes were built for the following species: American kestrel (*Falco sparverius*), barred owl (*Strix varia*), northern saw-whet owl (*Aegolius acadicus*), wood duck (*Aix sponsa*), tree swallow (*Tachycineta bicolor*), and barn swallow (*Hirundo rustica*). 69 of these boxes were installed during the summer, which consisted of 16 American kestrel, 3 barred owl, 5 northern saw-whet owl, 5 wood duck, 25 tree swallow, and 15 barn swallow. This summer also had great nesting success with tree swallow boxes that were previously placed at Union Road pit, with 15 out of the 24 boxes being occupied.
