Winter River – Tracadie Bay Watershed Association (WRTBWA)

Final Report – Summer 2009

SPRING RIVER SURVEY 2009

SUMMER PROJECTS 2009

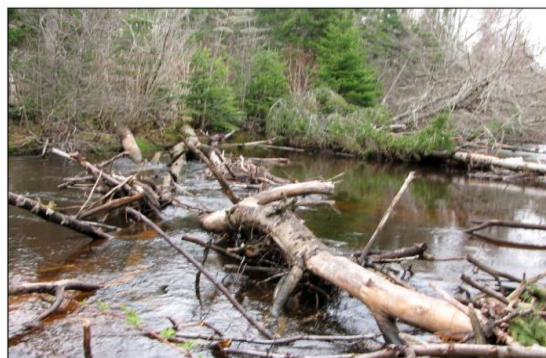
Figure 13. One of the few major blockage areas located near the head of the tide of the Winter River, by Gauthier & Parkman.

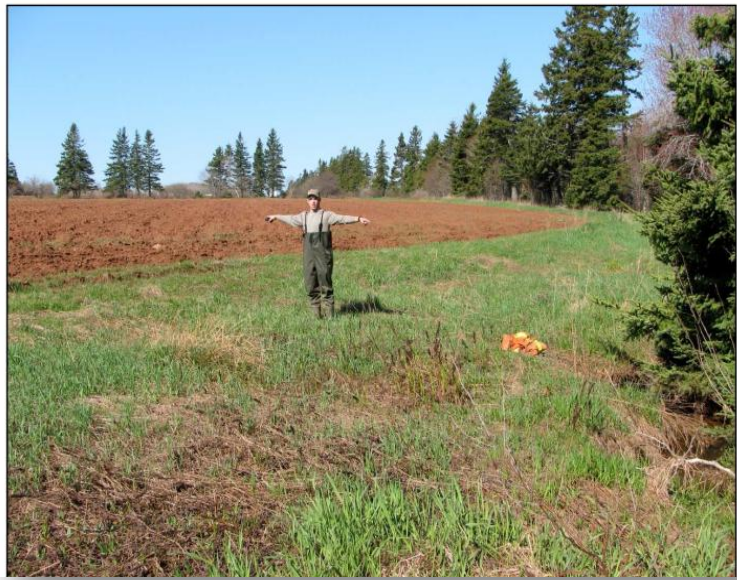
We identified a section, after a small dam, where the buffer is almost non-existent. This would be the same location identified in the River Survey Report and is an area needing brush mats and lots of tree planting. We opened the dam up for better water flow where it narrowed significantly, but this will probably need extra work because it collects debris easily cutting off the water flow. The dam appears to be full of silt and has a fairly shallow layer of water. I'm speculating that the dam was created long ago by the construction of a road to gain access to the other side of the stream. There are concrete blocks that could probably be removed to allow for better water flow, if that was the best course of action and had the support of the landowner. An assessment of this particular area should be carried out by a qualified watercourse technician and a decision made by the stakeholders involved.

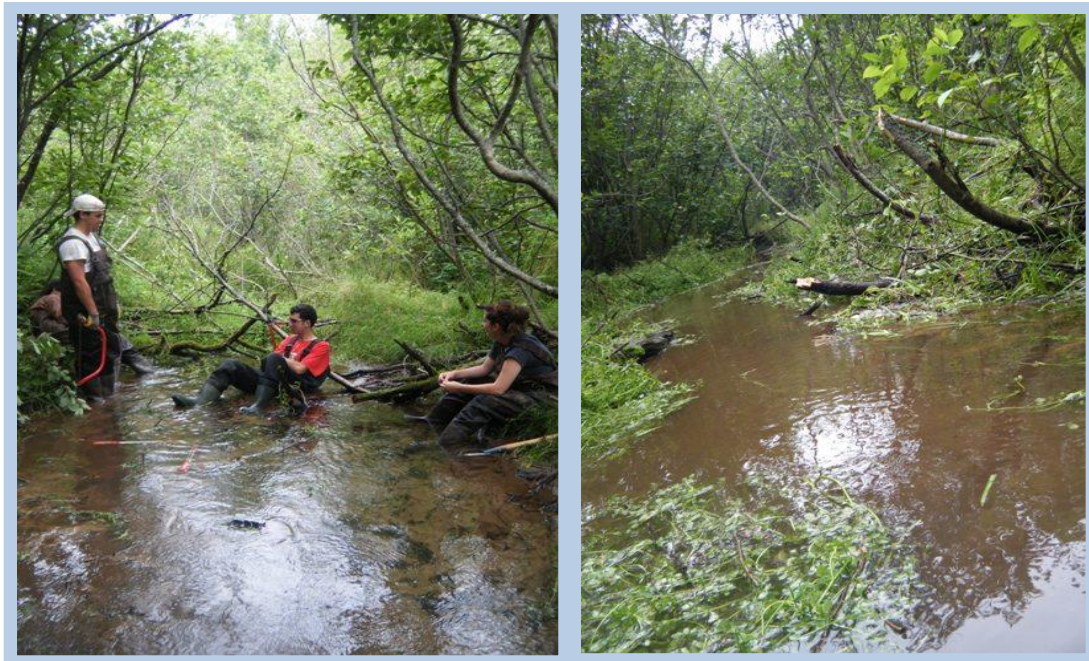
July 27th – Aug 7th: For the first week, we began on the east side of the Union Road and worked our way up to the 'Y' where the stream turns back west. We completed this section then split up and worked on two different parts of the stream. Mark and I worked our way toward the driveway leading to the City's Union Station pump house while Mick, Morgan and Jeremy started at the top end where the three streams break off from the main river. This is the section that completes the middle stream. By the end of the week, we had completed the section from the road (middle stream) to the 'Y' and back to the driveway where we crossed over to finish the mini-section by the house, back to the main road. We also had a small start on the 'connector section'.

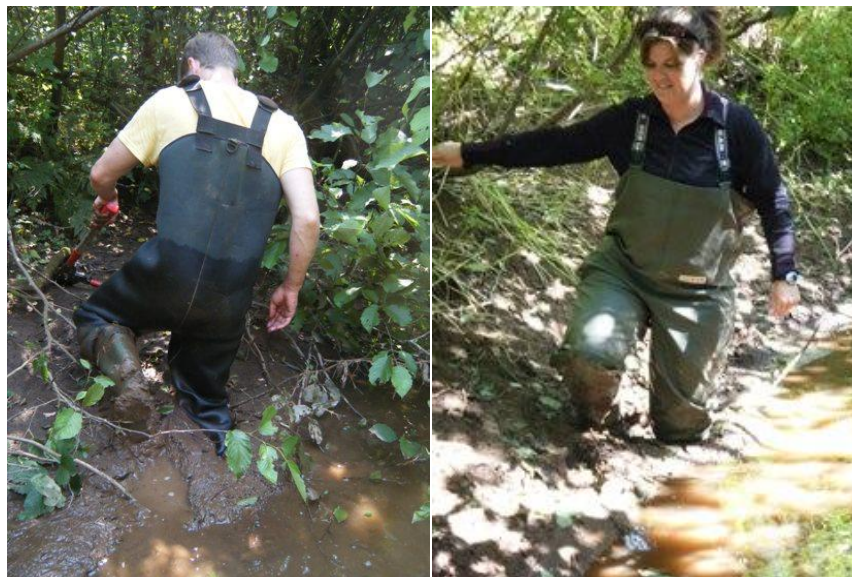
There were some areas from the road to the 'Y' where we found some silt, but otherwise in good condition as far as having a gravel bottom. The section beginning the 2nd stream (west from the 'Y') is in great shape...long sections of nice gravel bottom. Only one area where there is a lot of silt. Found a dead trout ~2" long at the pool where there are 3 culverts under the pumphouse driveway. The mini-section (past the house) was a complete nightmare as far as work goes. There was a great deal of alder growth here to the point where you couldn't see past 2-3 feet. In any case, we completed clearing this back on one of the hottest days (36°C humidex). We didn't want to have to go back! Fairly silty in this area and we did see schools of fish some ~6" long.

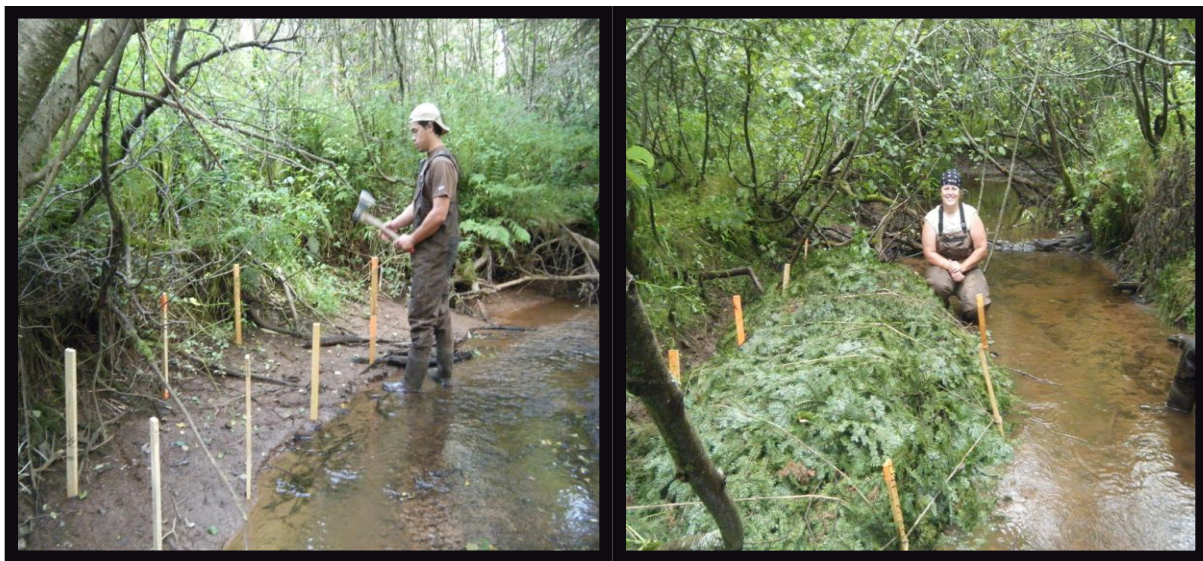
The second week began with me attending the Beaver Management meeting in Montague and Mark/Mick going to FCBB. Tuesday, Mark and I continued to work up on the 2nd stream. This section had much lower levels of water than 2 weeks ago and there was still some alder growth to be removed, but can be done in subsequent years. On Wednesday and Thursday, we began constructing brushmats in the center stream on the pumphouse side of the Union Road. Fairly silty areas in and around the pumphouse station and we will likely continue to build brushmats in this area for the next couple of weeks. Friday was a welcomed holiday!
