WINTER RIVER - TRACADIE BAY
WATERSHED ASSOCIATION

Work Report for 2020-21

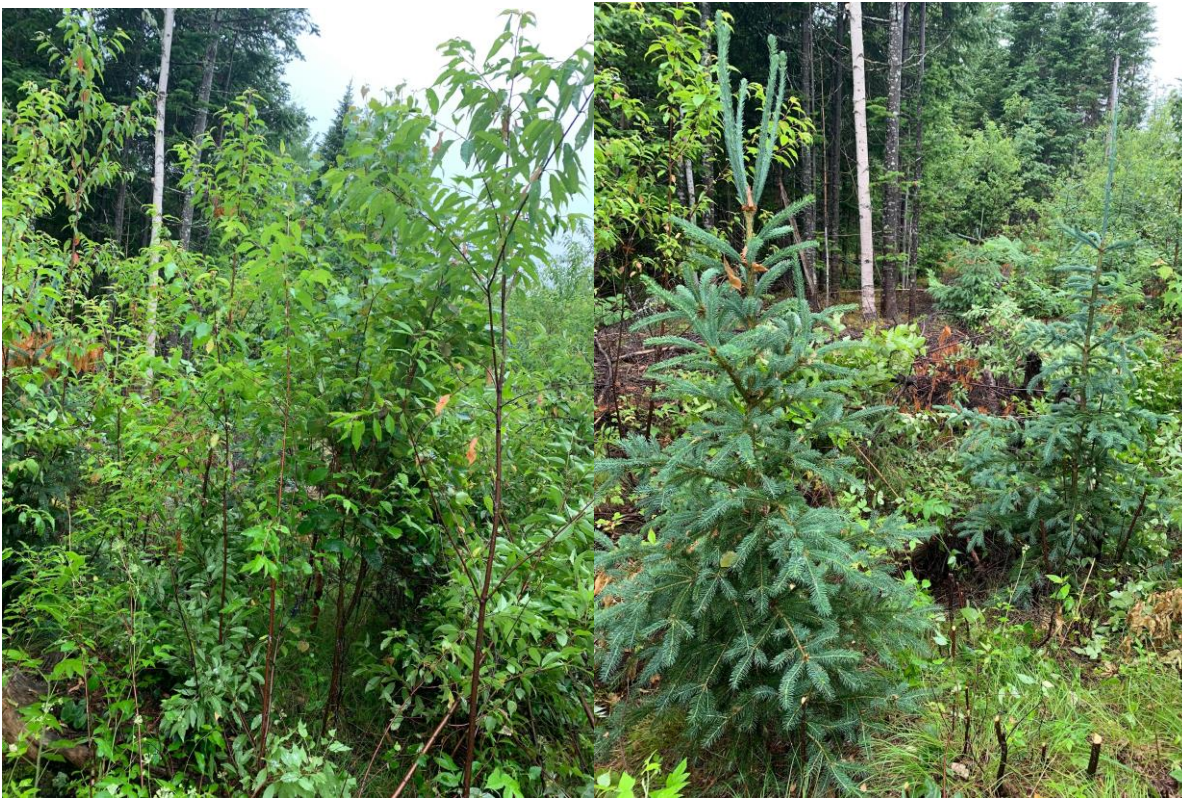
Tree clearing and pruning occurred at a couple sites on the Glenaladale property this season. At the Glenaladale woodlot, trees were thinned out in areas dominated by pioneer species such as Pin Cherry, White Spruce, and Gray Birch to create space for other species to thrive. Pruning efforts focused on pruning multiple leaders and removing dead branches, or those that would break and cause problems for the tree in the future. This was a continuation of work started on the woodlot last year, and some tree planting has already been completed in this area with Eastern Larch, Red Maple, Yellow Birch, White Birch, and White Pine. Brush piles were constructed with the cut trees and branches, creating habitat for wildlife in the area. This summer, the crew also removed chicken wire, buckets, and other garbage from the woods.

Figure 2. Before and after pruning to release trees at Glenaladale woodlot.

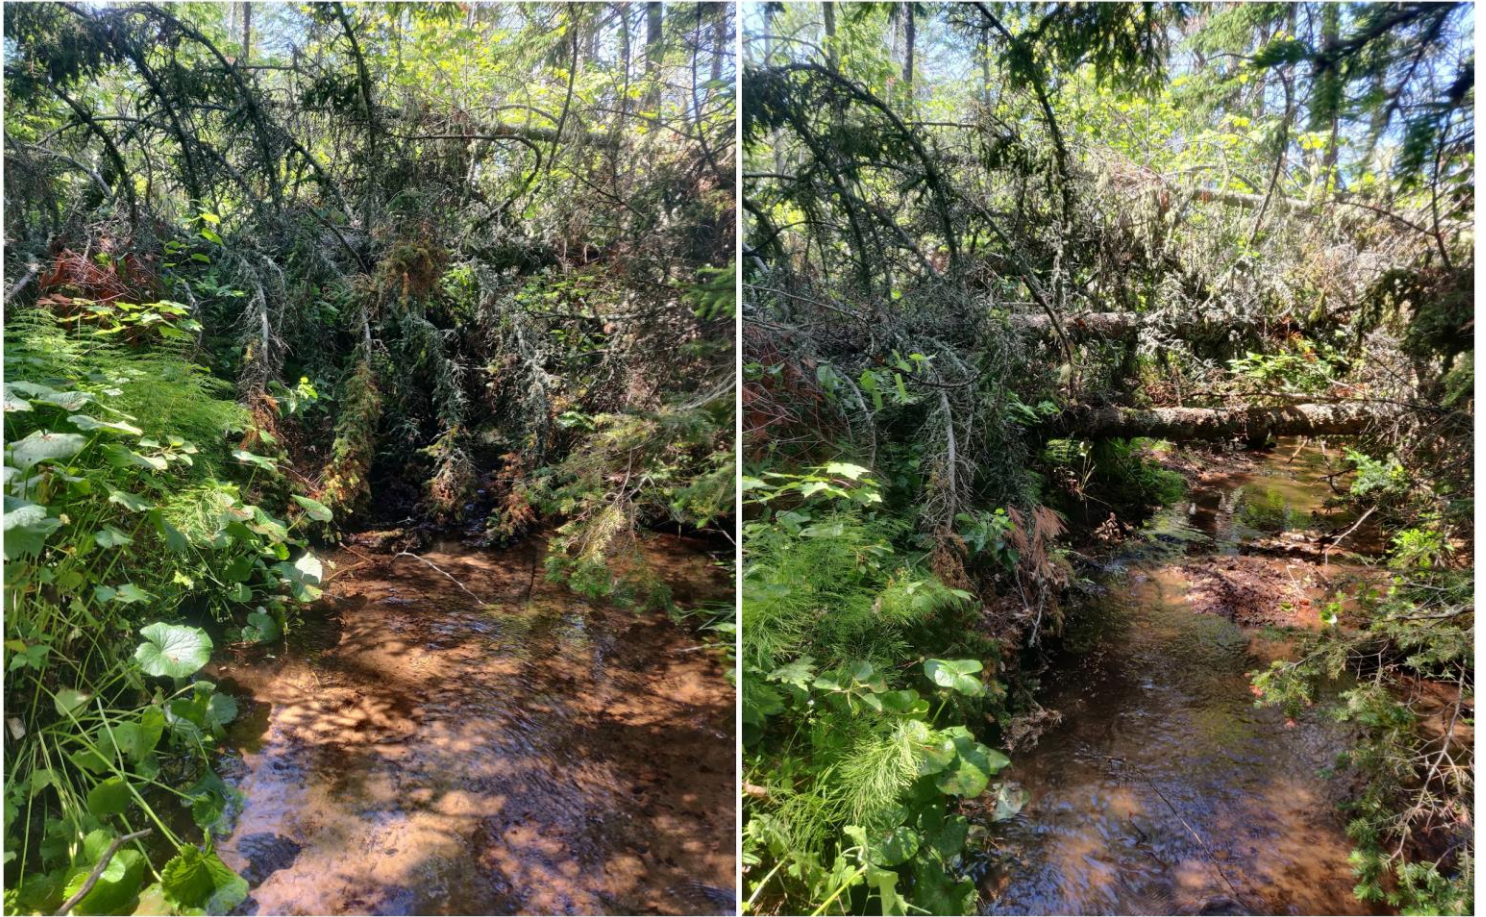
Figure 3. Before and after work was completed to minimize stream blockage for fish passage from fallen trees. Chainsaw crews will eliminate these trees in future years.

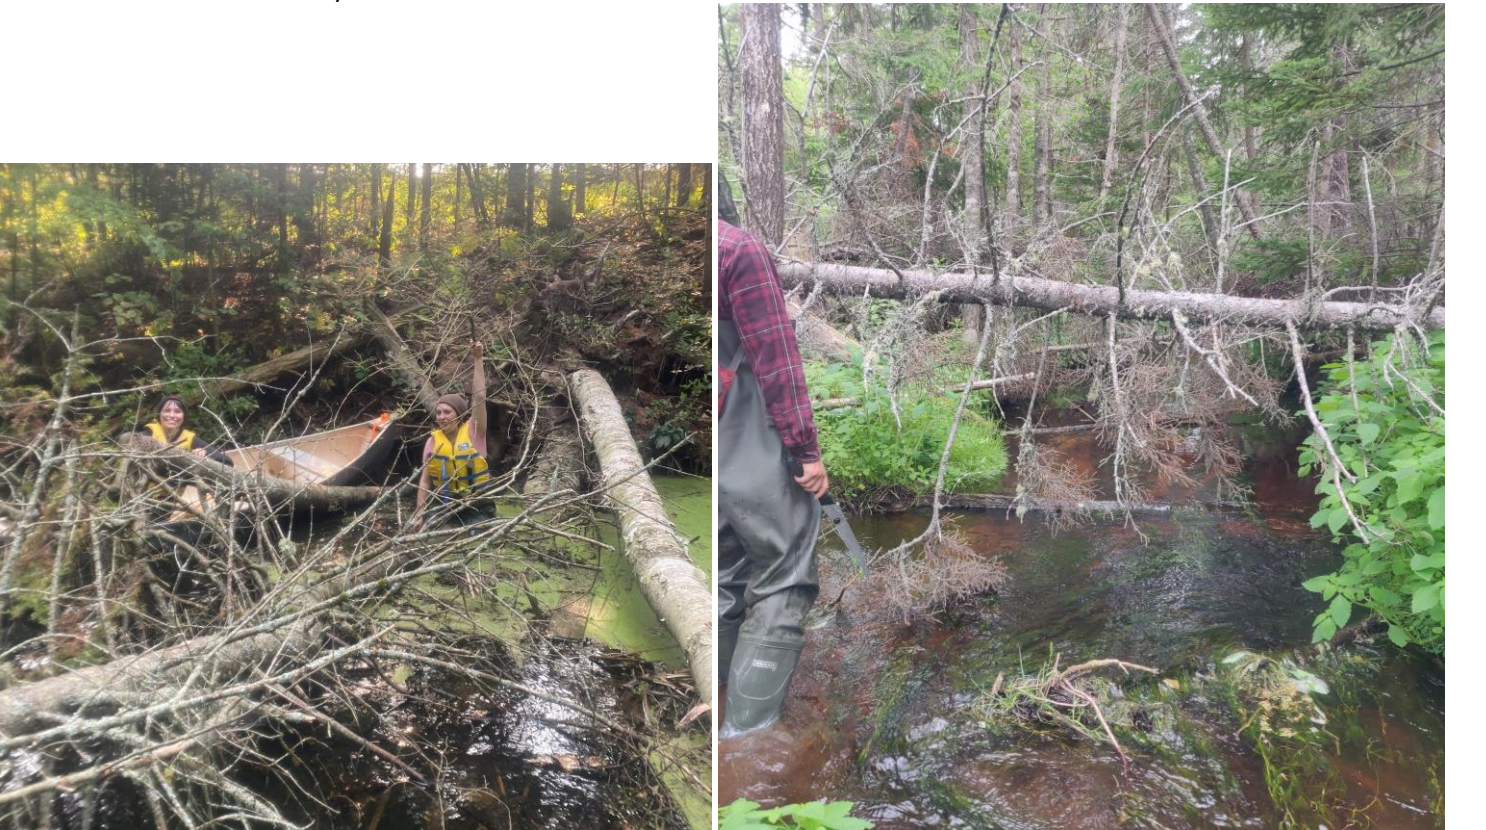
Figure 4. The crew getting ready to stream clear along the main branch of the Winter River (left) and Friston South (right).

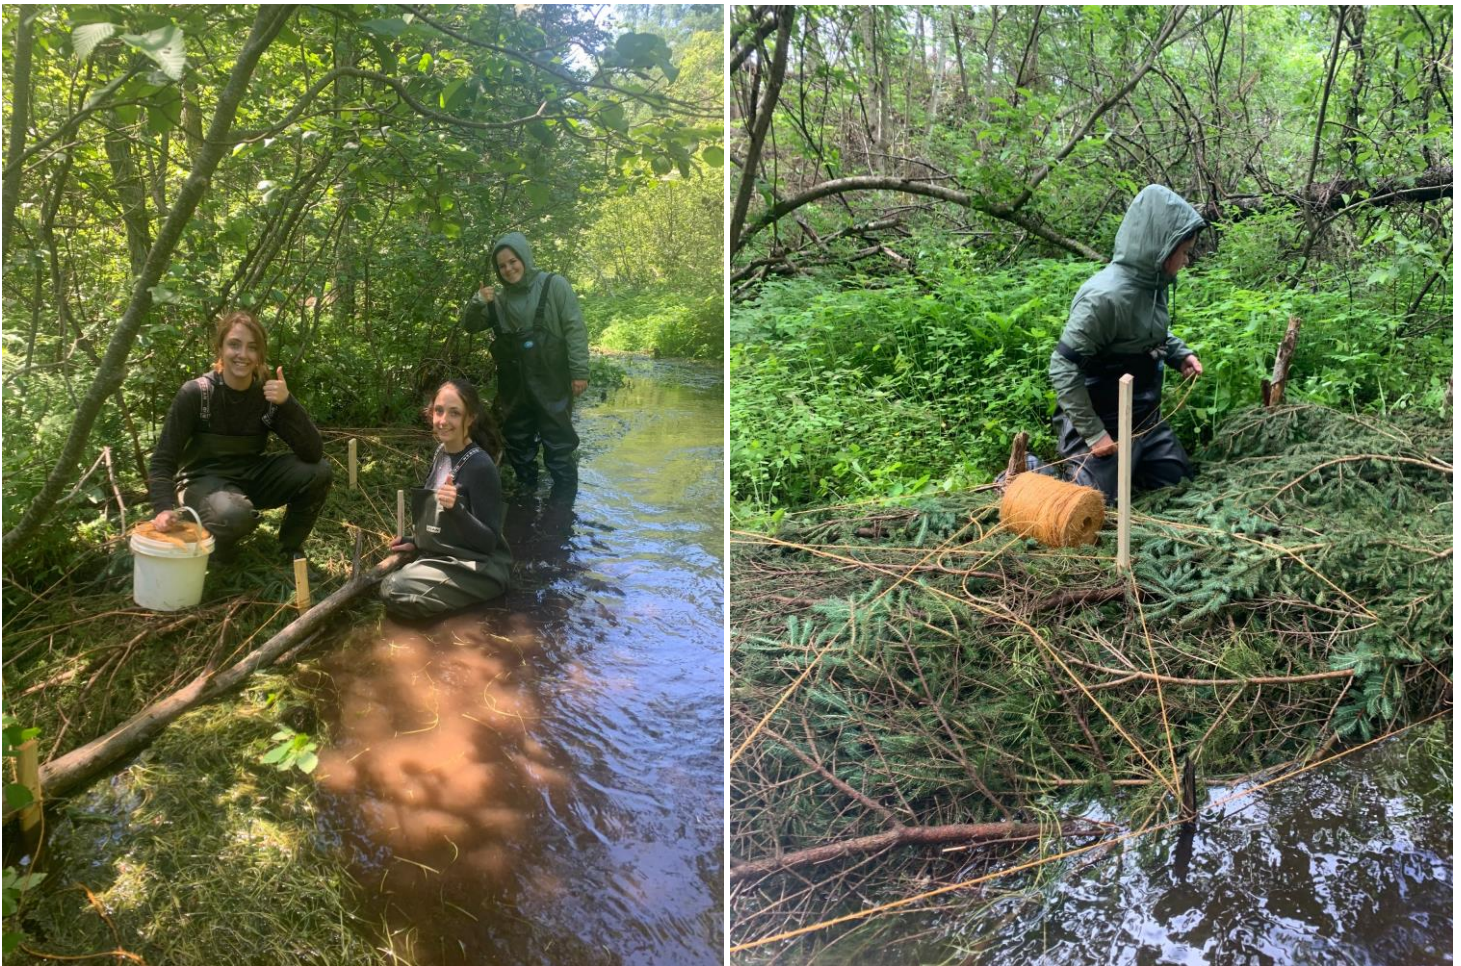
Figure 5. The crew building brush mats along Tim's Creek.

Brush mats were enhanced above and below the road crossing at Tim's Creek to reduce sediment in anticipation of the culvert replacement on Suffolk Rd. The replacement was originally scheduled for summer 2020, but with COVID-19 delays, the installation of the purchased culvert has been rescheduled to 2021. On the Friston Branch, 3 brush mats were improved. This is quite a silty branch of stream, and is located near an active shale pit. The brush mats will help collect silt, building up the bank in the process. The brush mats will also work to narrow the stream channel, following the natural meander of the watercourse. Further brush mat construction occurred along the MacLauchlan branch, a continuation of advice given by fish biologist Rosie MacFarlane, who identified a site as being important for young fish. Brush mats were needed on both sides of the stream to narrow the channel, increasing flow and allowing the sediment-covered stream bottom to start scouring itself out.

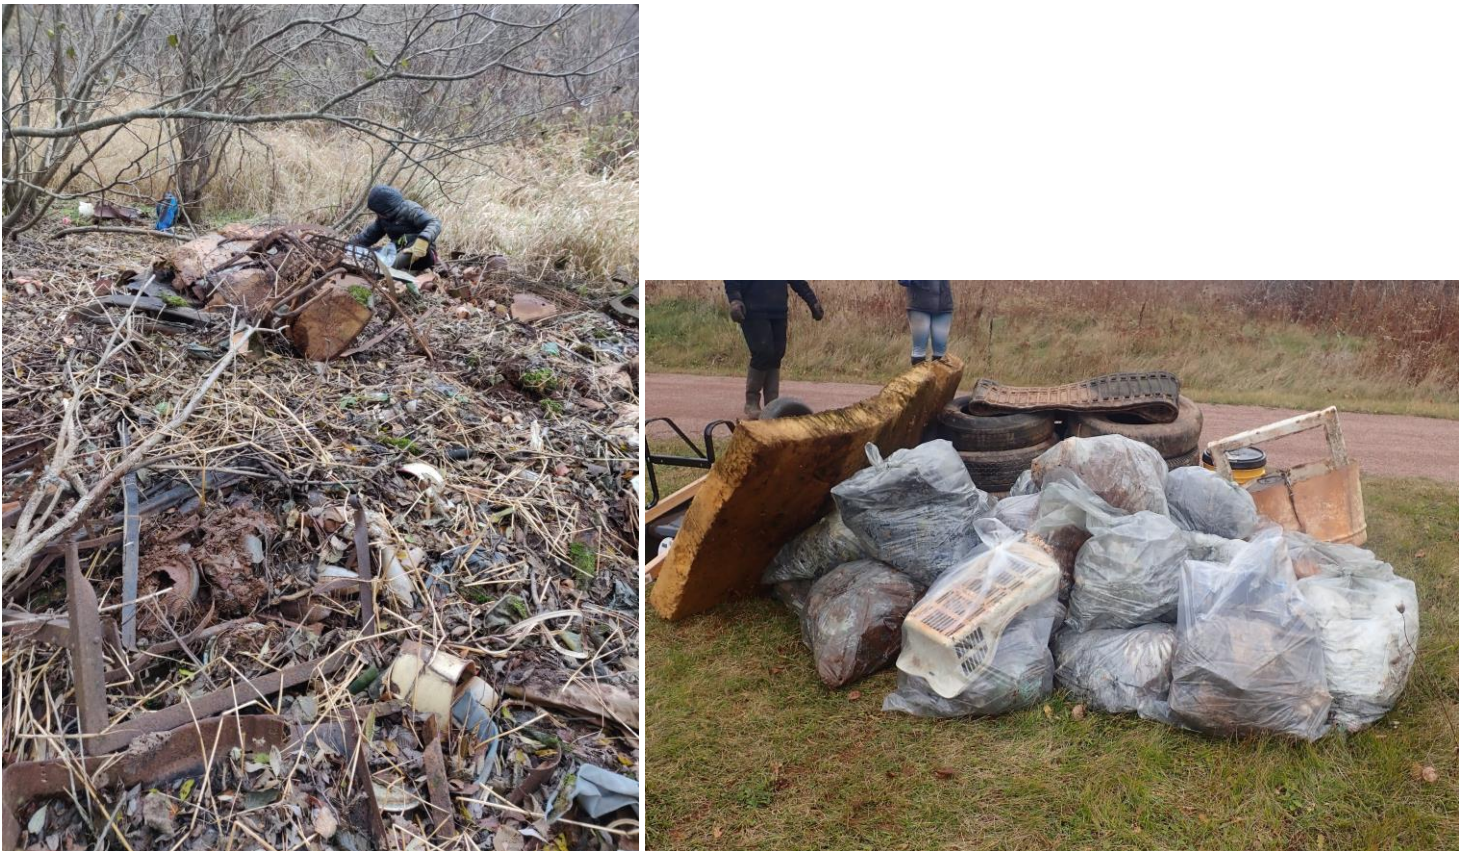
The crew also took on the cleanup of several old dump sites near streams. The garbage here included old vehicles, tractor parts, glass and metal food containers, oil cans, cleaning products, shotgun shells, paint cans, barbed wire, old appliances, many tires, and even old pesticide containers. Due to the very large volume of materials that were found, staff prioritized items that would pose greater risks to the environment, and secondly those which were a risk to people who would be completing stream work in these areas in future. 1,300 kg of garbage was cleaned up from these sites, and more work is planned for next year.

Figure 6. The crew cleaned up garbage at many dump sites adjacent to streams this fall. The photo on the right is 1 of many piles that were taken to Island Waste Management Corporation for disposal.

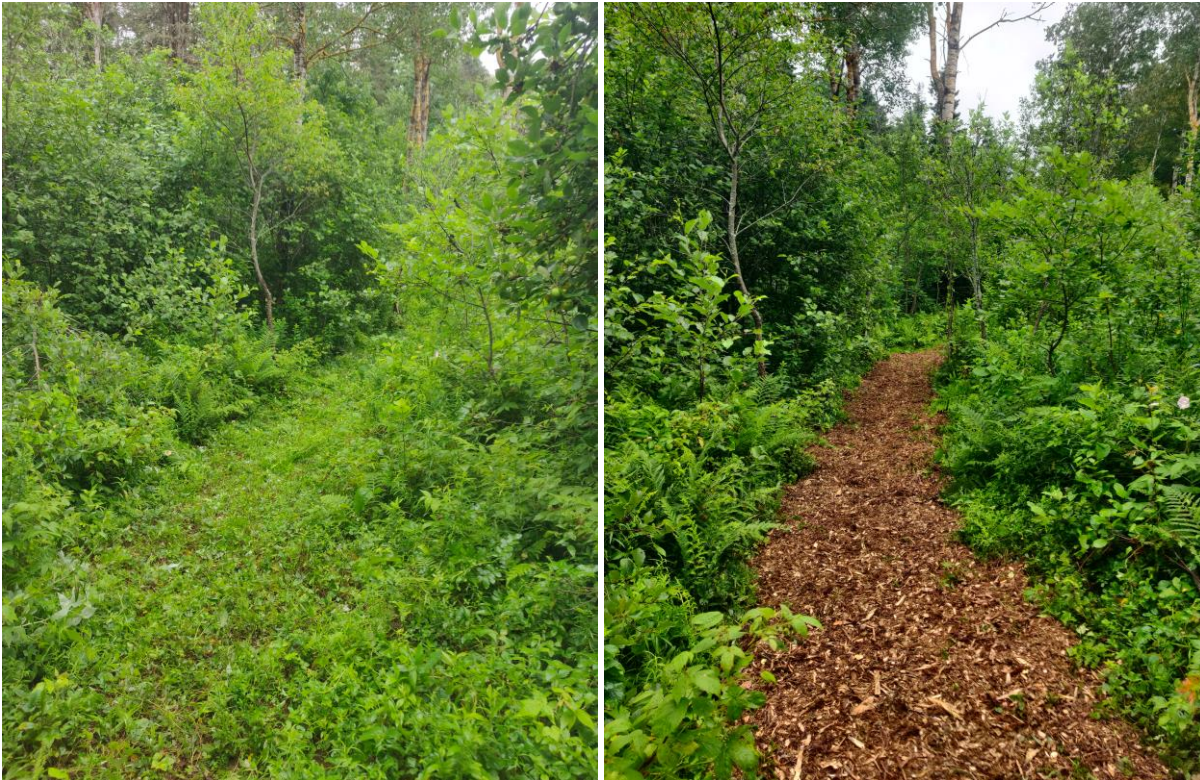
We received wood chips from trees that were cut along the Suffolk Road by Maritime Electric maintenance crews. There was 1 load dropped off at the Watershed property, but due to space limitations, further material was put at the farm of a volunteer about 1 km away. Material can be transported from this site to the Watershed property as needed. The field crew spent time carrying wood chips from the pile at the centre of the property, and placing them on the trail to inhibit future plant growth on the path. Wood chips also help to define the path more clearly for visitors. Figure 7 shows an example of before and after crew members cleared vegetation and covered a section of the trail with wood chips. In preparation for future work on the trail, brainstorming was done

Figure 7. Before and after vegetation was cut and wood chips were laid on the trail at the donated woodlot trail.

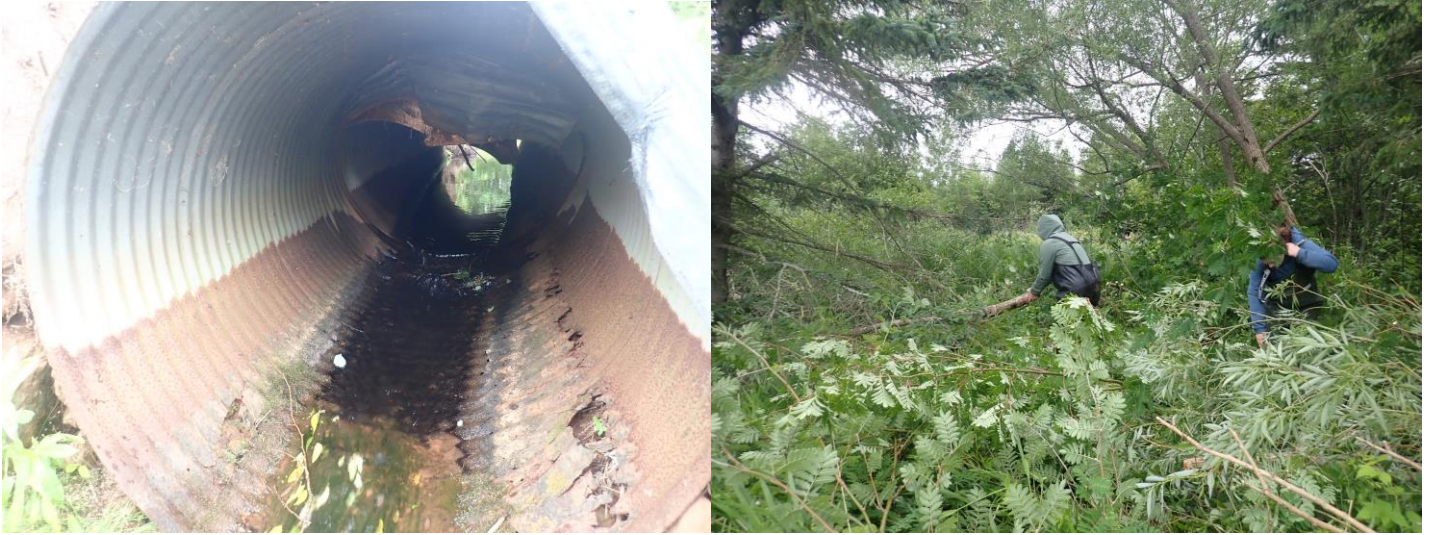
Figure 8. Left: culvert PR-039 from the downstream end on 2020-07-14, before removal in August. Right: crew clearing a path for equipment to come in to remove the culvert.

Culvert PR-039 was removed this summer. The culvert was part of an old stream crossing, no longer in use, between agricultural fields. Before its removal, it was assessed and found to have a large outflow drop, shallow water, and insufficient backwatering. It was also quite deteriorated and bent, where 2 sections of pipe were no longer well connected and each had a different slope. Brook Trout have been spotted during stream assessment surveys in this area on multiple occasions, and the removal of this culvert should help to improve their passage through the area.

Prior to removal, the surrounding trees were pruned or limbed to allow easier access for the contractor. A couple trees growing on top of the culvert had to be cut down with a chainsaw. Heavy equipment was used to haul out the old culvert and grade the slope of the banks on either side of the stream afterward. After removal, the crew raked the banks and planted grass seed. Geojute was pegged down on top using live willow cuttings to help control erosion, holding everything in place as the vegetation on the banks became established. The area was periodically watered and checked after rain events for signs of erosion. Shortly after removal, the streambed began scouring itself out, and in the coming years the stream should carve out a more natural, meandering path where the culvert once impeded this. The culvert site was last checked in late November, and the grass had become well established, with no signs of bank erosion.

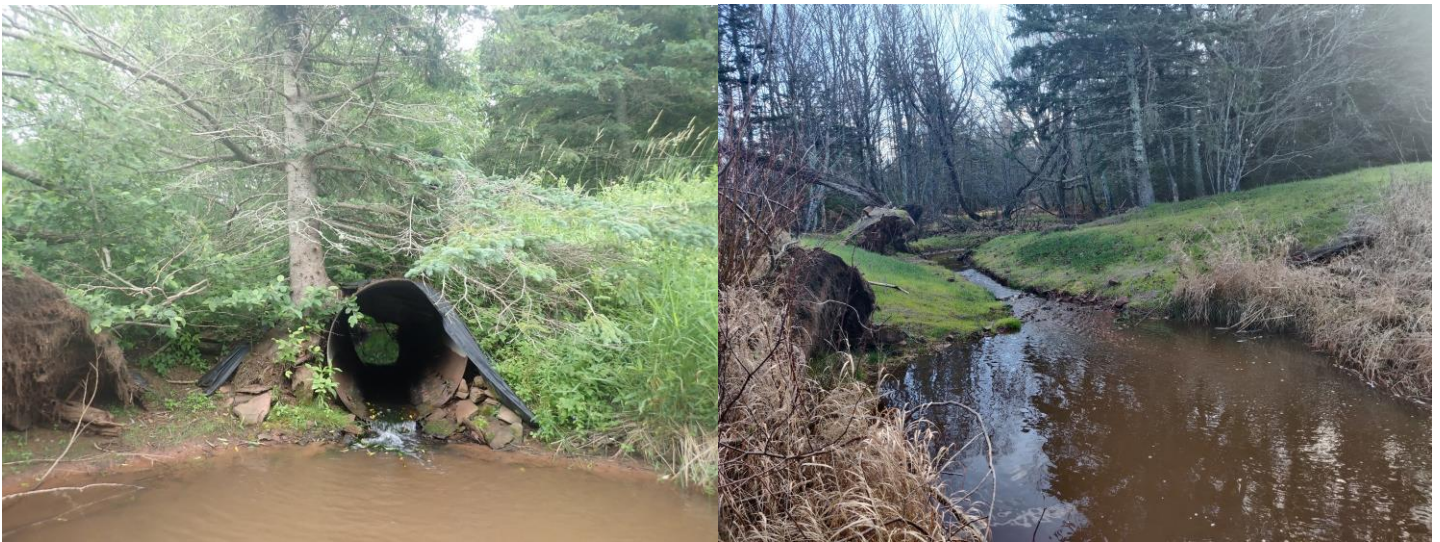
Figure 9. Before and after the culvert removal at site PR-039. The left photo was taken in July, the culvert was removed in August, and the right photo was taken at the end of November.

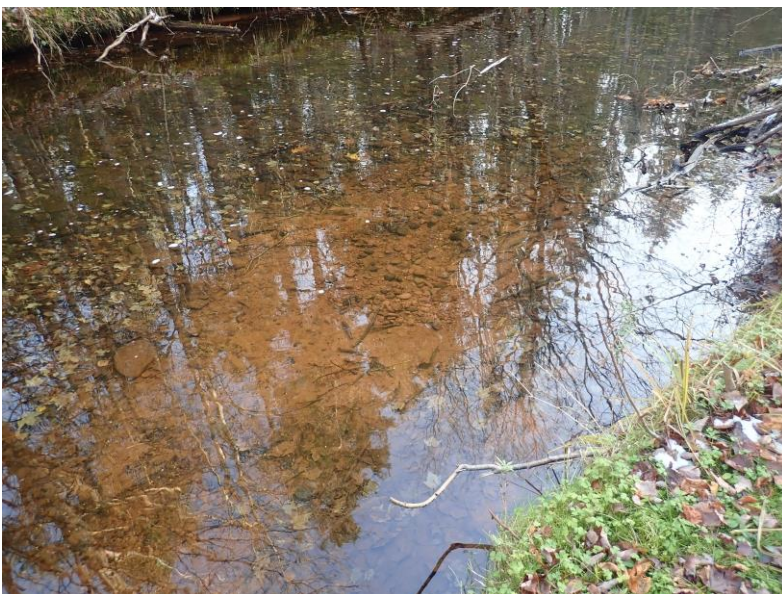
We found 43 potential redds in total, along 9 of the branches surveyed throughout the Watershed. For the past few years, we have been unable to conduct redd surveys due to the siltation that can occur after the heavy rain events typical of the fall months. Streambeds with high levels of fine sediment in the areas where spawning or incubation occur can have a negative impact on fish reproductive success. It can lead to silt infiltration in the nest over the winter months, collecting around the eggs and limiting the amount of oxygen available to the developing embryos (Franssen, 2011). As such, we are looking into ways to correct this issue, but we were happy to see redds and Brook Trout of reproductive size in our streams this year.

Figure 10. A redd found along 1 of the branches surveyed in the Winter River--Tracadie Bay Watershed.

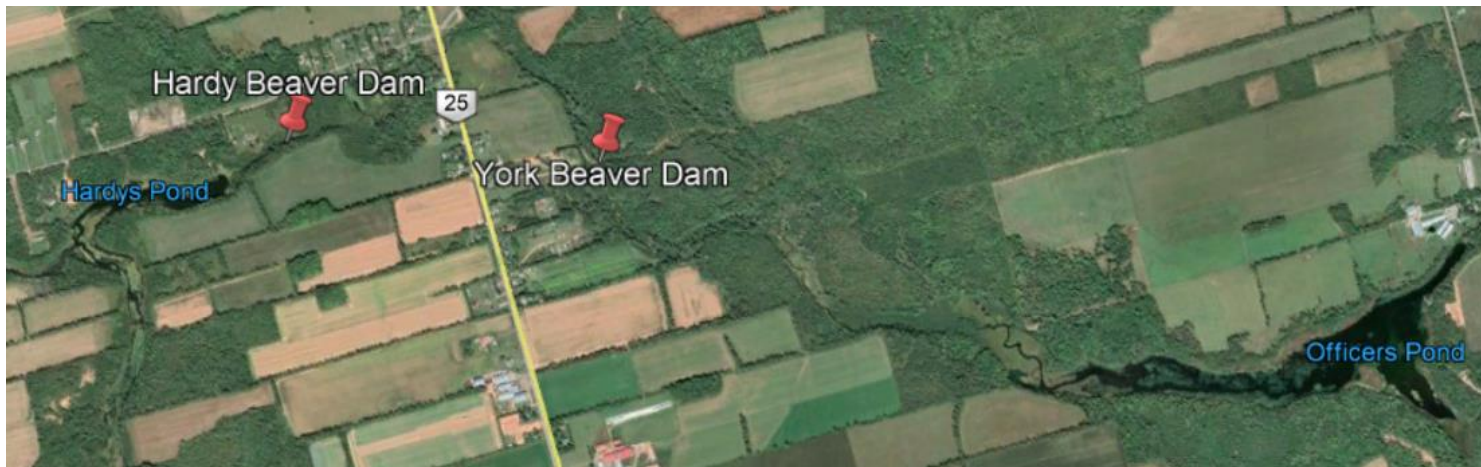
The beaver dam below Hardy Mill Pond was in the same location as last year. In December 2019 a trapper was sent out and caught 4 beavers, and we breached the dam once all were removed. During a stream assessment

survey in the fall of 2020, it was found that beavers came back and repaired the dam, making it even more robust than before. The area is still being actively trapped at the time of writing, with 1 beaver trapped so far.

Figure 12. The beaver dams observed in 2020 within the Beaver Management Zone of the Winter River-Tracadie Bay Watershed.

After the trapper had been out to the York site, a notch was made in the dam to allow water to flow. If there were any beavers in the area they would be attracted to the sound of the flowing water and come to patch up the hole. While the trapper did not catch any beavers, the dam had not been repaired when checked a few days later, so it was assumed that the beaver was no longer present in the area. Raena and Brittany then went back out to the site and breached the dam, removing the intertwined sticks and muddy debris with beaver hacks and handsaws. This area seems to be a reoccurring problem; in 2018 8 beavers were trapped from this location.

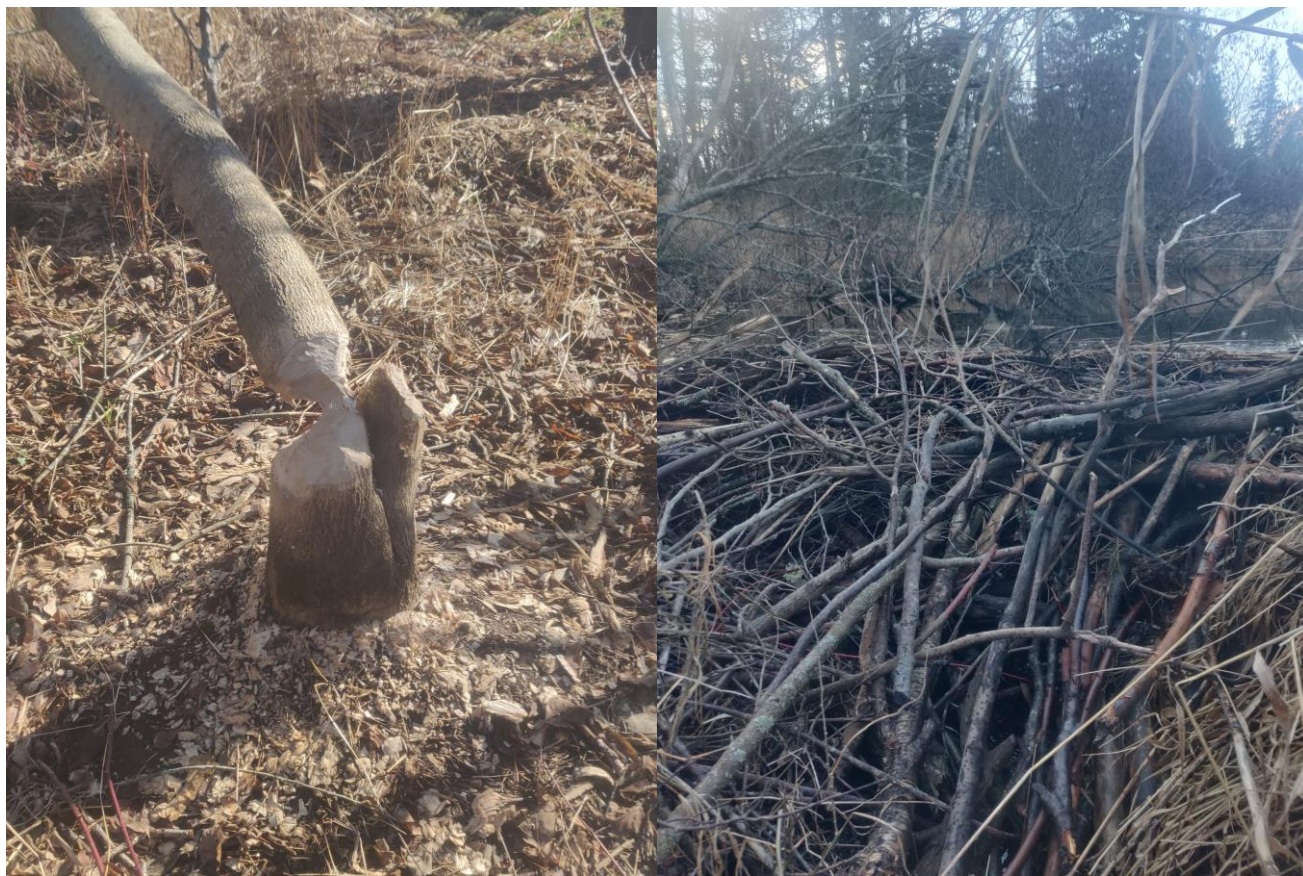
Figure 13. Beaver sign (left) and dam (right) downstream from Hardy Mill Pond.

During the stream assessment in the spring, there were signs of beaver activity observed along a few areas within the beaver-free zone. In the fall, a trapper was hired to remove beavers from 2 locations along the main branch of the Winter River. The beavers built dams in York and below Hardy Mill Pond that were impeding the flow of water and greatly affecting fish passage (Figure 13).

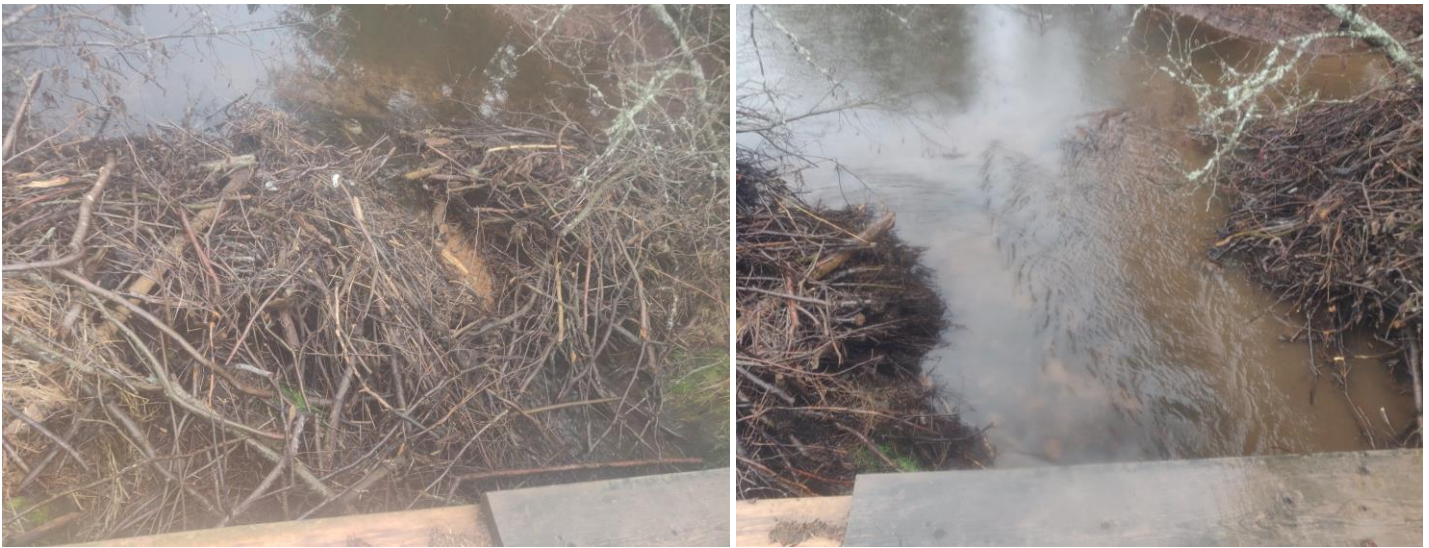
Figure 14. York beaver dam before and after clearing by fall crew.

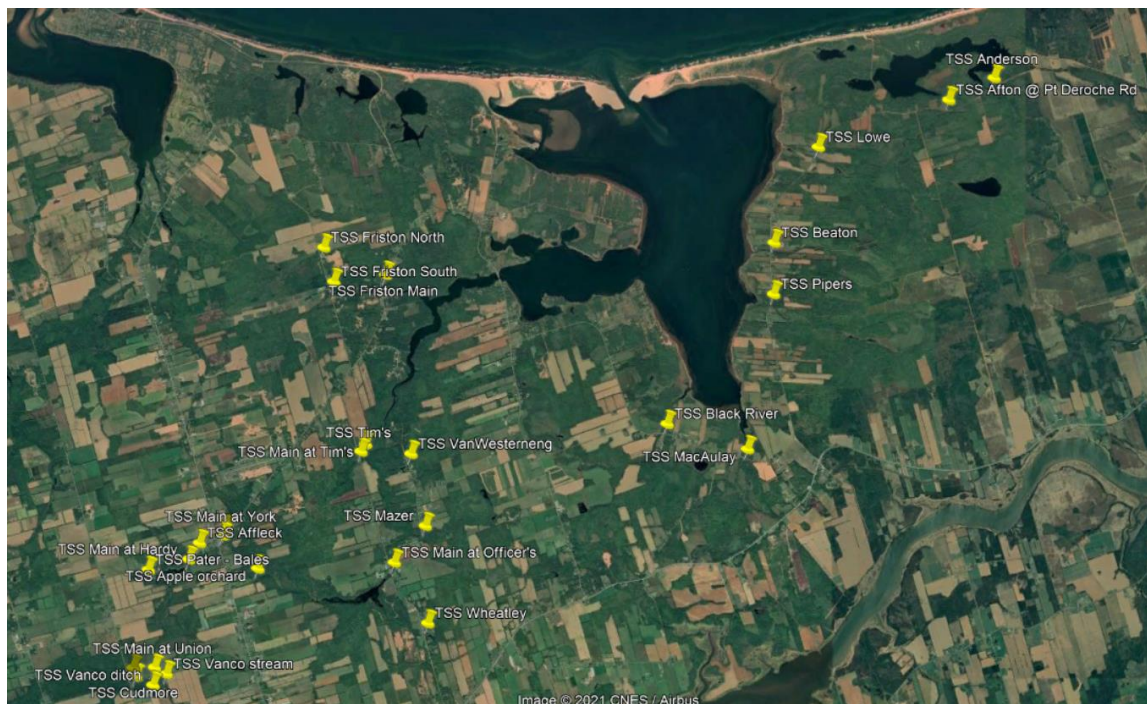
Figure 18. Map of total suspended solids (TSS) sampling sites in 2020.

Table 4. Total suspended solids (TSS) sampling results from 2020-09-24, from lowest to highest TSS per site. See Figure 18 below for a map of locations where these samples were taken.

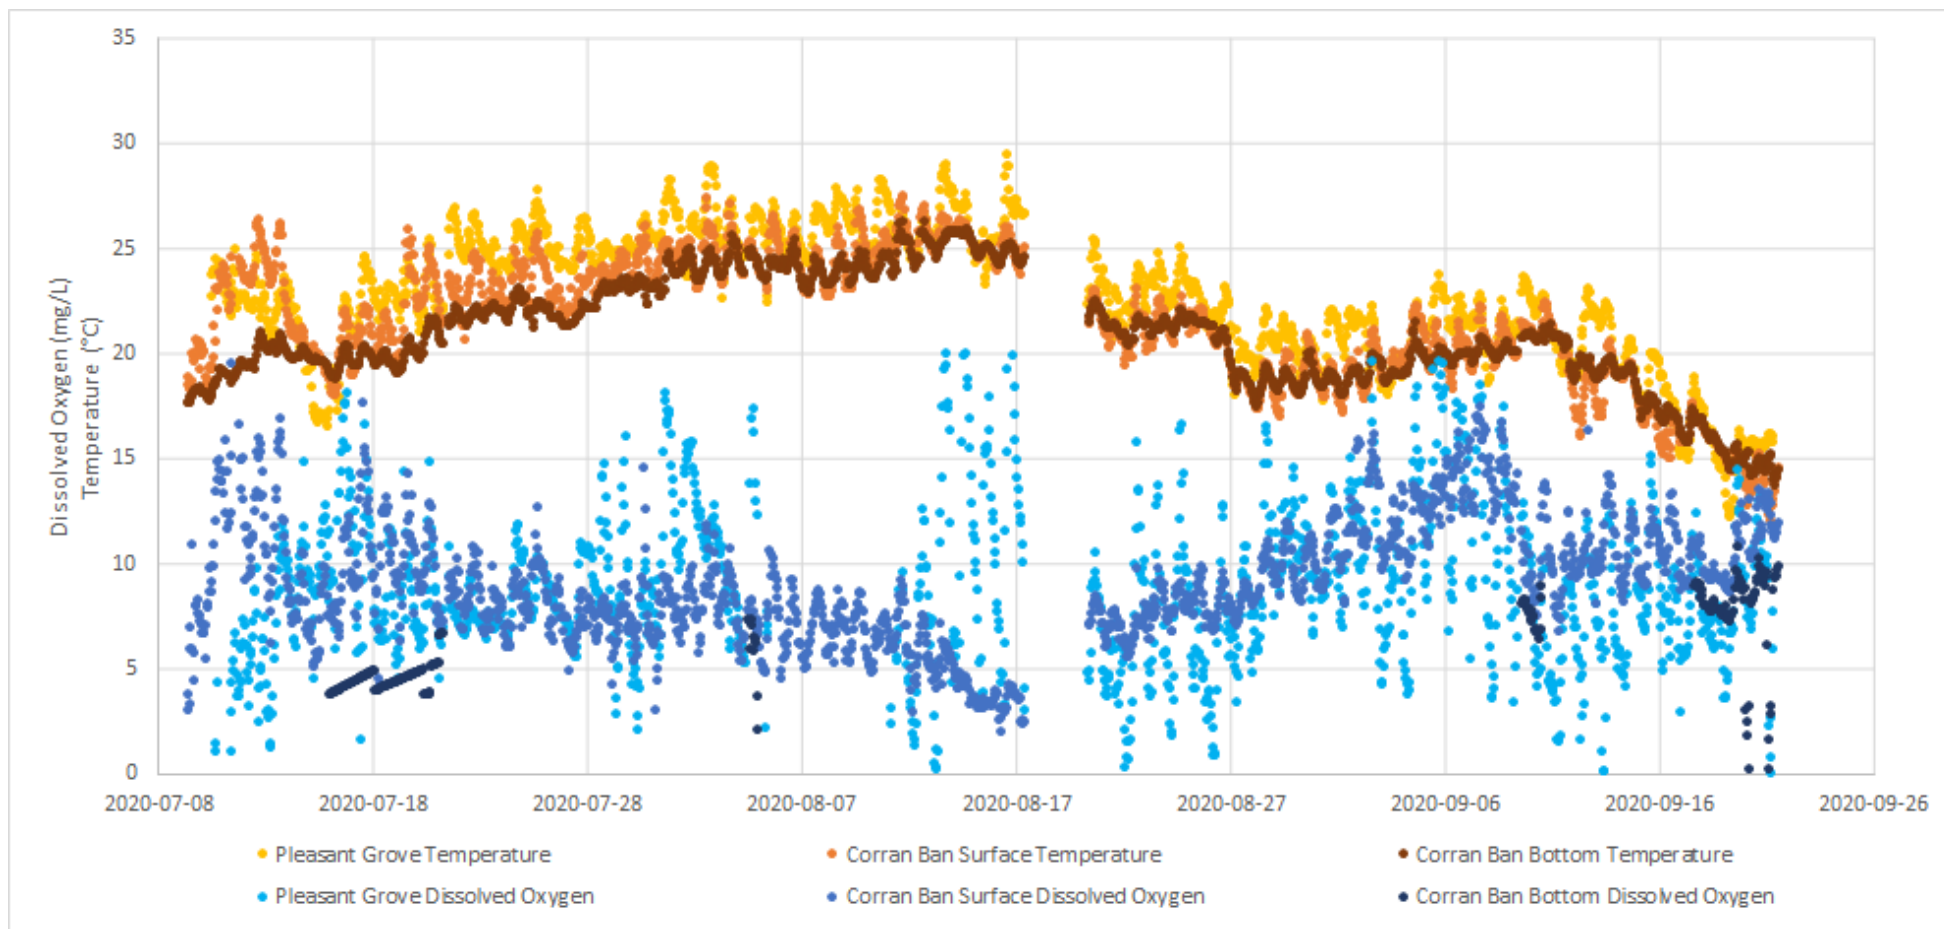
Figure 19. The temperature and dissolved oxygen values recorded every hour by 3 HOBO U26-001 Dissolved Oxygen Loggers deployed at sites in the Winter River estuary from 2020-07-09 to 2020-09-21. The Corran Ban Bottom site dataset is significantly reduced due to data quality issues.

It should be noted that there were some data quality issues with the loggers, with extremely high and low values recorded sporadically. The bottom logger at Corran Ban was especially problematic. The sensor repeatedly became covered in muck from the bottom of the estuary with the changing tides, despite efforts to keep it clean. As a result, a large section of data had to be removed from the dataset. Some data also had to be removed from the Pleasant Grove dataset due to poor quality readings. As such, results should be interpreted with caution. According to the logger manual, the reading range for dissolved oxygen is 0-30 mg/L and the calibrated range is 0-20 mg/L. As such, all values under zero and all values over 20 were removed during data analysis. There are short breaks in data approximately every 2 weeks where data was downloaded from the loggers back at the office. The loggers were usually redeployed the same day they were retrieved, but from 08-17 to 08-20 they were all out of the water for a stretch before redeployment.

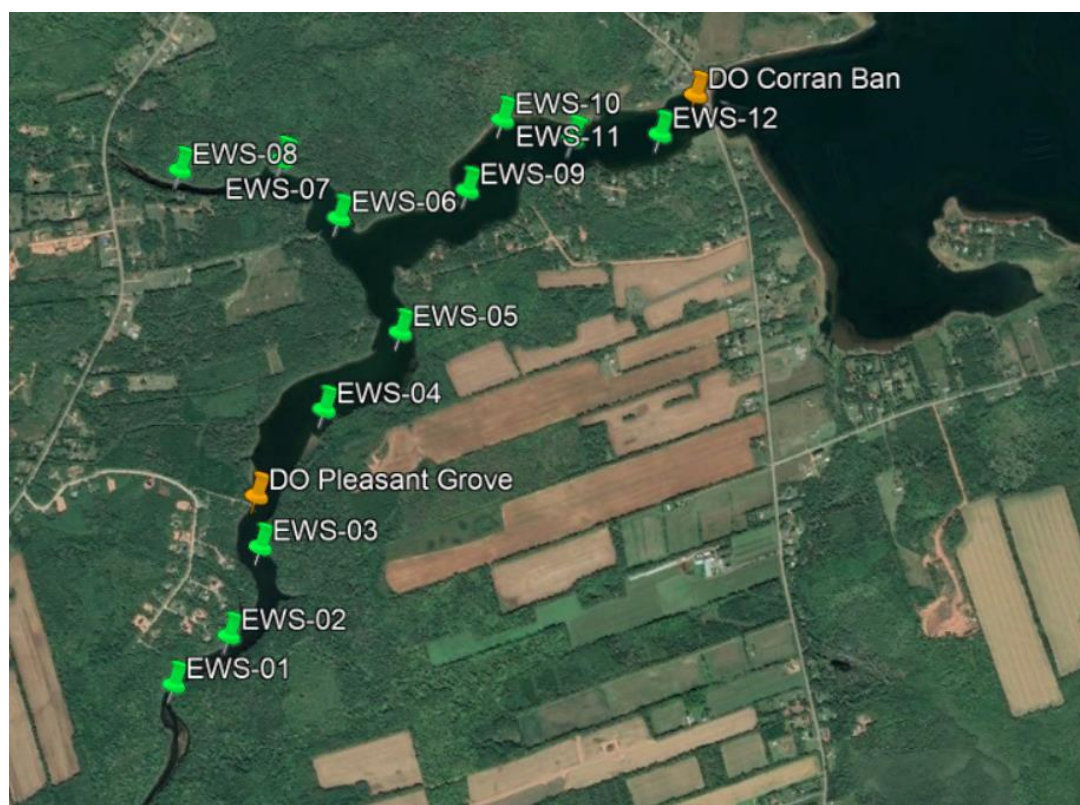
Figure 25. Map of points sampled during each Estuary Survey in the Winter River estuary. Shows proximity of each point to the bay and head of tide (end of tidal influence).

Table 6. Dissolved oxygen (mg/L) measured with the YSI for the 12 Estuary Survey monitoring sites in the Winter River estuary. Red values are hypoxic, grey are without data. EWS-02 and EWS-03 were the only points with YSI readings taken on 2020-07-21, due to extra time available after checking the DO loggers that day. The missing points from 2020-07-28 are due to time constraints on that survey day. On 2020-09-16 survey point EWS-08 could not be measured due to an extremely low tide.

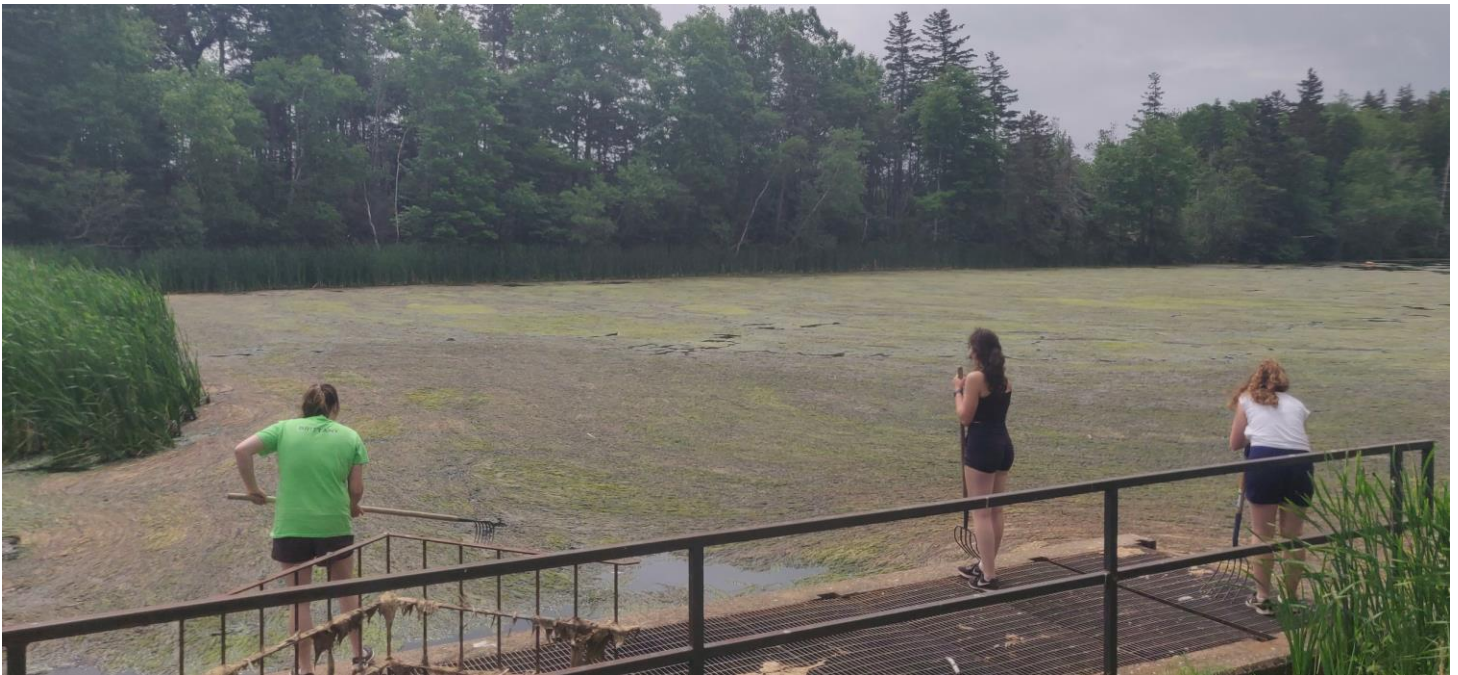
This summer the drought experienced in PEI likely impacted the water temperature within the ponds. Without rainfall to flush the pond, and with limited groundwater flow (due to a history of water extraction by the City of Charlottetown), water has a long time to continue warming in the shallow pond before moving on downstream. The amount of algae within Officer's Pond was also noticeably worse this year. This was commented on by our staff members and by the landowner. There were also numerous dead fish found in this area (Figure 30) and while the cause of this is unknown, there is a possibility it was related to high temperatures or oxygen issues related to the algae build up. Our staff members made efforts to clear some of this algae using hand tools as a temporary improvement (see Figure 29). Throughout the summer, large quantities of algae also accumulated near the Officer's Outlet depth logger, which were routinely cleared away by staff during water discharge measurements.

Figure 29. Crew members using rakes to clear away built up algae at Officer's Pond.

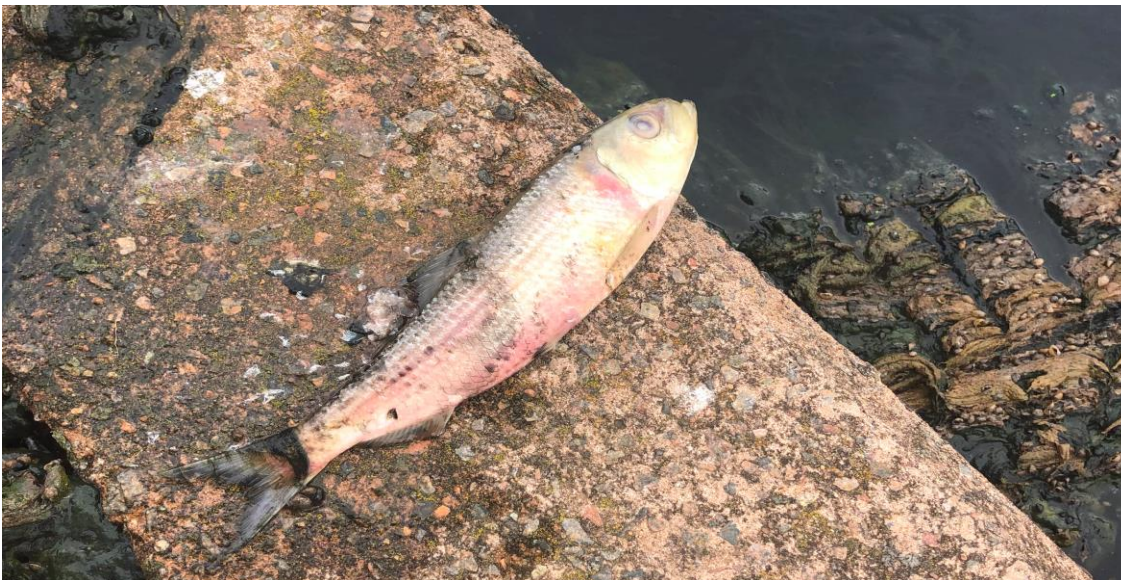
Figure 30. An example of the numerous dead Gaspereau found at Officer's Pond during the 2020 field season.

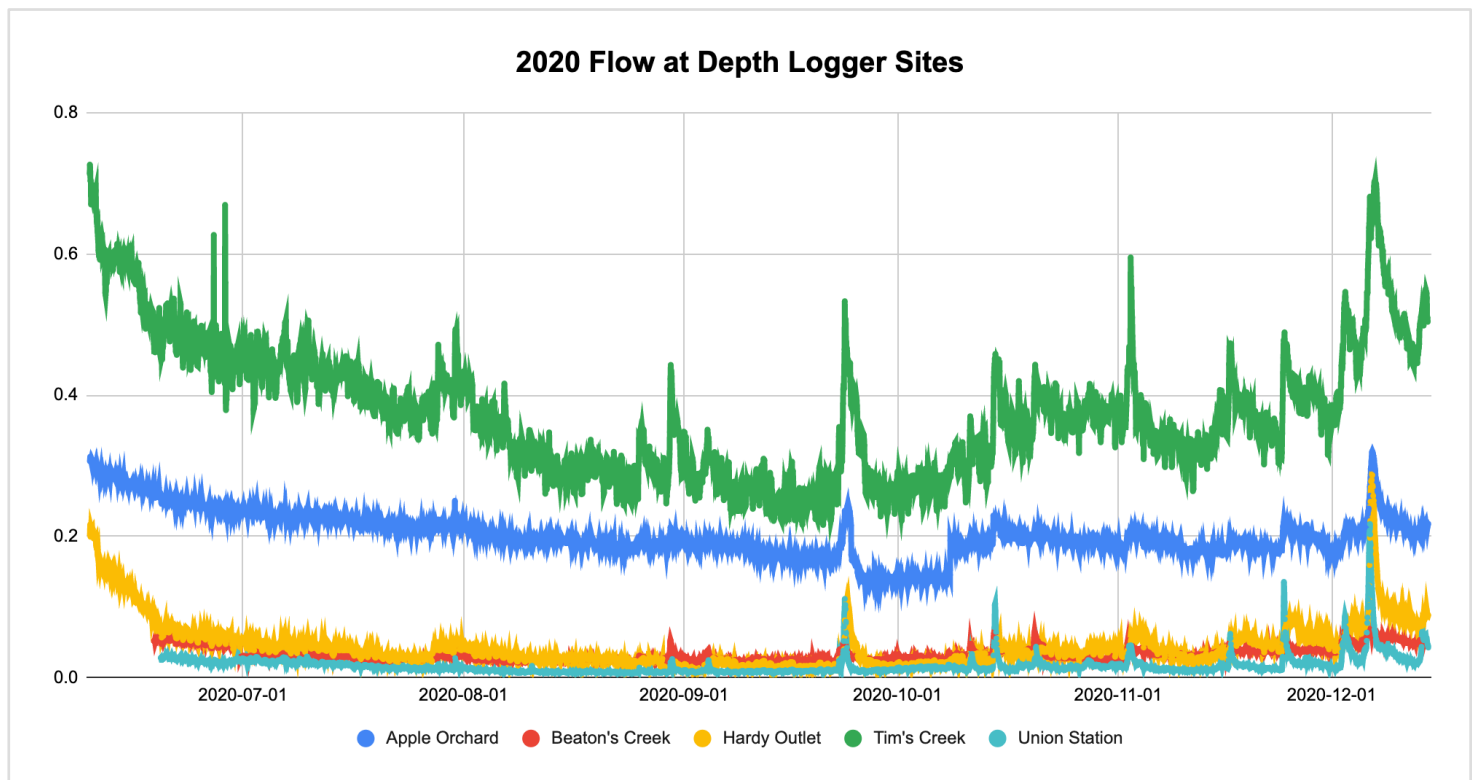
Figure 34. Flow values for the 2020 field season at each of the depth logger sites. Note that the depth logger location for Officer's Outlet has been omitted due to logger error.

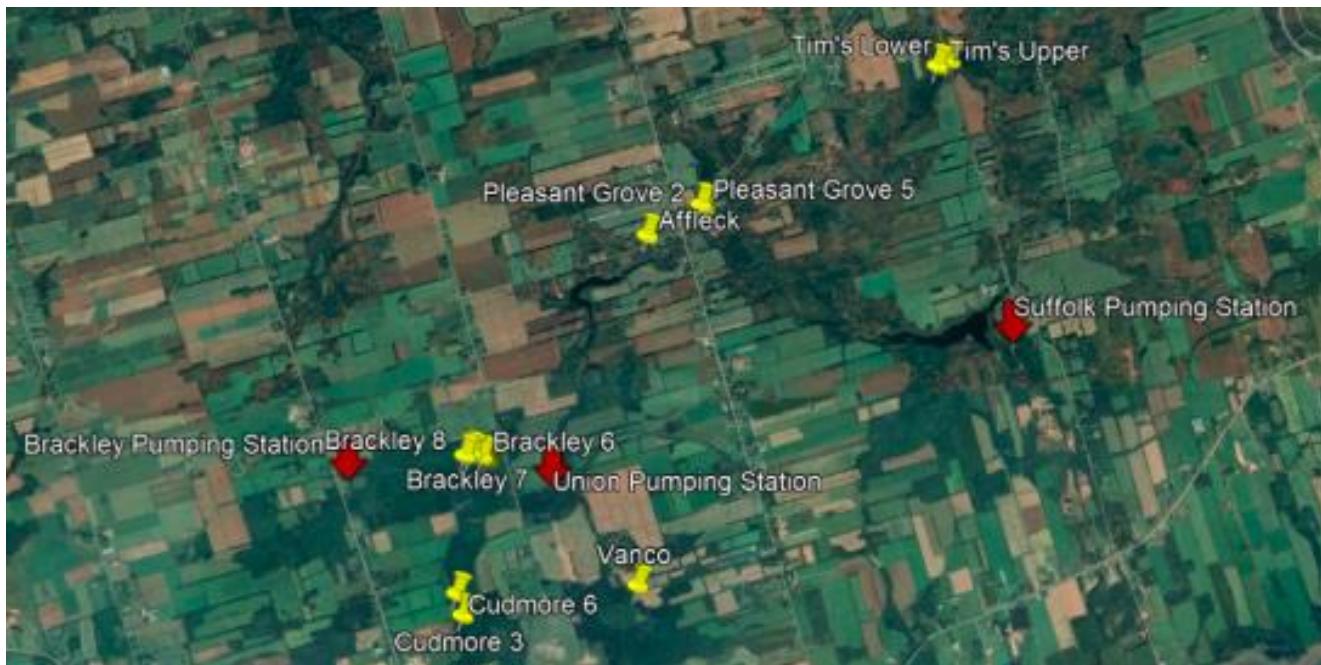
Figure 39. All 2020 weir sites, with position shown in relation to water pumping stations in the WRTB watershed.

Table 13. Average discharge at 2020 weir sites. Note Tim's Creek Lower weir was not included due to lack of reliable data.
