# WINTER RIVER - TRACADIE BAY WATERSHED ASSOCIATION

## 2021 Annual Field Report

Written by Jennifer Woods, Raena Parent, Lyndsay MacWilliams, Evan Cahill, and Ashley Artz

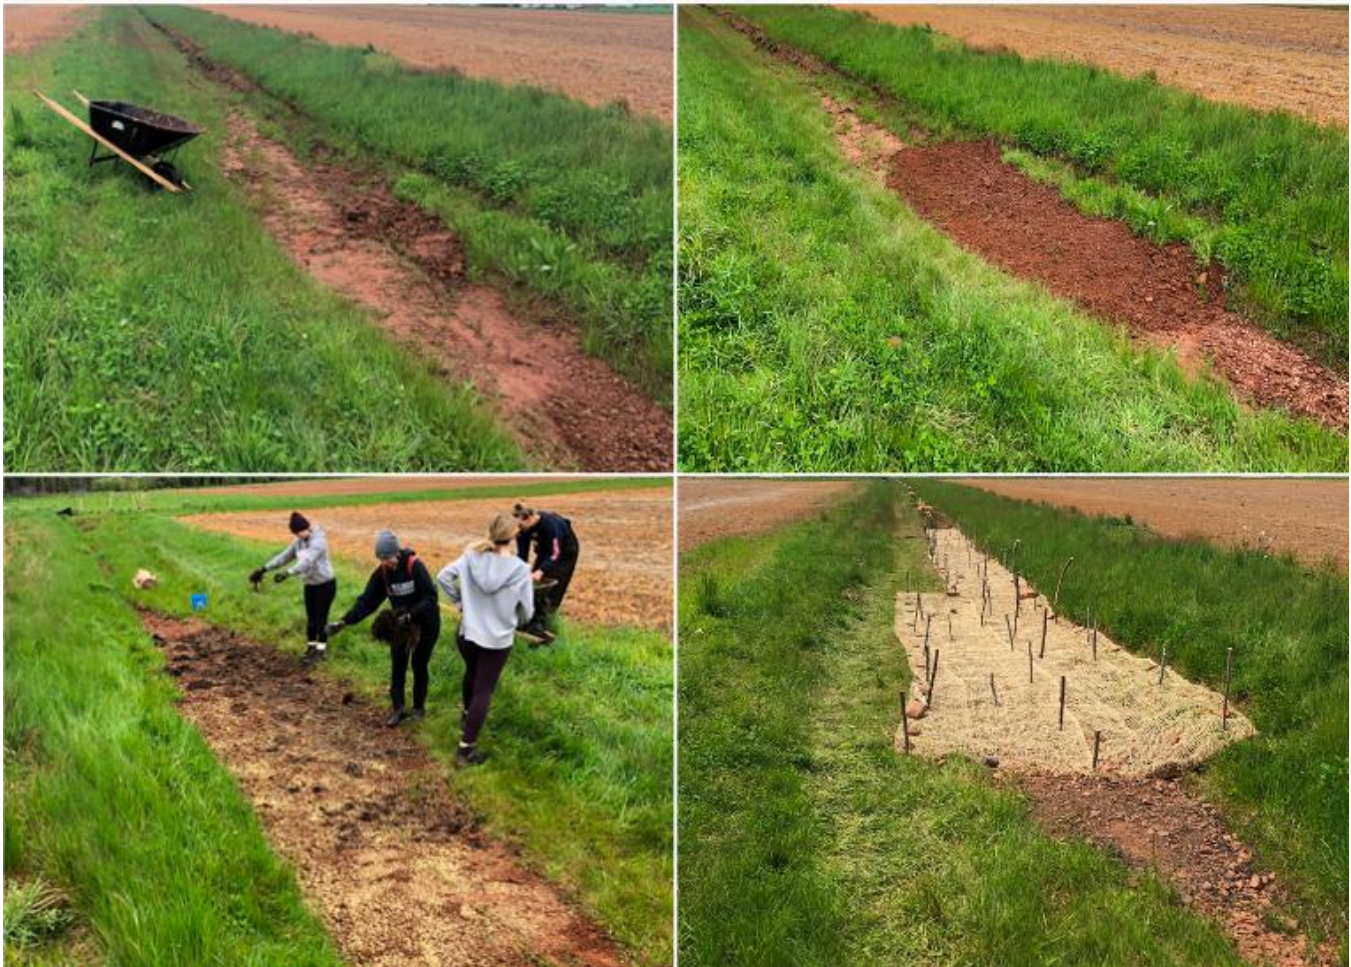
**Figure 8.** (From top left to bottom right) Beginning to fill in a large section of the gully; Soil in the gully after tilling; Covering seeded section with loose hay; Complete juted section of diversion terrace.

In an attempt to remedy this, the crew filled in the trenched areas with soil in some areas and tilled and raked the existing soil in other areas before adding a grass seed and barley mixture to the trenched waterway. To aid in the germination of the grass seed compost was worked in with the soil as well as fertilizer, and of course, some watering. In some of the more worrisome areas, jute and hay were added on top of the added grass seed; this was held down with stakes. The process and progression of this task can be shown in Figure 8.

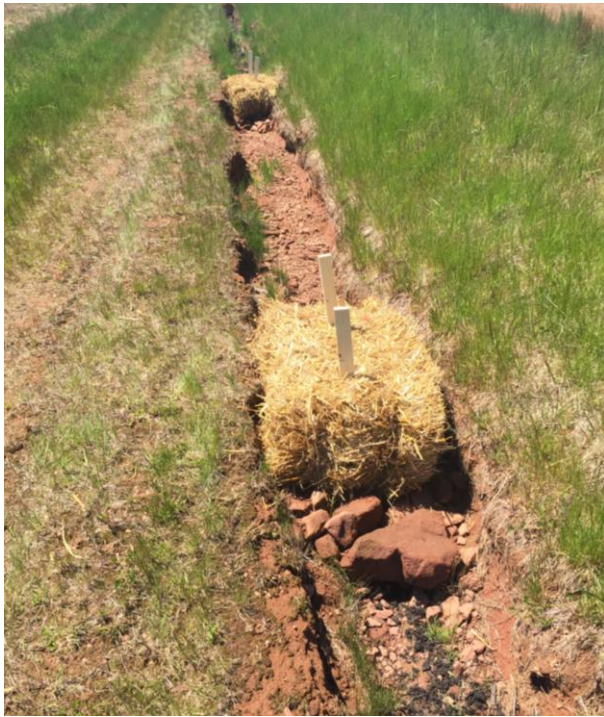
**Figure 9.** Straw bales and rocks in a deep part of the gully.

Ideally, the entire trench would have been filled in, seeded, and covered with jute, but time and equipment constraints meant that this could only be done for one portion of the trench. In other deep areas, the crew placed hay bales in the trenches, spaced apart evenly, to slow down the water flowing in the trench gradually and promote water infiltration. In addition to this, large stones were placed on each side of the hay bales to keep them in place. The surface roughness of these stones should also assist in slowing down the water flow through the channel.

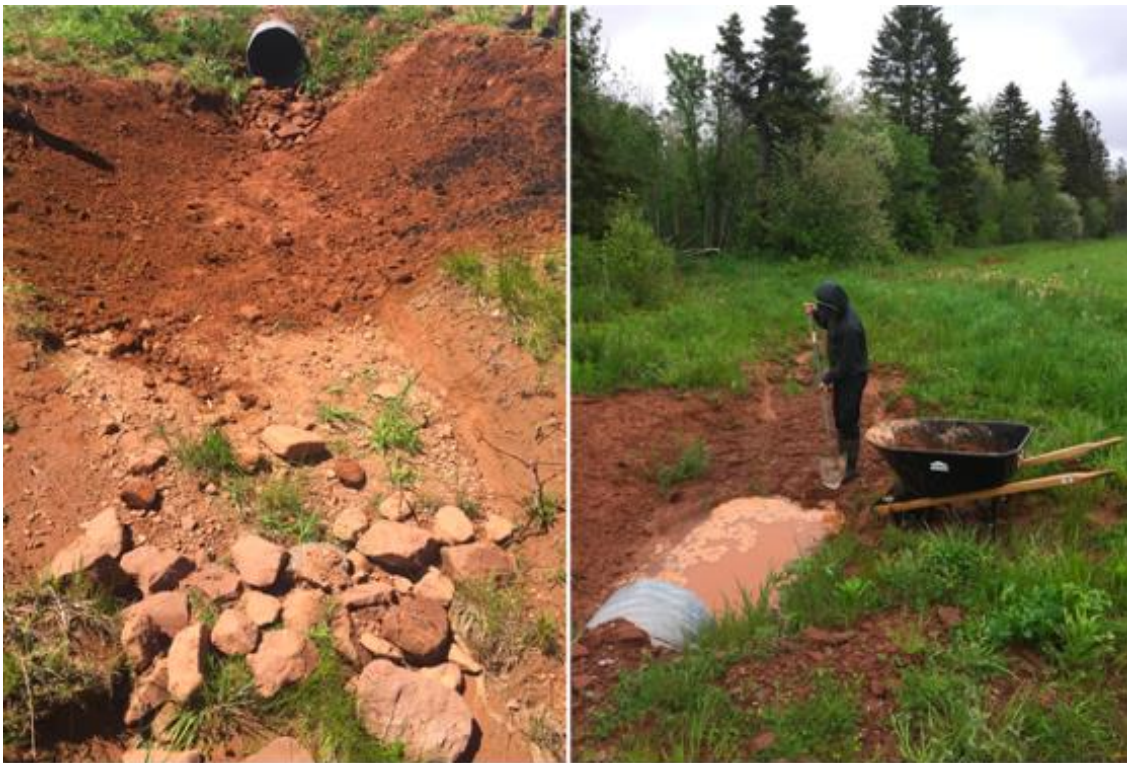
**Figure 10.** Left: Outflow pool with rock check dam. Right: Digging out outflow pool.

The soil that was dug up to fill in sections of the trench was taken from the outflow of the grass waterway. The pre-existing outflow pool was made to be much larger and was also seeded and covered with jute. This larger pool would theoretically slow down the flow that much more while again, promoting infiltration and grass growth. Following the pool was a rock check dam, where the surface roughness of the rocks would slow down the flow.

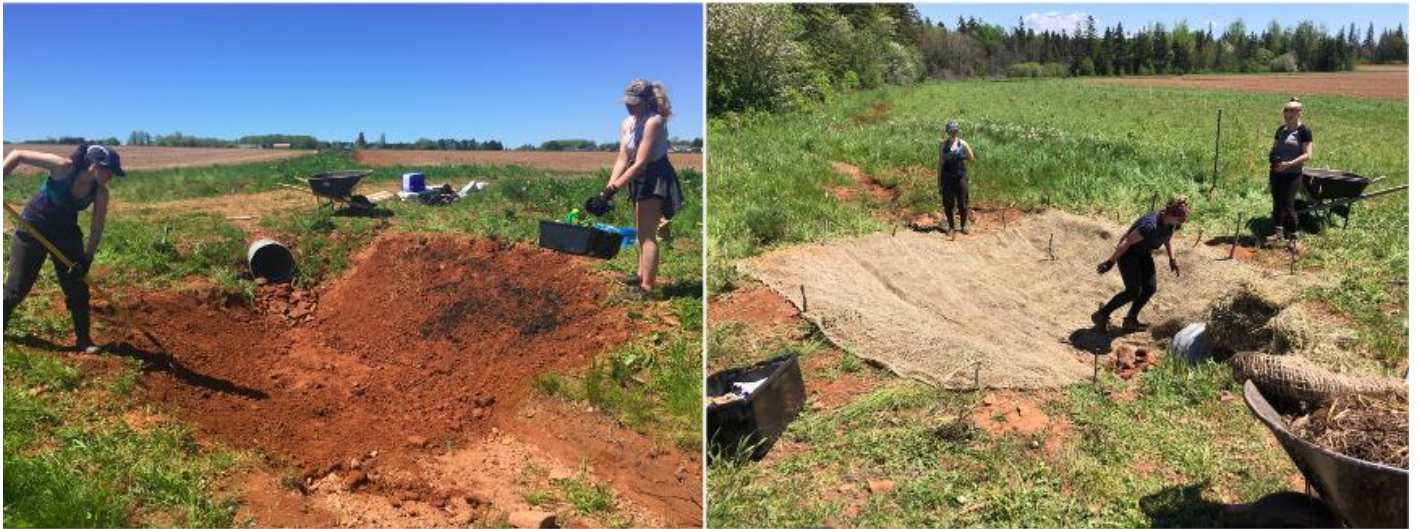
**Figure 11.** Left: Seeding and composting the outflow pool. Right: Staking the jute covered outflow pool.

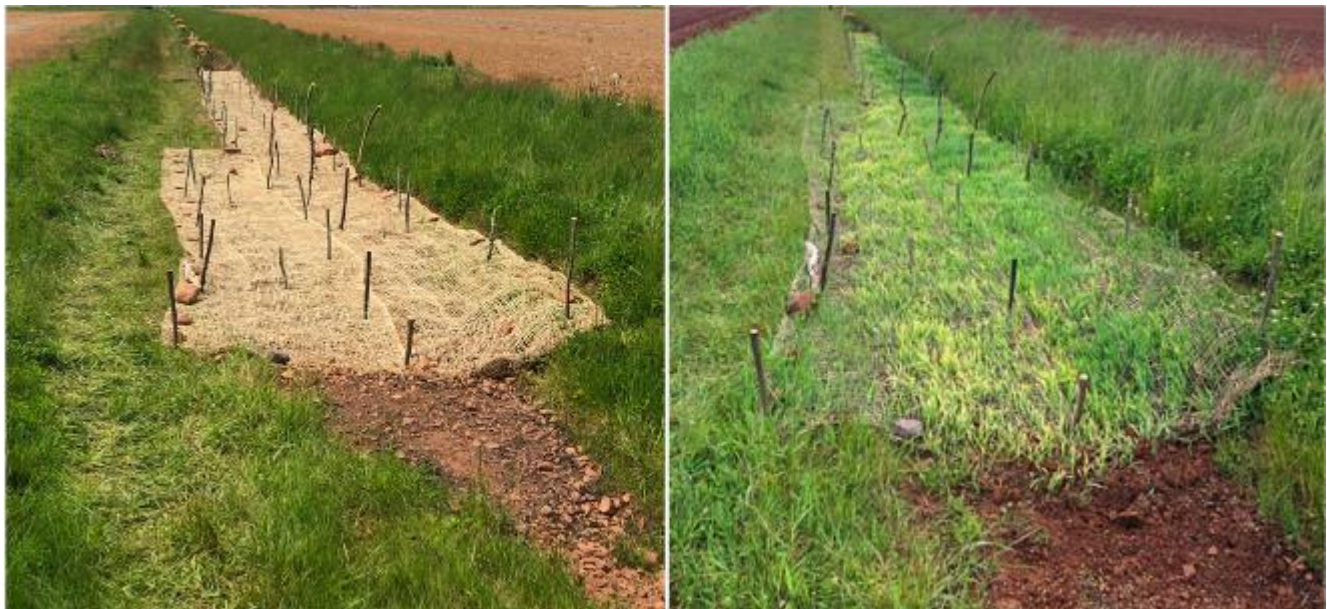
**Figure 12.** Grass growing in juted section of diversion terrace.

After only a couple of rainfall events, the freshly planted grass and barley began to grow, especially in the juted sections of the grass waterway, as shown in Figure 12.

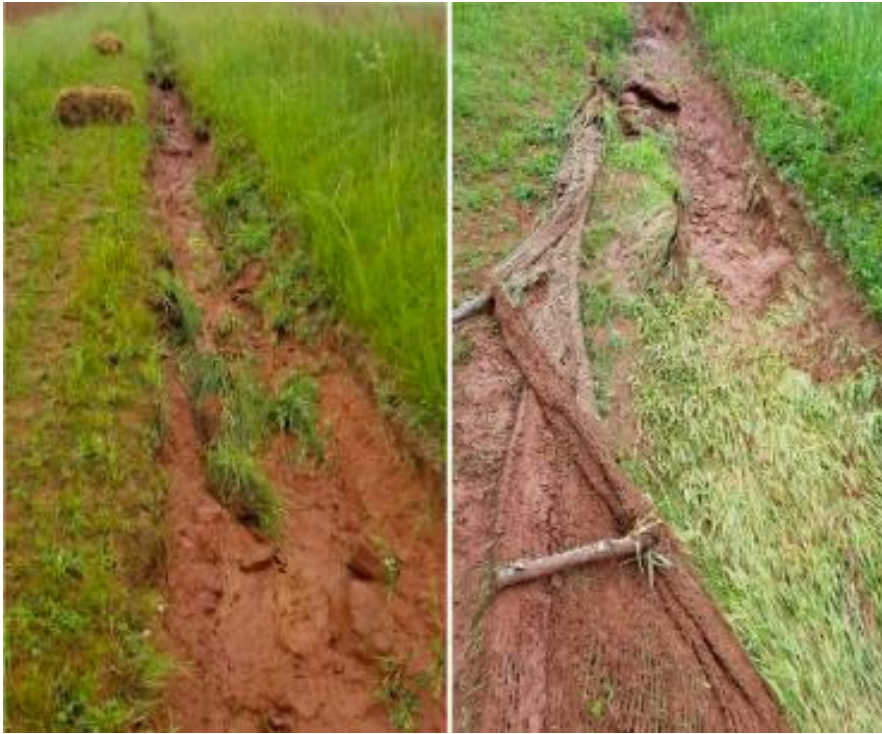
**Figure 13.** Left: Washed out gully after heavy rain; Right: stakes and jute moved by heavy rain.

However, after the first heavy rainfall event of 40 millimeters, the straw bales washed out of the gully. This showed that the rocks holding the bales in place were not heavy enough to deal with this amount of flow. Also, the seeded sections further uphill between the bales did not seem to produce much grass and washed out as a result. This heavy rainfall event also caused some of the stakes in the juted sections to fall down, uplifting some of the jute (Figure 13). To remedy this, heavy-duty stakes were used to replace the old handmade stakes; these go into the soil much deeper and should remain more stable when the soil is highly saturated.

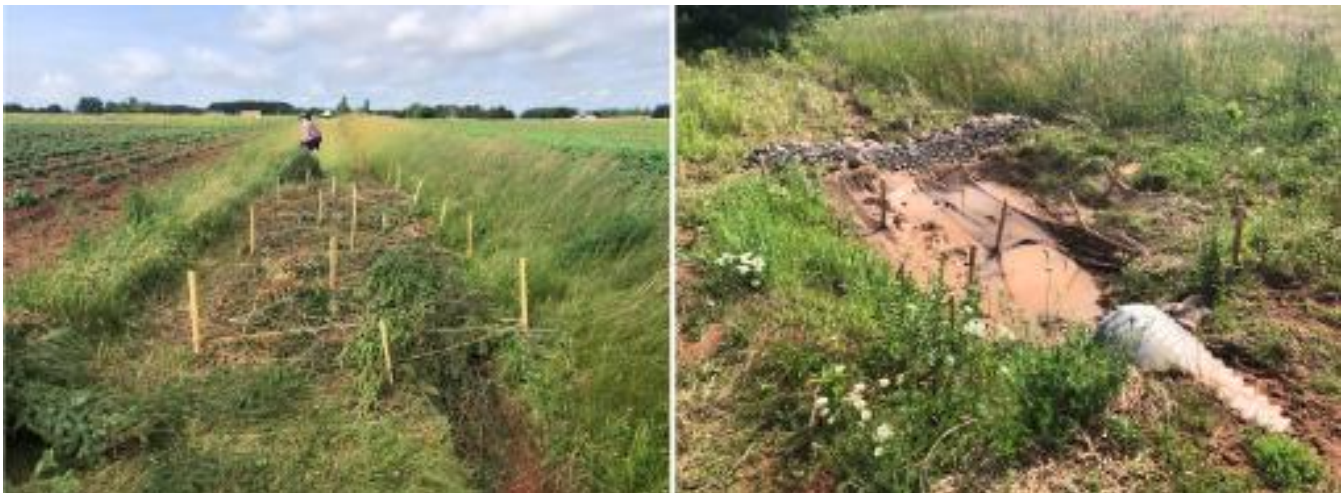
**Figure 14.** Left: Brush mat created on terrace. Right: Rock check dam placed at the end of an outflow pool.

To address what happened after the heavy rainfall event, several brush-mats were added to the gullies, as well as additional rock dams. A brush mat should slow down the water flow through the gully while also trapping some of the sediment in it. Over time, the voids in the brush mat should fill in with sediment, filling in the gully.

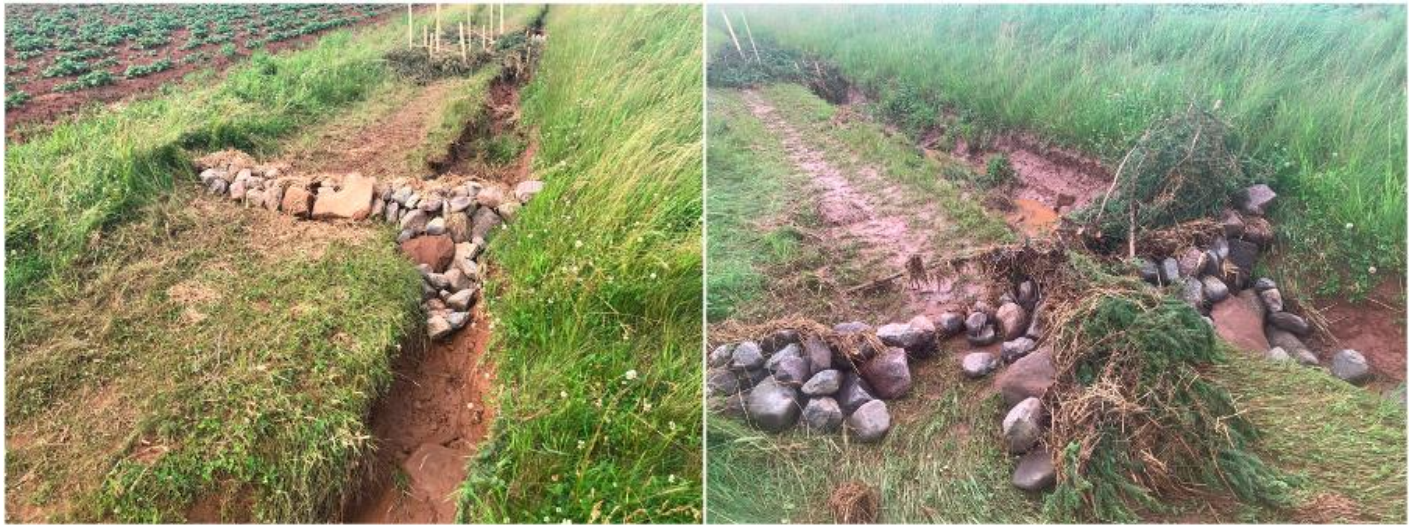
**Figure 15.** Rock check dam before (left) and after (right) a big rain.

After more rainfall events, it was discovered that the rock dams and brush mats did not significantly slow down the water flow in the gully; a lot of the dams were slightly washed out and even a couple of brushmats (see Figure 15 below).

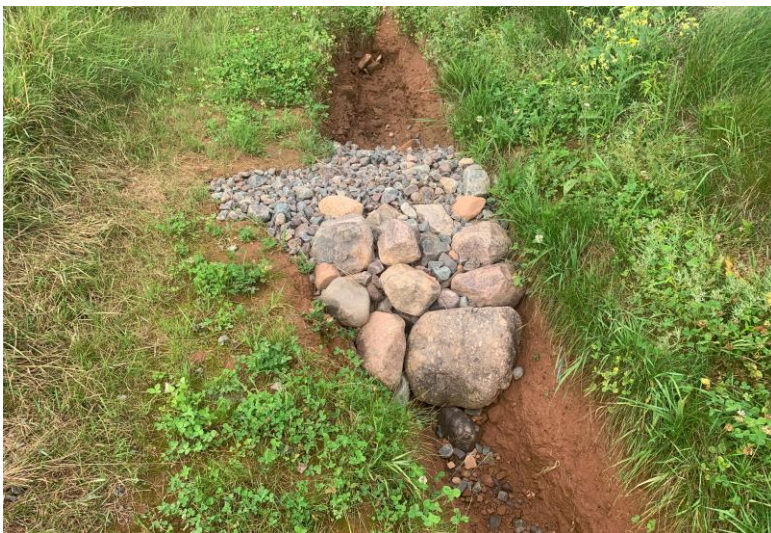
**Figure 16.** Improved rock check dam with heavier rocks on the downslope end acting as anchors and smaller rocks on the upslope end.

Initially, the rock check dams and brush mats filled in the gully but also slightly covered the pathway of overflow on the grass next to the gully. After meeting Tyler Wright with the Department of Agriculture, we learned that it was more important to focus more on filling in the trench and not focusing as much on the overflow of water going on the grass. The grass will slow down the water if it is to flow over it, and the water will also promote the growth of the grass. Over time, covering the grass would kill it, which is unfavourable. The brush mats were left as they were for the time being and the check dams that were washed out were reassembled in the trench only, again trying to have the heavier rocks on the downslope end, acting as an anchor for the smaller rocks placed on the upslope side.

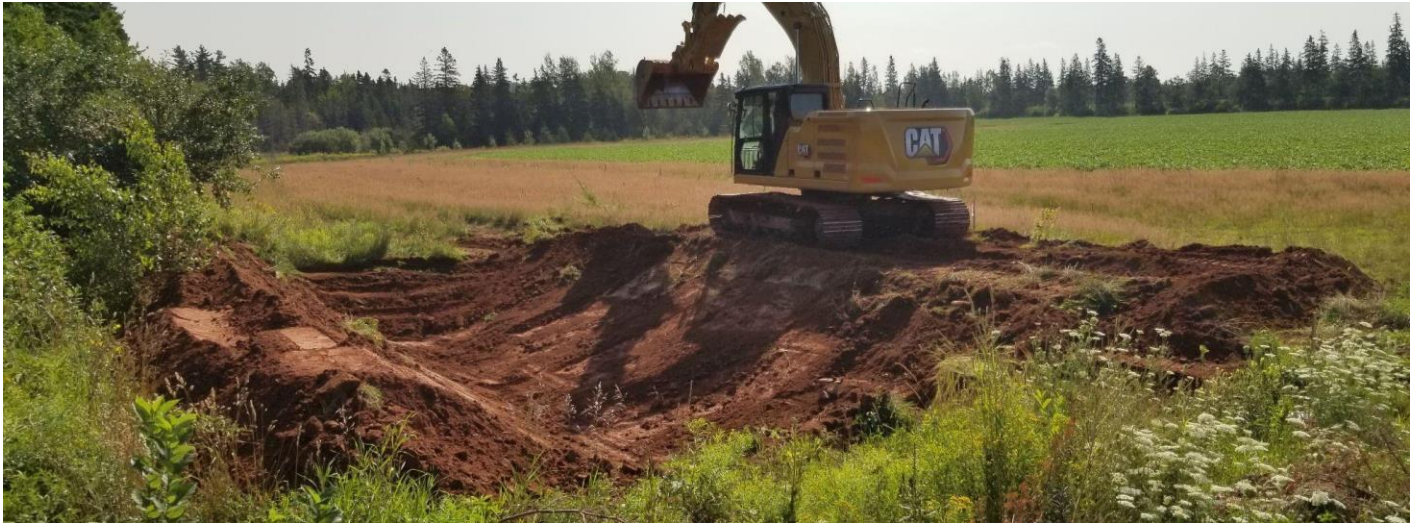
**Figure 17.** Construction day one - 2021-08-13.

After not seeing much progress from all of the hours of work put in, the WRTBWA board of directors made the decision to stop further work on this grass waterway project. Beginning in mid August, a silt trap was constructed as a final attempt for the time being to inhibit agricultural runoff from going into a nearby stream. A summary of the work done can be viewed in Figures 17 through 20.

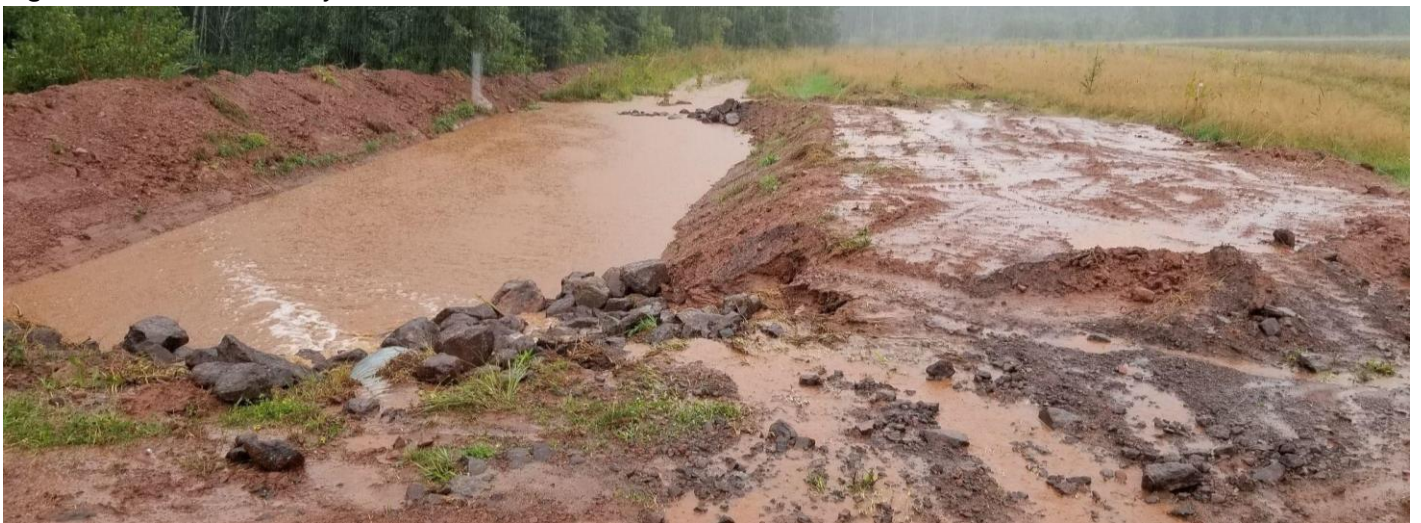
**Figure 18.** During the heavy rain associated with former Hurricane Ida (2021-09-02) when construction was mostly complete.

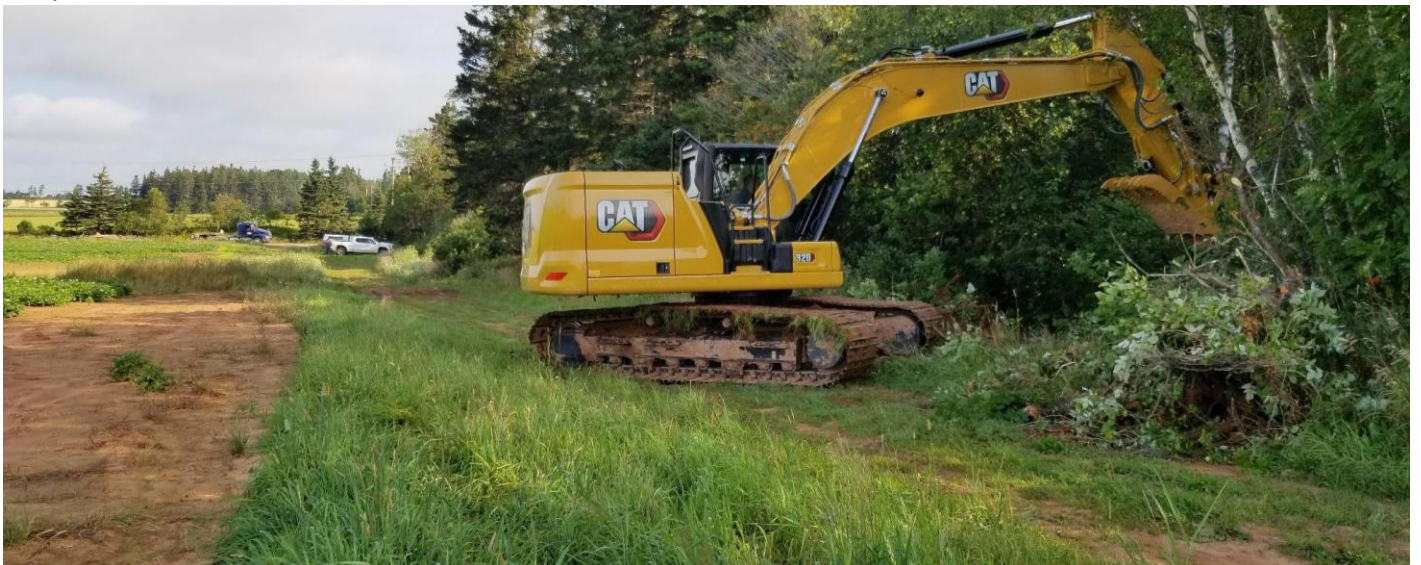
**Figure 19.** Excavator creating a berm in a laneway directly into the buffer zone.

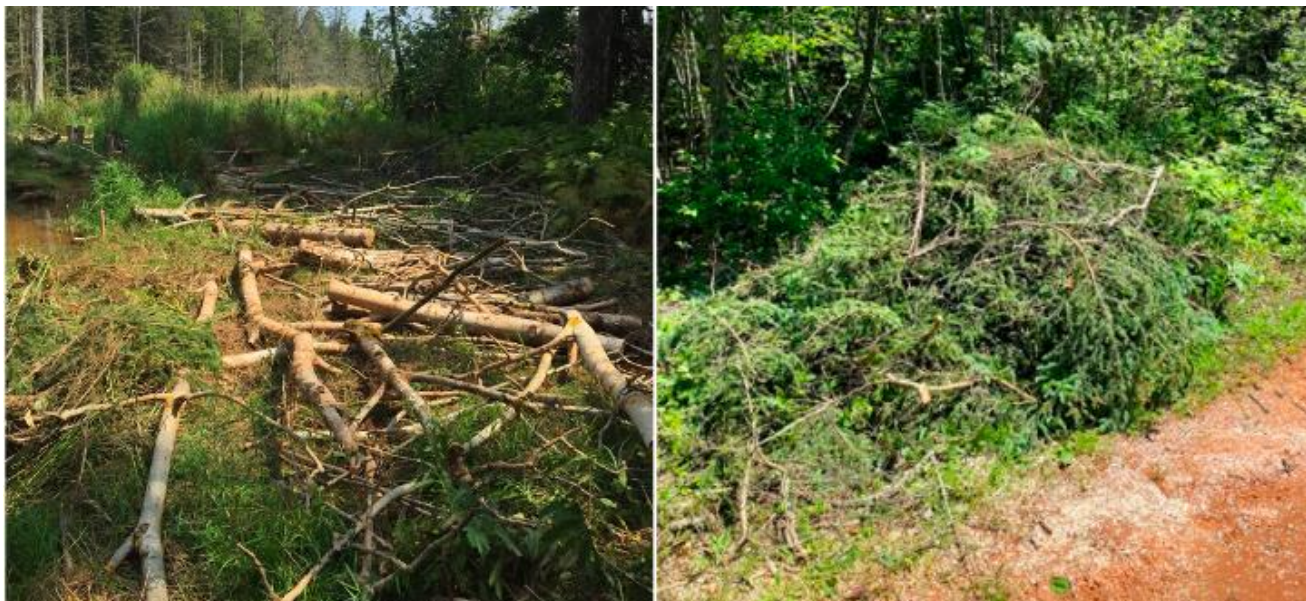
**Figure 22.** Left: Logs placed on banks of the stream at the soil erosion site. Right: Brush collected from white spruce trees at the Pleasant Grove woodlot.

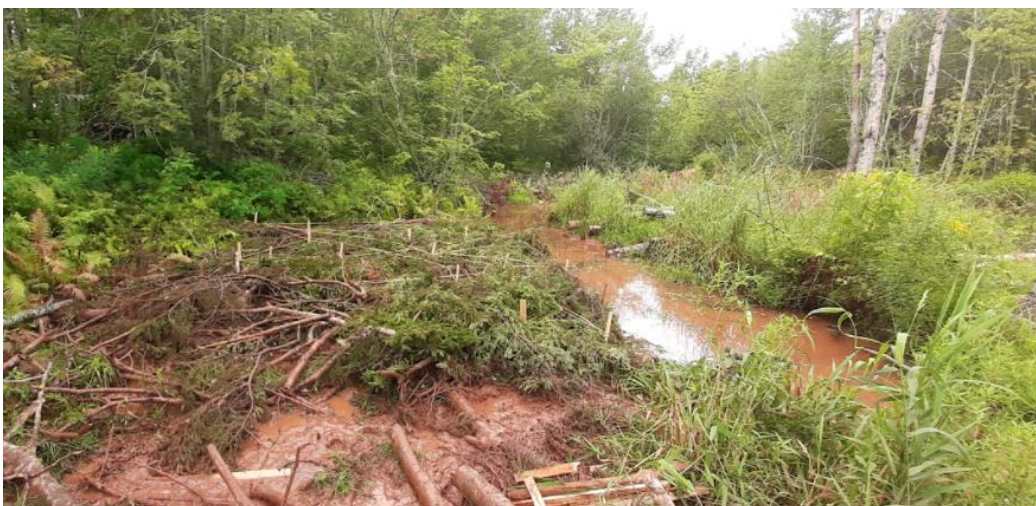
**Figure 23.** Large brush mat in place at soil erosion site.

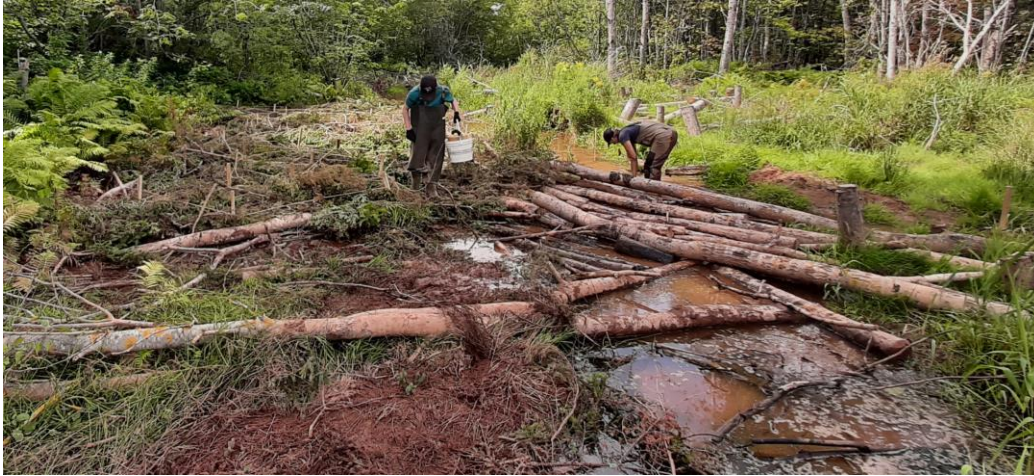
**Figure 24.** Staff using logs to guide water flow of the stream.

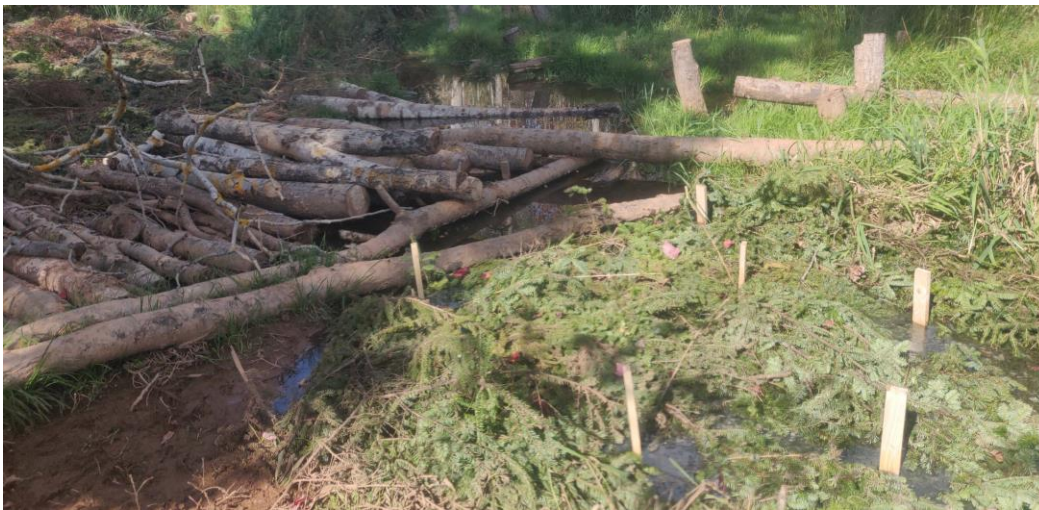
**Figure 25.** Brush mat and logs in place.

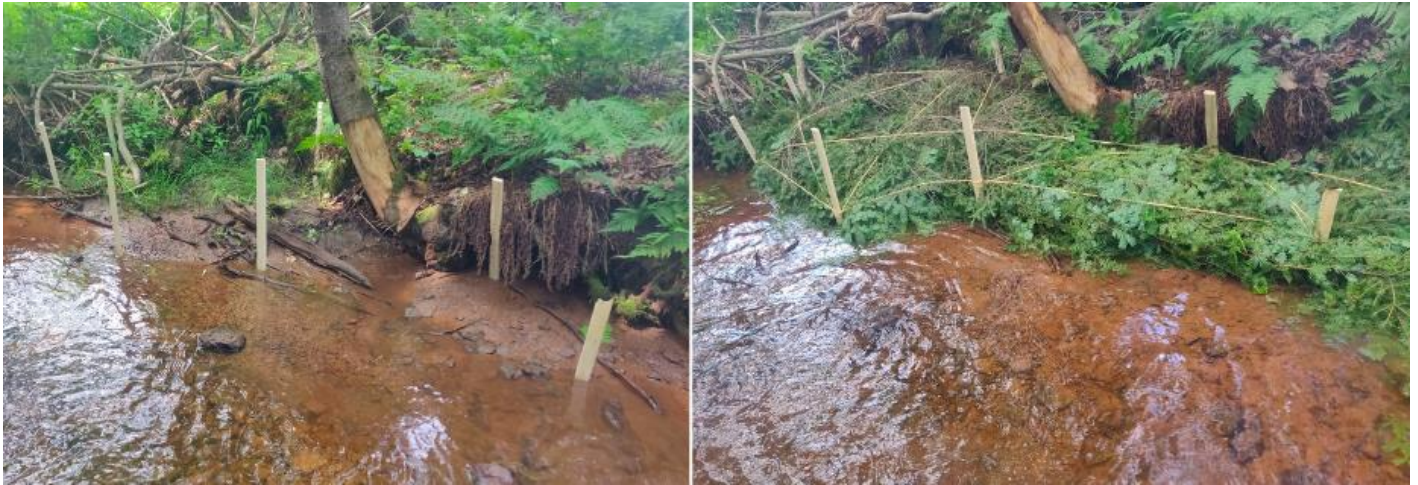
**Figure 26.** Before (left) and after (right) the installation of a brush mat.

The goal of a brush mat is that it will last a long time, collecting enough silt to eventually establish a base for vegetation to grow. Brush mats are an important part of stream restoration and using the technique is vital to the longevity of healthy streams on PEI.

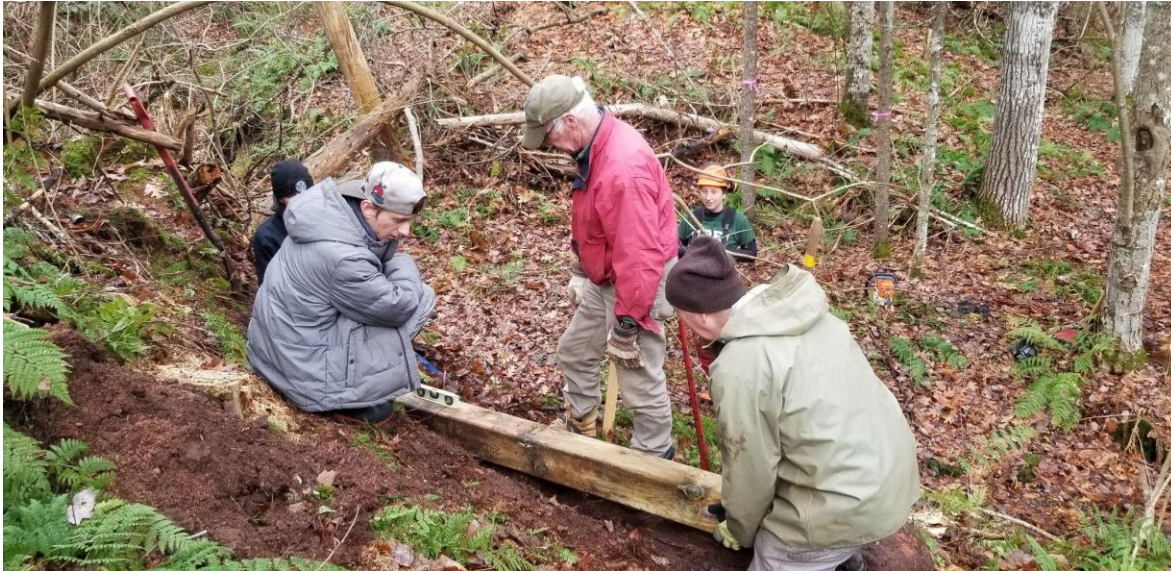
**Figure 33.** Left to right: Lyndsay (face obscured), Liam, John, Sheldon, Jenn - installation of mudsill.

Compared to the previous year, trail work on the donated woodlot in Suffolk was not a high priority. However, any work that was done focused on making steep inclines safer and more accessible. In the late fall, WRTBWA received funding to build 2 bridges along the trail. Sheldon Wheatley, a retired contractor, volunteered to lead the fall staff in the construction of both bridges over a span of a few weeks. Pictures summarizing bridgework can be viewed below (Figures 33 to 36).

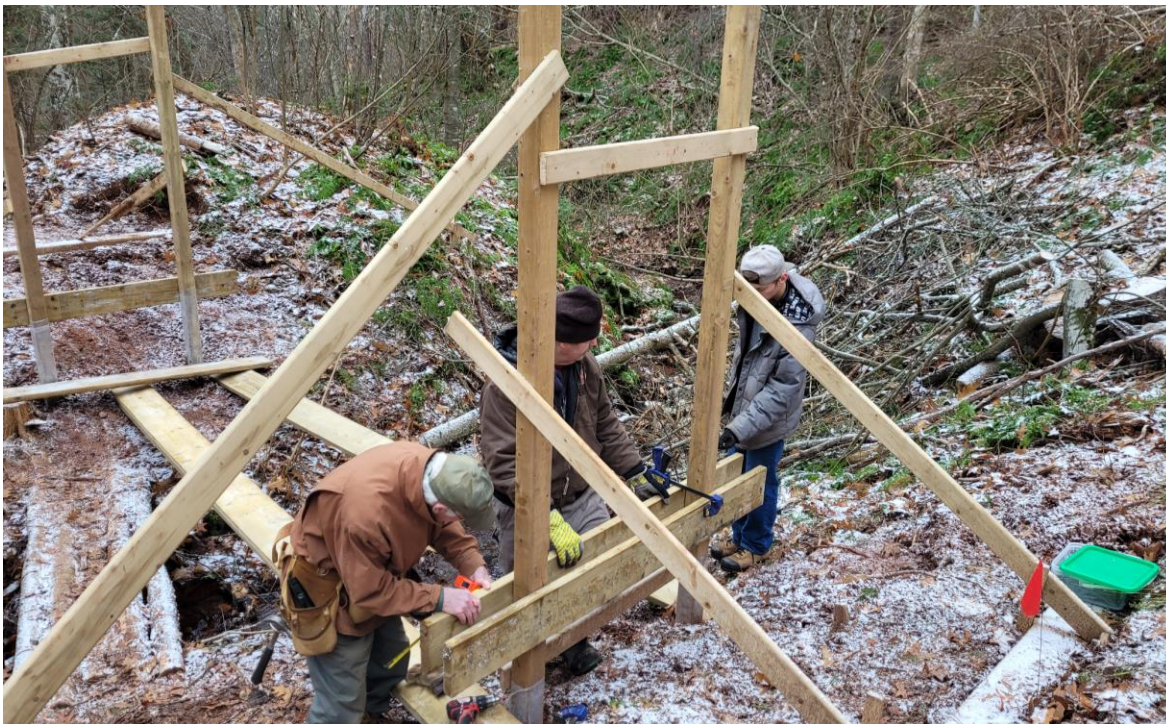
**Figure 34.** Left to right: John Hughes, Sheldon, and Liam levelling posts.

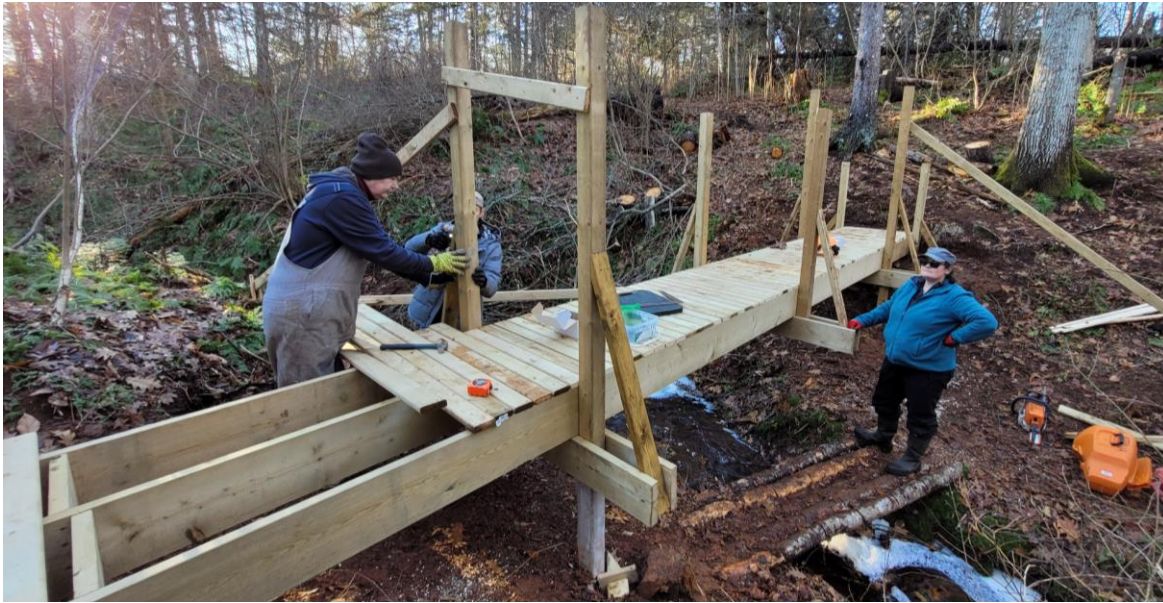
**Figure 35.** Left to right: Sheldon, Liam, and Sarah nailing down planks to create bridge floor.

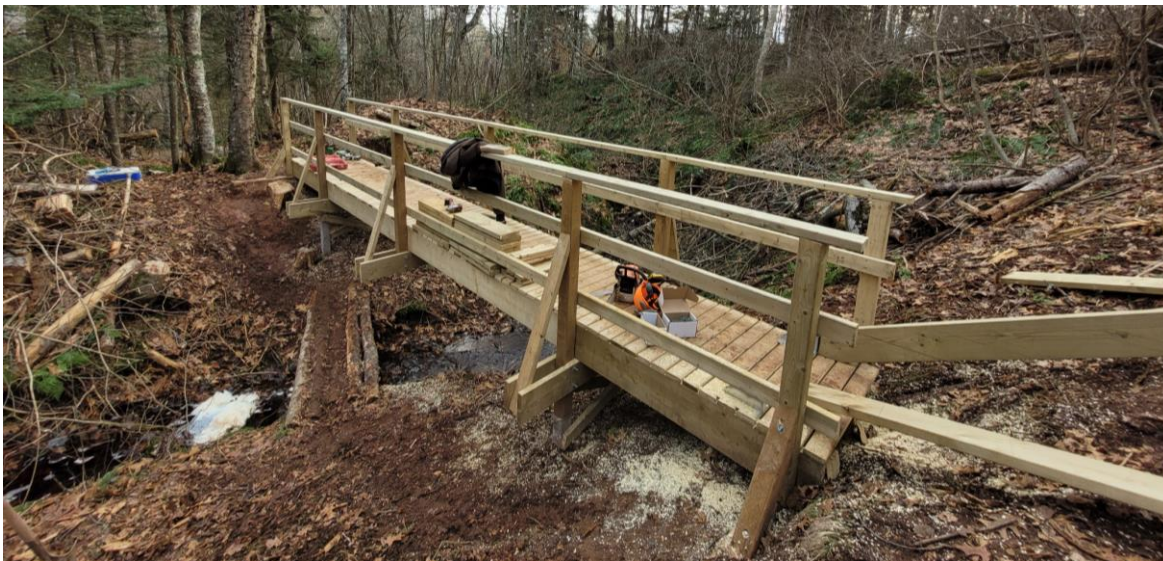
**Figure 36.** Mostly completed bridge.

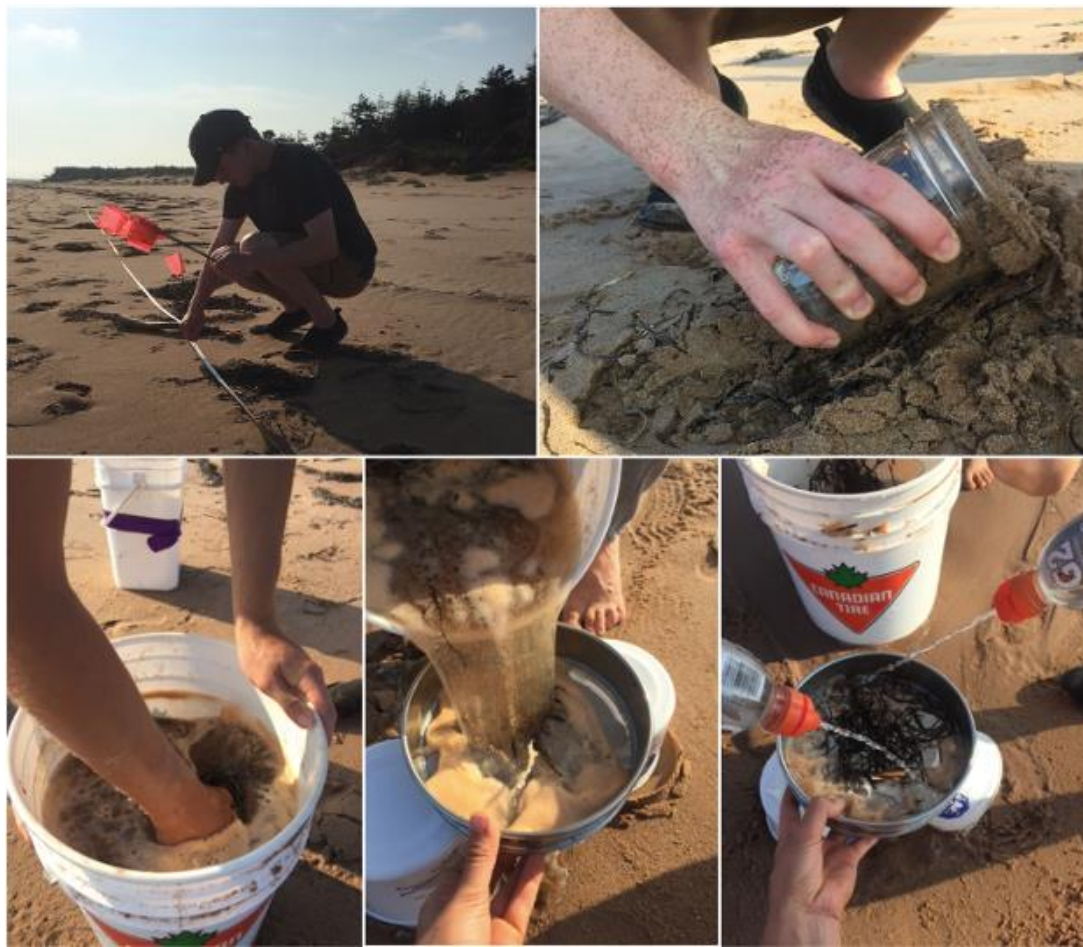
**Figure 51.** Shoreline microplastic sampling process.

In order to take microplastic samples from the shoreline, a length of 100 feet was measured out horizontally to the water then using a random number generator, 4 distances were selected as the sample transects. Each transect was measured out into a 1x1 meter square. Crew members then filled half of a 5-gallon bucket by scooping the top 5 centimetres of the transect, everything including sand, debris, and organic material. The remaining space in the bucket was filled with water. Everything was mixed by hand to allow any plastics in the sample to float to the top and the water was then poured through a sieve measuring 335  $\mu\text{m}$ . This process of mixing the collected sand with water and pouring it through the sieve was done three times per sample. The sample was then rinsed off using Gatorade bottles filled with water and then placed inside a glass jar with a cap full of hydrogen peroxide.

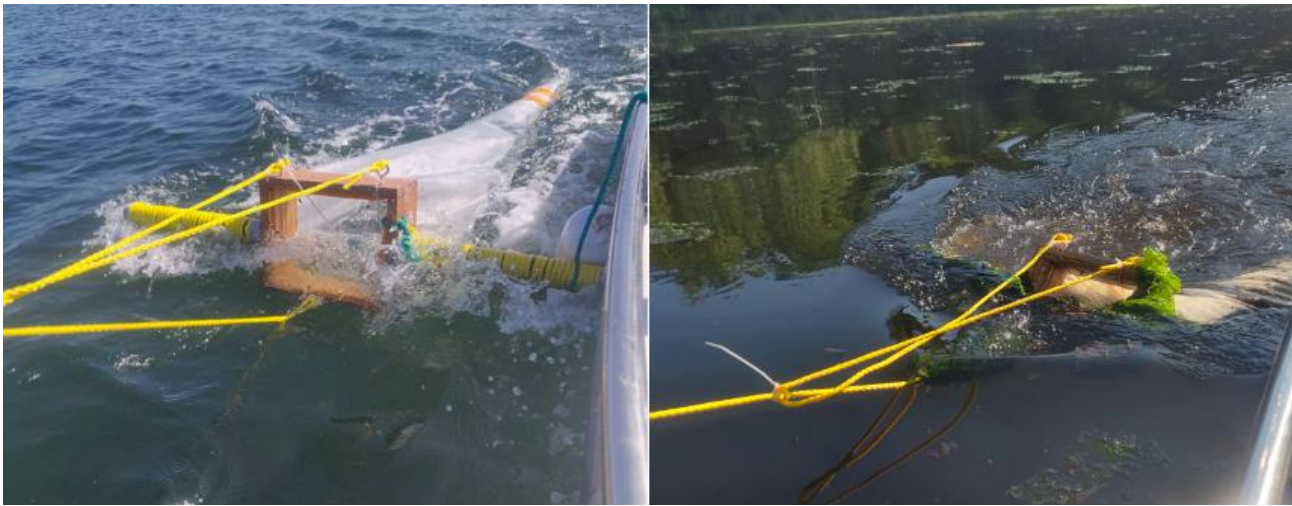
**Figure 52.** Left: LADI trawl in action. Right: LADI trawl weighed down by algae, causing improper sampling conditions.

Out of the 6 locations, trawls at Winter Bay, North End of Tracadie Bay, Old Bedford Road Beach, and South End of Tracadie Bay were all executed successfully. Staff were only able to complete microplastic sampling for 2 of the 6 trawls at the Offshore locations because of issues with the size of the boat being used; with the boat being a smaller size, waves were felt more intensely making staff unable to process the samples in such rough conditions. In the future, a bigger boat is recommended for the Offshore trawl locations. The second problematic location was the Winter River. 4 of the 6 trawls were run through successfully but 1 location had a large amount of algae that continuously built up and caused the cod end to come off (see Figure 52). After multiple attempts to complete 1 trawl, 2 of the 3 cod ends were lost within

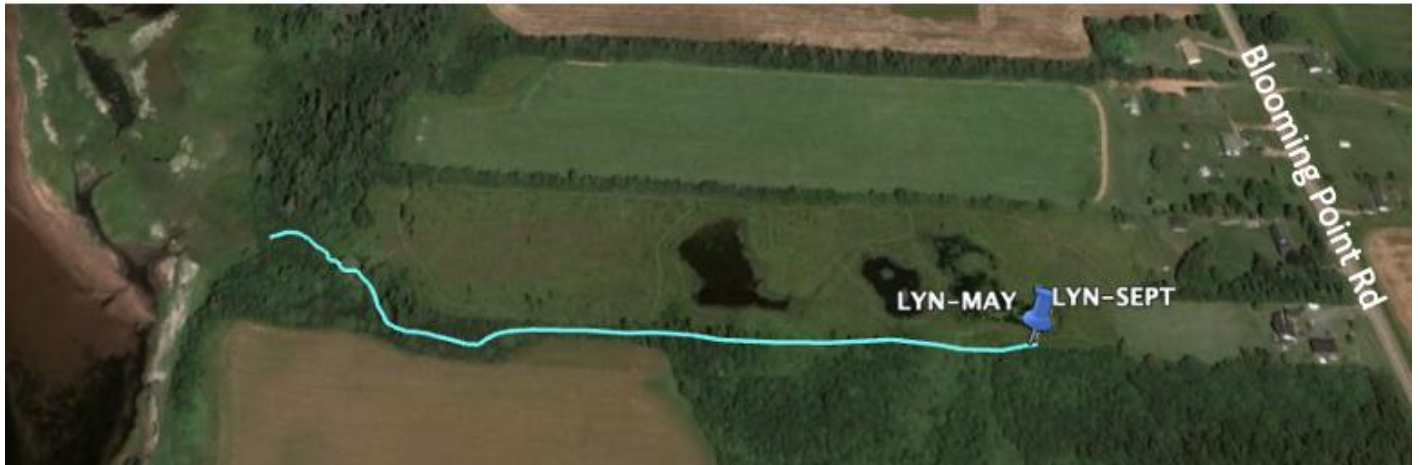
**Figure 57.** Map of headwater surveys conducted in September and May 2021 at Lyon's Creek, showing where the stream dried up.

Stream	Distance dried up over summer
Lyon's Creek	May had a longer dry length vs September by 8.1 meters.
Lawton's Creek	106 meters of stream dried up from May to September.

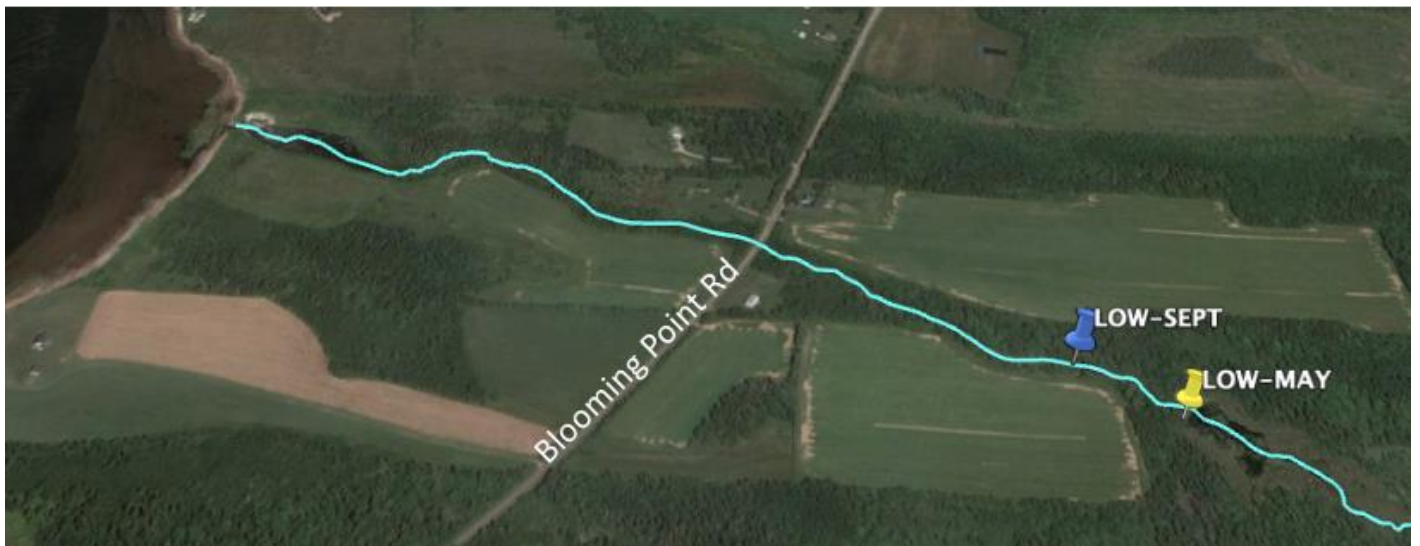
**Figure 58.** Map of headwater surveys conducted in September and May 2021 at Lowe's Creek, showing where the stream dried up.

Lowe's creek	No change. The stream had flow throughout both survey periods.
--------------	--

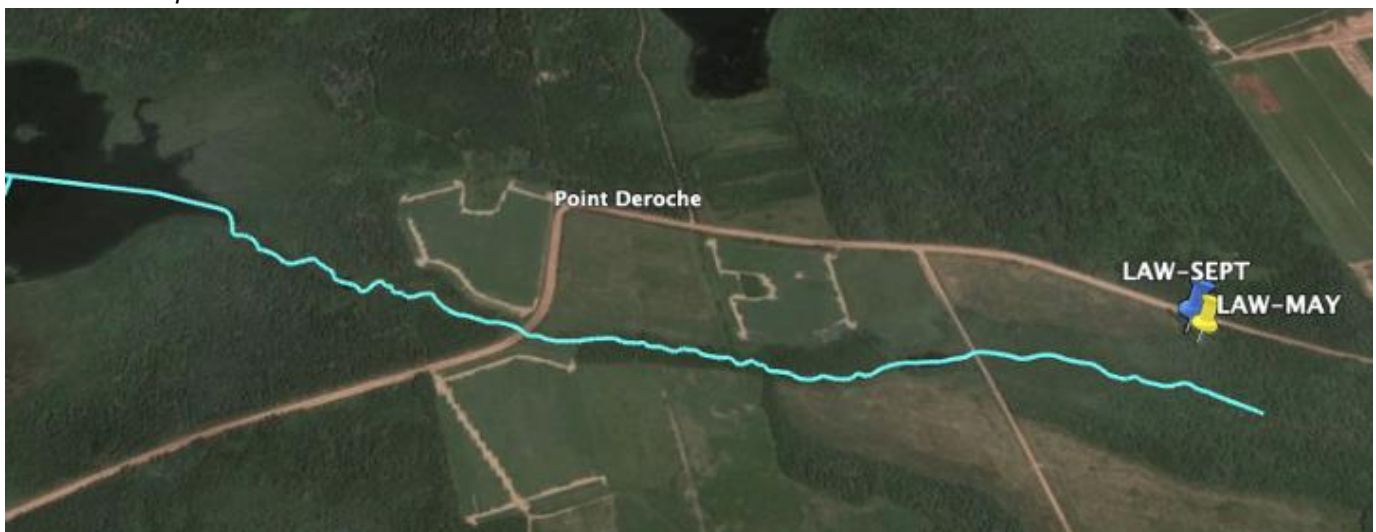
**Figure 59.** Map of headwater surveys conducted in September and May 2021 at Lawton's Creek, showing where the stream dried up.

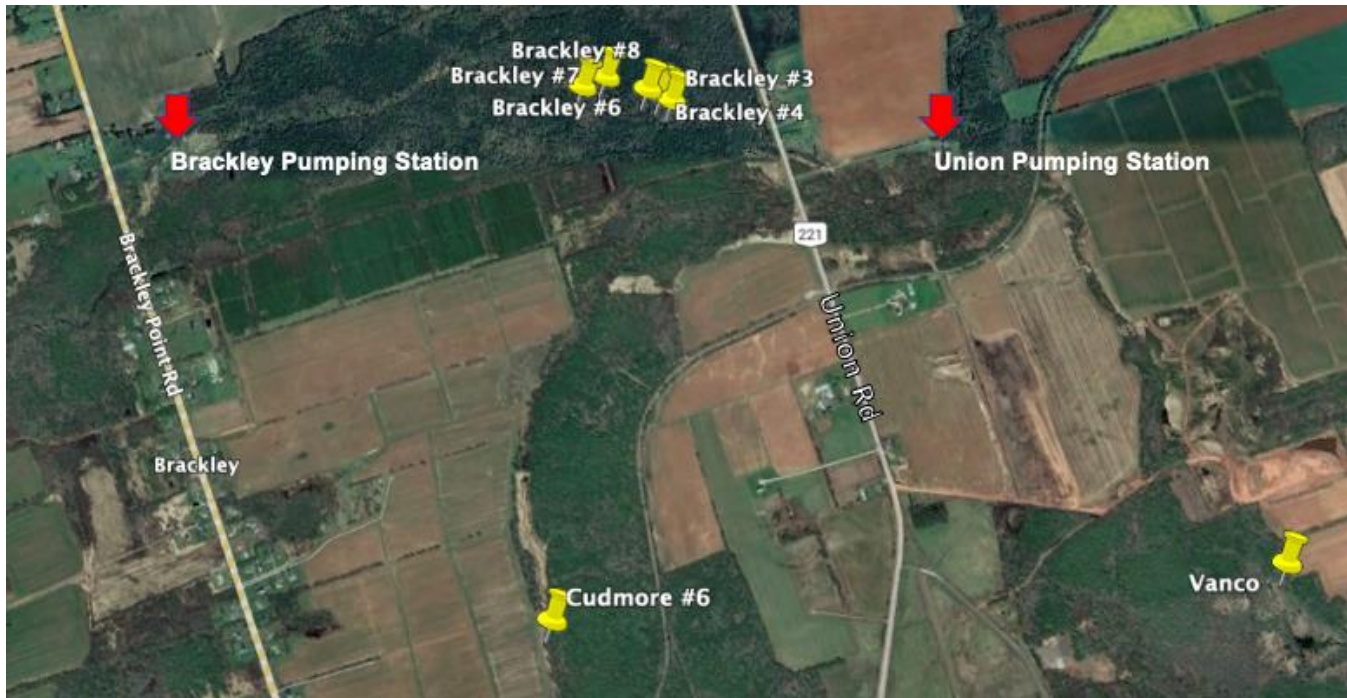
**Figure 67.** All 2021 weir sites shown in relation to the Brackley and Union water pumping stations.

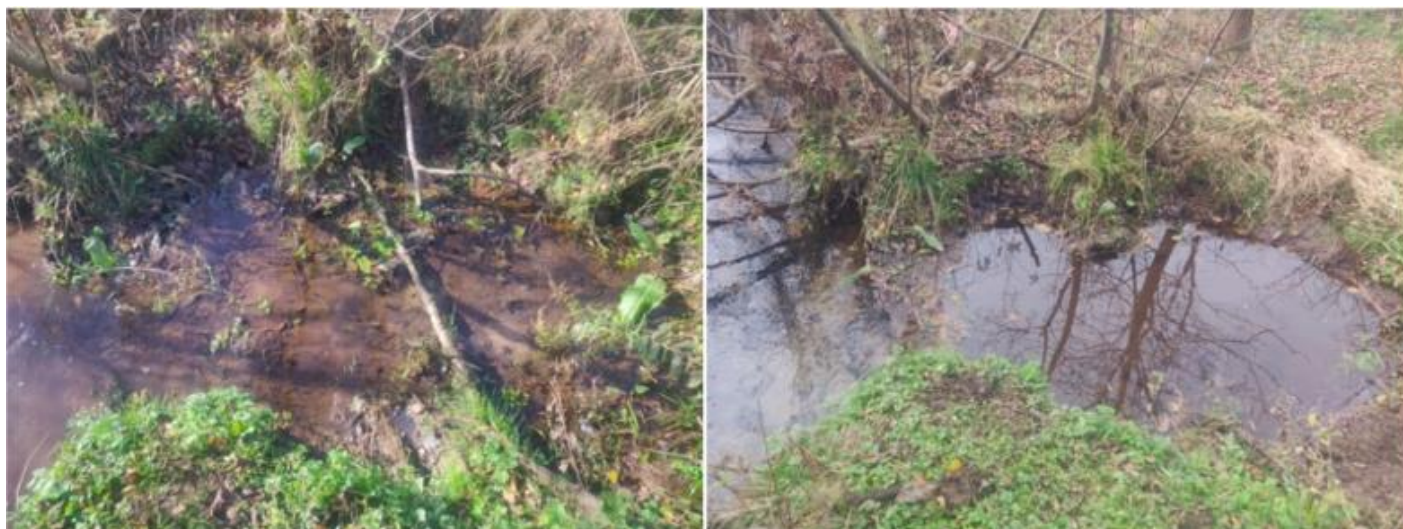
**Figure 77:** Brackley spring #7 before (left) and after (right) excavation.
