# WINTER RIVER - TRACADIE BAY WATERSHED ASSOCIATION

## 2021 Annual Field Report

Written by Jennifer Woods, Raena Parent, Lyndsay MacWilliams, Evan Cahill, and Ashley Artz

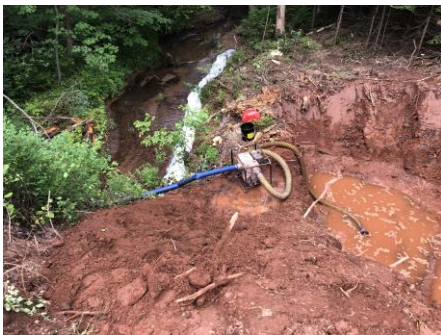
Excavation continued today. The water accumulating in the bottom of the pool is now being pumped into a silt trap. This is basically all that happened today.

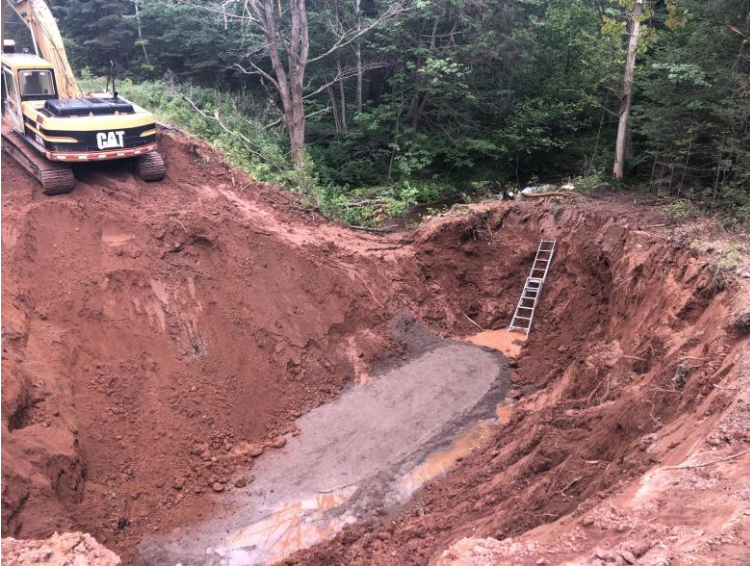
In the afternoon, Class A gravel was placed in the bottom of the hole and flattened using rakes. After this, the excavation on the other side of the road commenced, now there is no possibility of passing through Suffolk road.

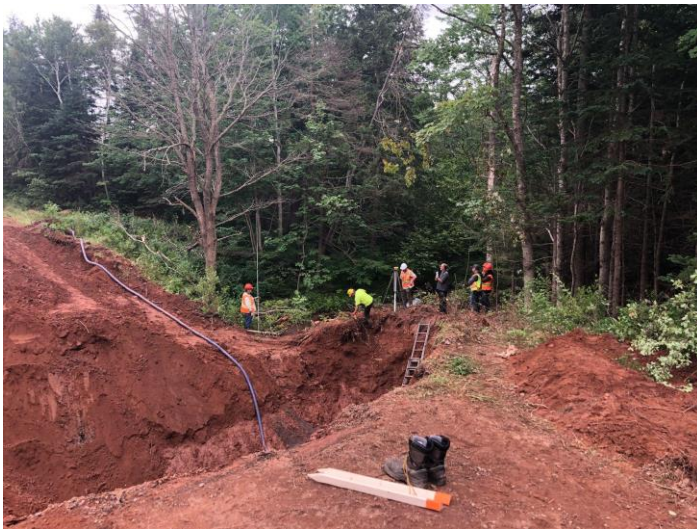
The excavation continued for the morning until the survey crew showed up. They were there to check the grade of the gravel bottom at the inlet side of the hole in relation to pre-existing benchmarks. After some back and forth it was found that the surveyors had made a benchmark error when surveying a couple of years ago and that Phillip, the foreman, had the correct grade.

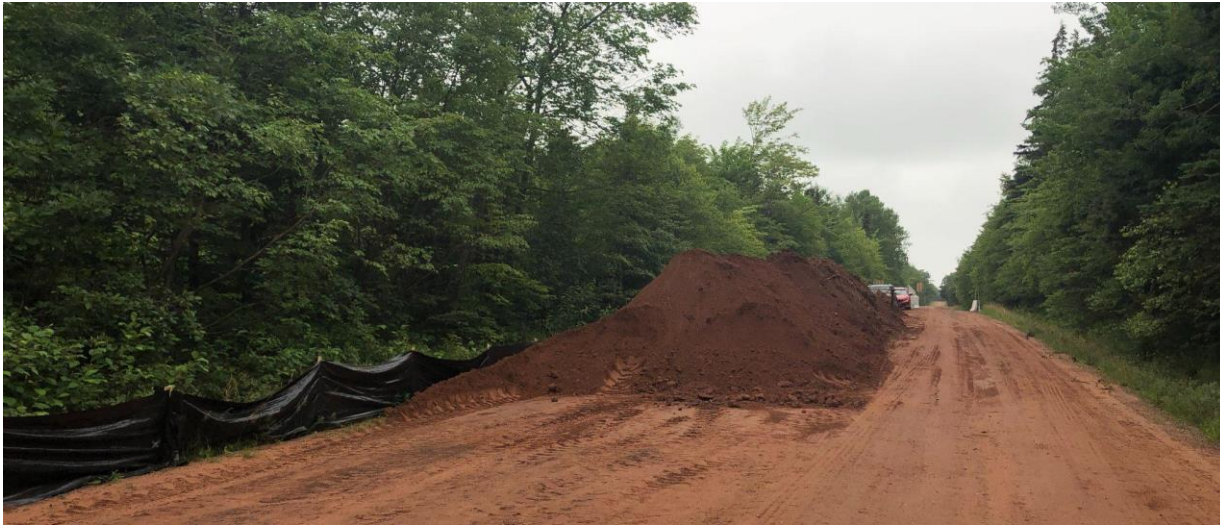
They began piling soil on the opposite side of the road after this and put silt fence on one of the sides – this could use more fencing probably; otherwise, a lot of the soil will runoff into the ditches and down the laneway.

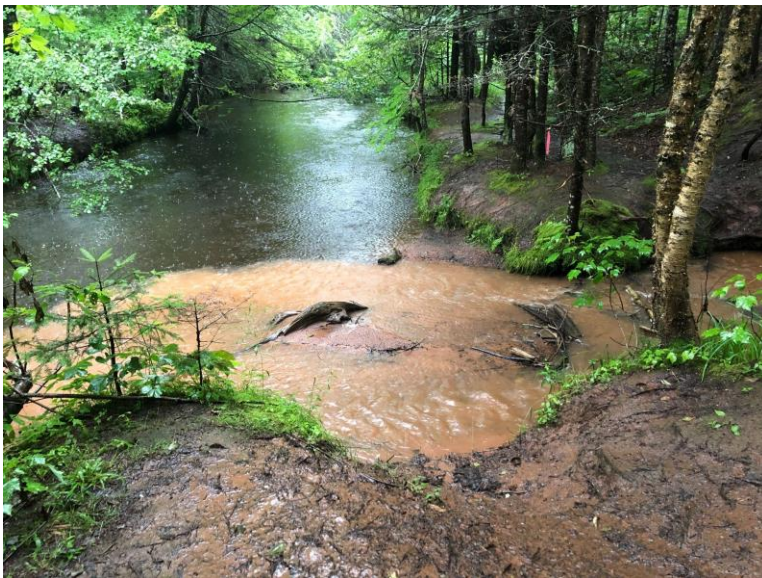
After periods of heavy rain overnight, and more rain throughout the entire day, all that was really done was water control out of the hole. It was being pumped into the silt traps like the past days. There is a lot of red water coming from the worksite. The erosion control could have been improved. The hay rolls that were used before were rolled back up and currently are not being used. Also, some bales aren't being used either; they should be placed downslope from the silt traps, where the water is being pumped.

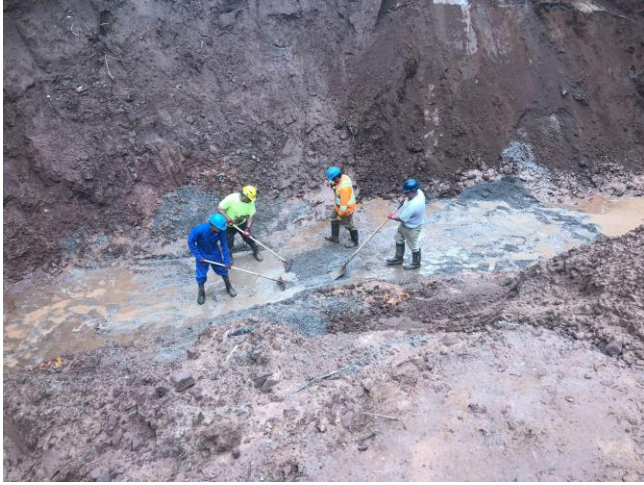
Excavating continued in the morning. Water is always being pumped from the hole into the silt traps upslope which are beginning to get shallower as they fill with sediment. Later, the hole was filled with gravel to give the floor more of a dense surface to minimize settling of the culvert over time. The survey crew was present, taking elevation readings as the hole was filled and raked to ensure that it had the correct grade.

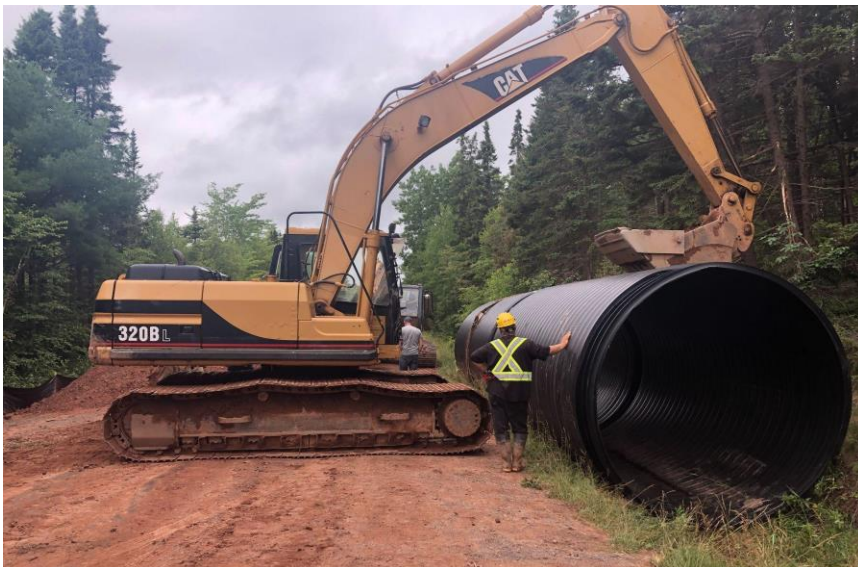
In the afternoon, the crew pieced together two sections of the culvert and dropped it in the hole (half of the entire culvert)

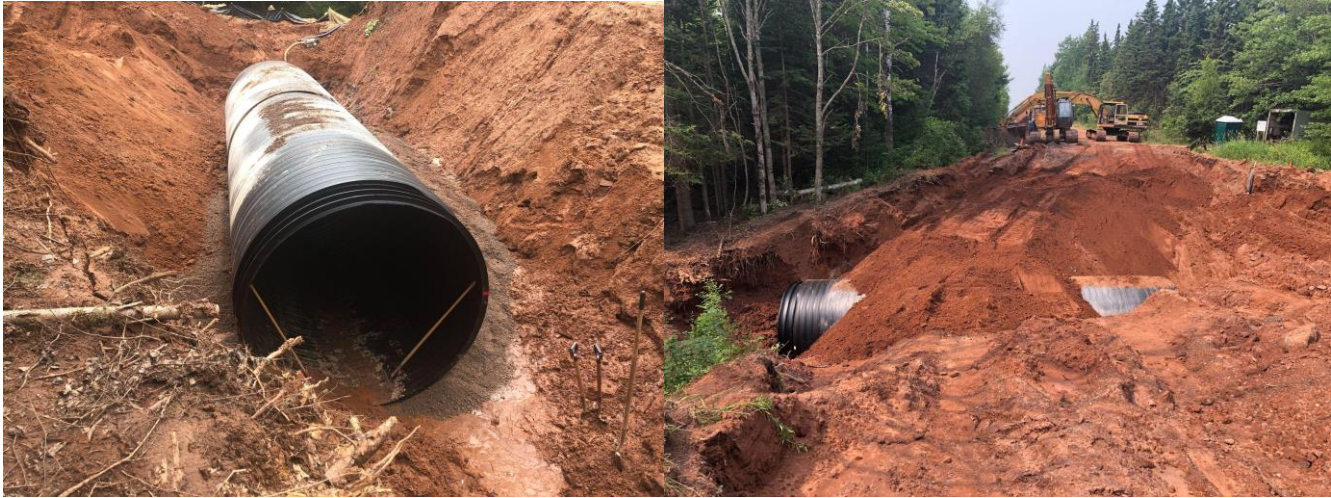
Now that the culvert is in place, gravel was placed on each side of it and packed in using shovels; this is to stabilize the culvert. After each side was filled in approximately half of the diameter of the culvert, soil was added on top.

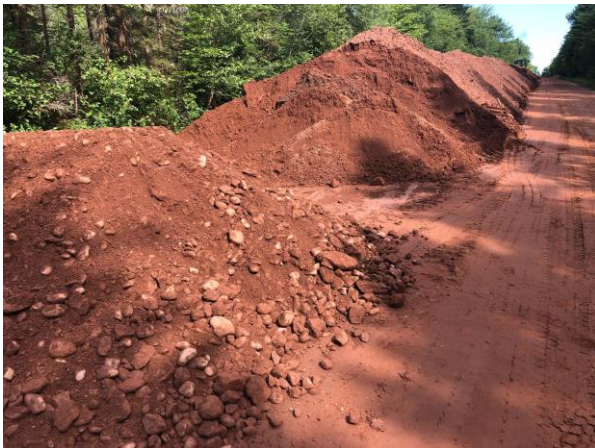
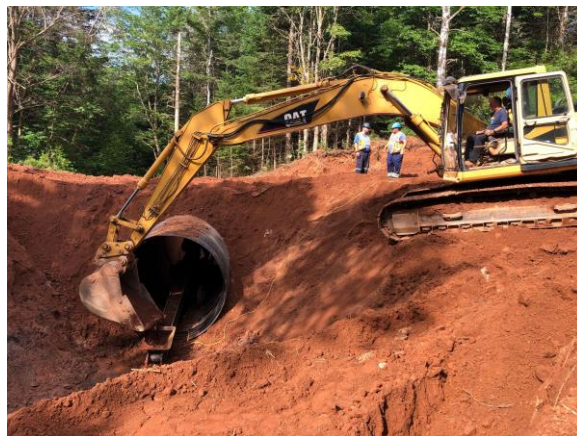
Today the conveyor belt was brought to the worksite and the pit run was dropped off. The crew began to fill in the culvert with the pit run using this belt. The pit run contains 60 percent gravel, 20 percent sand, and 20 percent fines (clay). Apart from the gravel, it greatly resembles the natural soil in the streambed upstream and downstream from the culvert. The idea is to have a very similar substrate so that if any pit run was to wash out, the composition of substrate downstream would not change significantly. But given the 8 foot width of the culvert and the deflectors and meanders inside the culvert (see Aug 5), the water should not be flowing through at high enough velocities for such a wash out, even in periods of high flow in the spring and fall. The pit run is supposed to be very stable given its low overall porosity, being the spaces of voids in the overall soil; the fines and sand should fill in most of the voids between the larger pieces of gravel. The pore water pressures within the saturated pit run in theory should create tight bonds between the different soil grains, solidifying it.

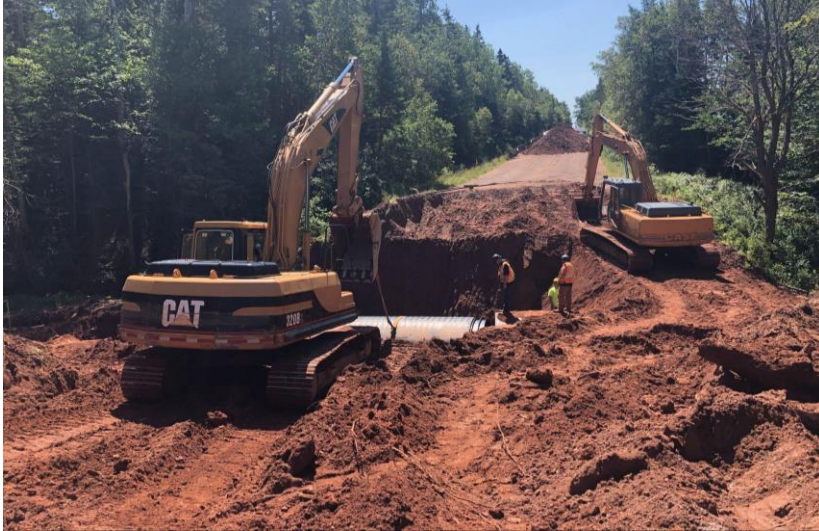
To start the day, they began to excavate a 'shelf' so that they could get closer to the culvert with the excavator. After this, the third section of the culvert arrived and the crew fastened this to the two sections already in the trench. After this section was attached, more pit run arrived and the crew filled in more of the culvert.

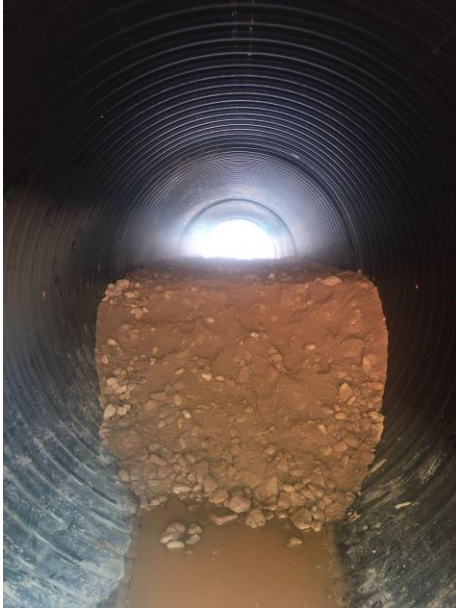
The first thing that was done in the morning was excavating a laneway down to the culvert outlet so that the mini-excavator could get down, close to the culvert. The large excavator uphill then passed pit run down to the mini excavator, which then dropped loads of it inside a conveyor belt, placed inside the culvert. There were crew members at the other end of the conveyor belt raking and moving the pit run. This took up the majority of the day. At the end of the day, the last section of the culvert was dropped off.

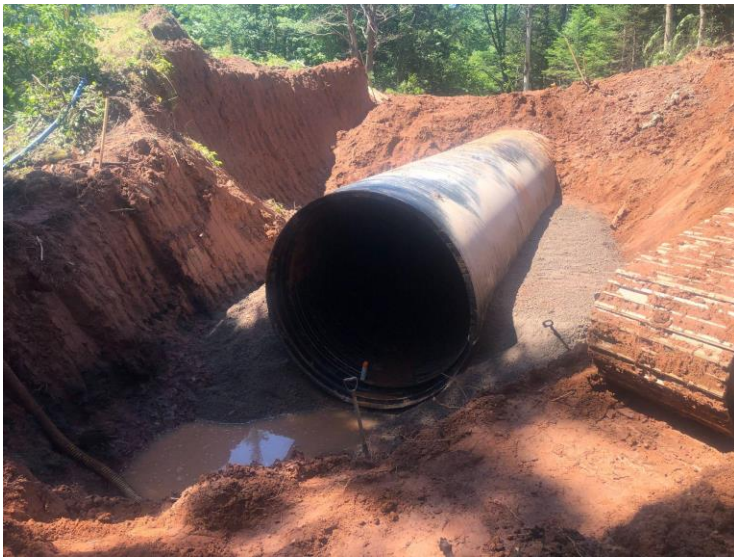
In the morning, the last section of the culvert was installed; this took a long time. Next, class A gravel was used to fill in the spaces on the sides (bottom half) of the culvert to stabilize it. After this, soil was added on top of the gravel and finally on top of the culvert to cover it.

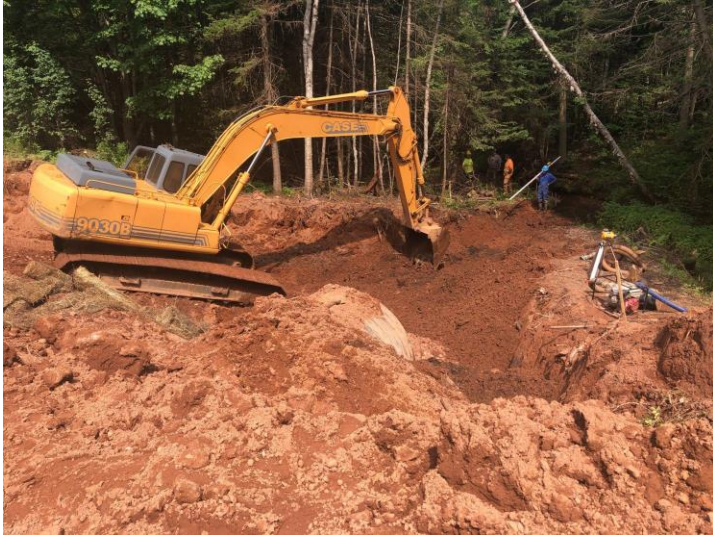
In the morning, more pit run gravel was dropped off and the crew got the mini-excavator again so they could put more pit run inside of the culvert. Now they are excavating what will become the new channel on the outflow side of the culvert. They then added R5 rock at the bottom of this channel and will then be covering this with pit run gravel, to match what's inside the culvert.

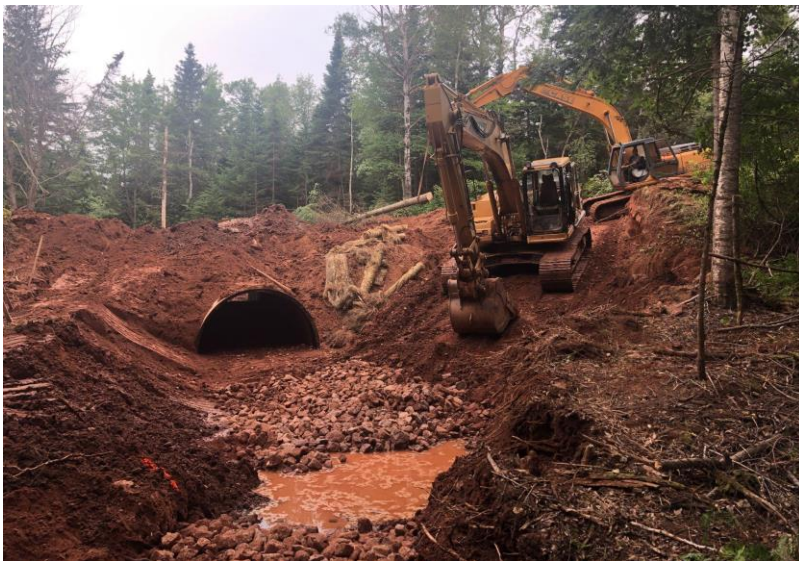
In the morning, some trees were being cleared both upstream and downstream close to the inflow and outflow to make more work-space. More R5 rock was then added to the downstream channel and pit-run, while grade readings were being taken simultaneously to make sure the slope from the outlet to where the stream connects is 2.5%, as per the design.

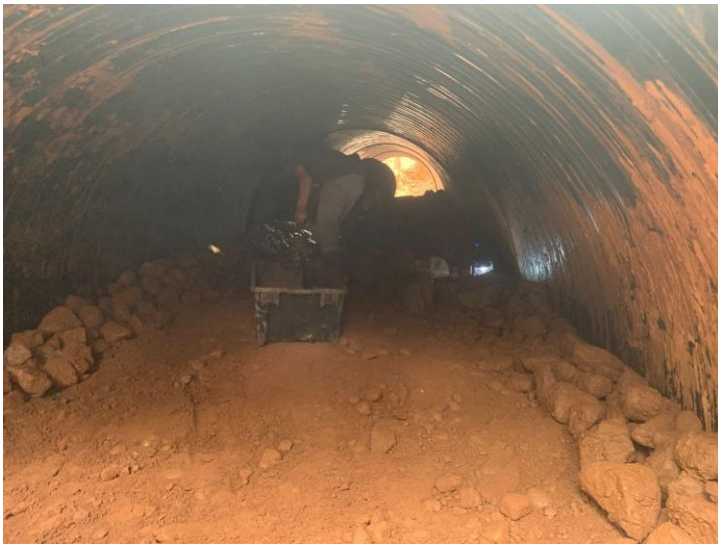
WRTBWA staff worked on the culvert on this day (as the contractors don't work Fridays) to move rock along edges of pipe, and dig a low-flow channel in the middle of the pit run gravel/sand/silt. This was completed on the downstream half of the pipe where pit run gravel had been installed.

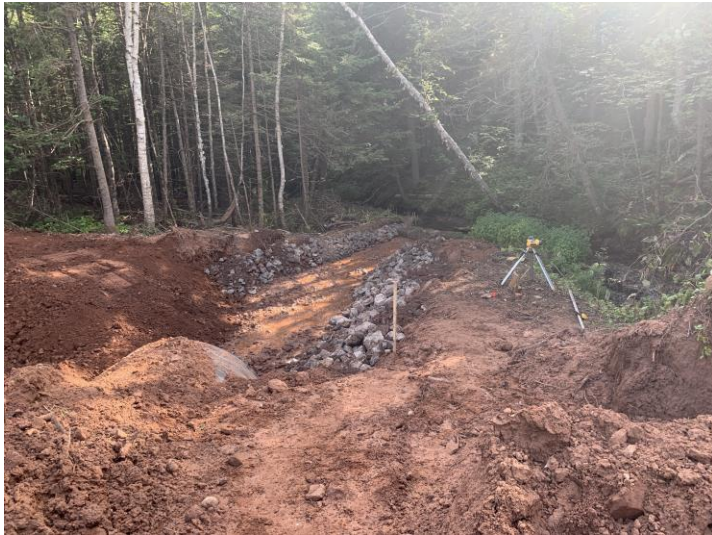
Figure #: The figure above shows the rock that was placed along the bottom side of the bank located on the outflow side of the culvert.

The crew continued to excavate the inflow side of the culvert. The bank on the outflow side of the culvert was enhanced with R25 rocks.

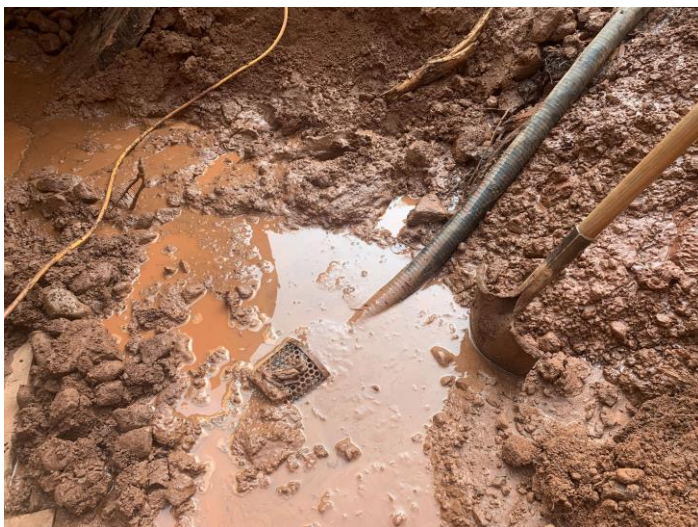
Figure #: The figure above shows the water being pumped out of the inflow side of the culvert to allow for a more manageable work area.

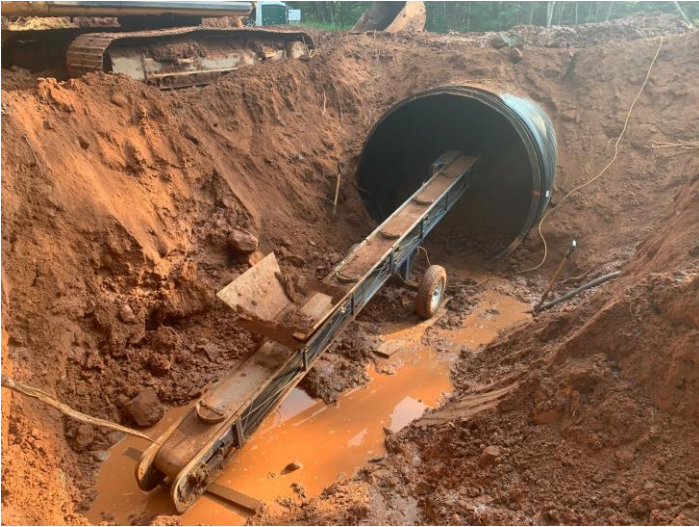
Figure #: The figure above shows the quantity of water in the inflow side of the culvert as pumping began. This image also shows the conveyor belt that was ordered and delivered from Caterpillar in Moncton.

A conveyor belt from Caterpillar in Moncton was ordered and was delivered today. The purpose of the conveyor belt is to transport granite rock which is from Nova Scotia into the natural substrate floor of the culvert. The crew positioned the conveyor belt on the inflow side of the culvert. Water was pumped out of the inflow side of the culvert to allow for a more manageable work area. Rock was delivered by dump trucks periodically throughout the day. More R25 rock was placed along the bank of the outflow side of the culvert. The bank on the outflow side of the culvert was flattened out more to minimize the bank's slope angle.

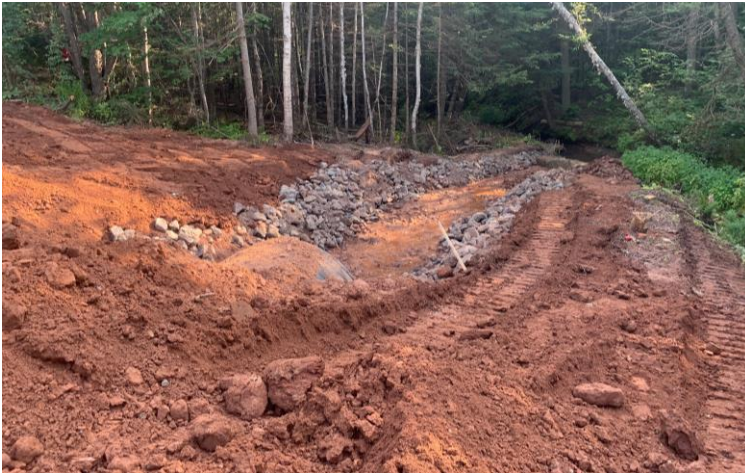
Figure #: The figure above shows the outflow side of the culvert. In the image you can see that the bank along both sides of the culvert have been flattened out to decrease the slope's angle. In addition, more rock was placed along the banks.

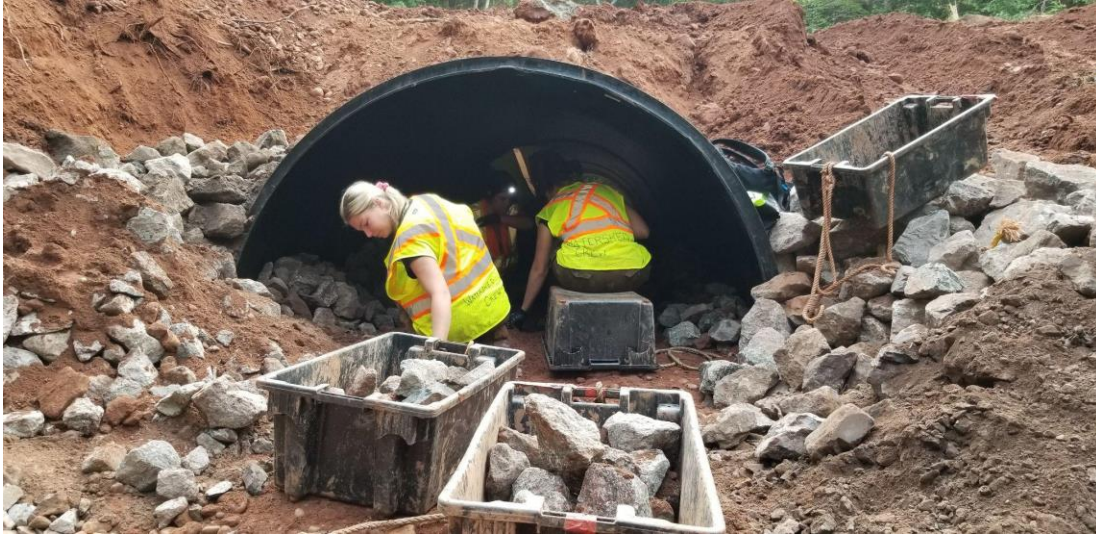
First thing in the morning the watershed crew continued the same project as started on August 6 on the upstream half of the culvert, after contractors had completed installing the pit run gravel/sand/silt mix the day before.

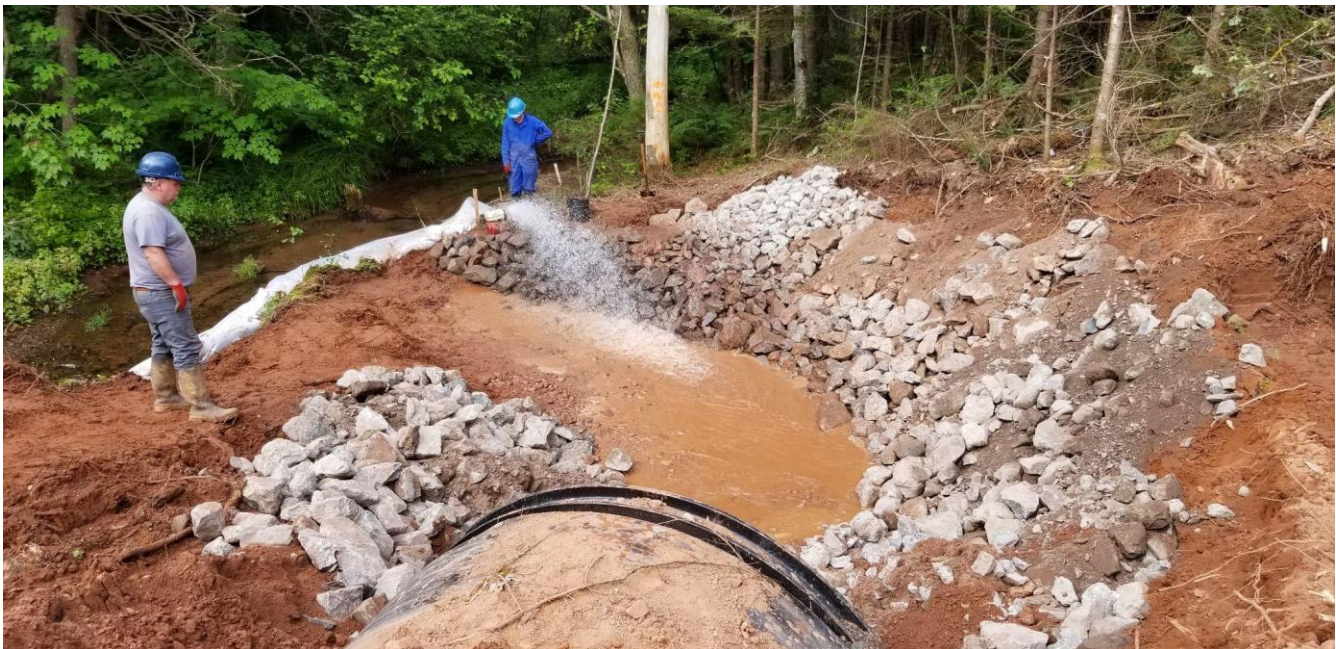
After the watershed crew finished inside the pipe, the contractors got set up to wash out the new channel. To do this water was pumped through the culvert, in a loop, before pumping it back to the silt trap upslope. The purpose of this is to wash out some of the looser fines on the surface of the streambed; this will aid in reducing the amount of washout that happens when the channel is finally opened up. This process went on for about 3 hours, until the water was running clear. The channel was now ready for stream water.

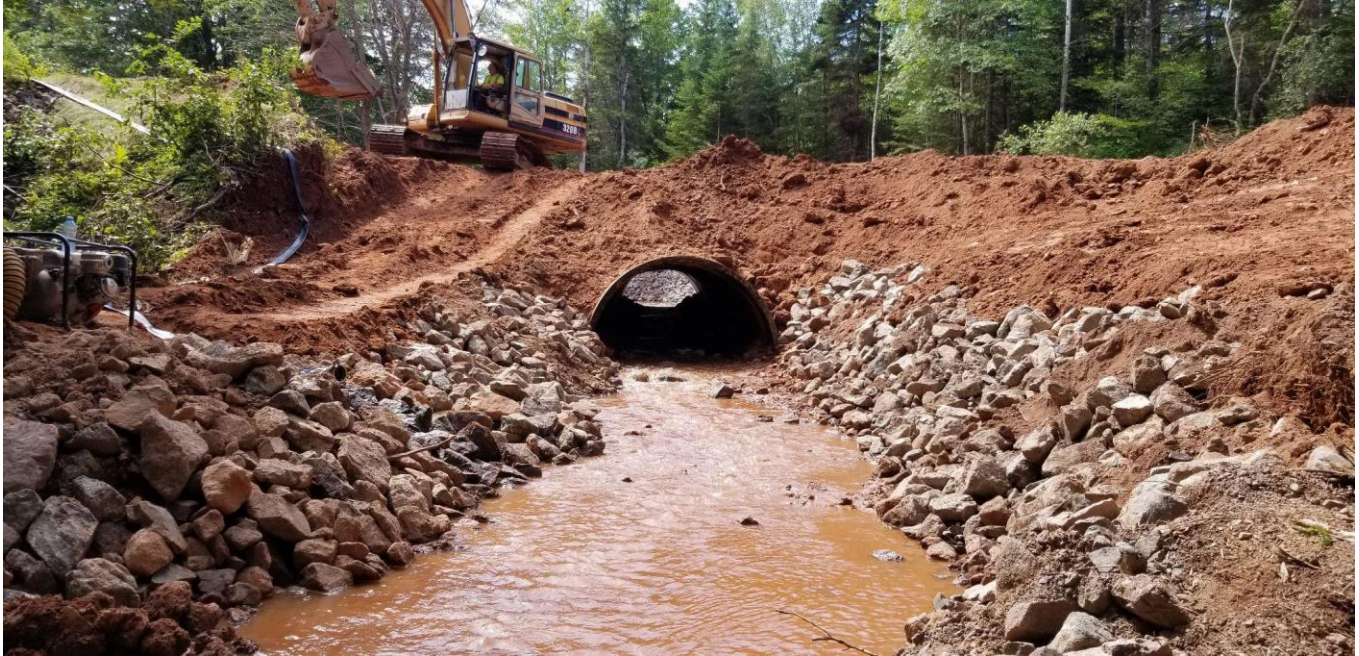
The sandbag cofferdam was moved to divert water flow through the culvert and shut off water through the old culvert. Water flowed through the culvert, some sediment was disturbed in this process. The river below Tim's Creek looked similar to after a heavy rain, though with all the sediment coming from Tim's Creek rather than from farther upriver.

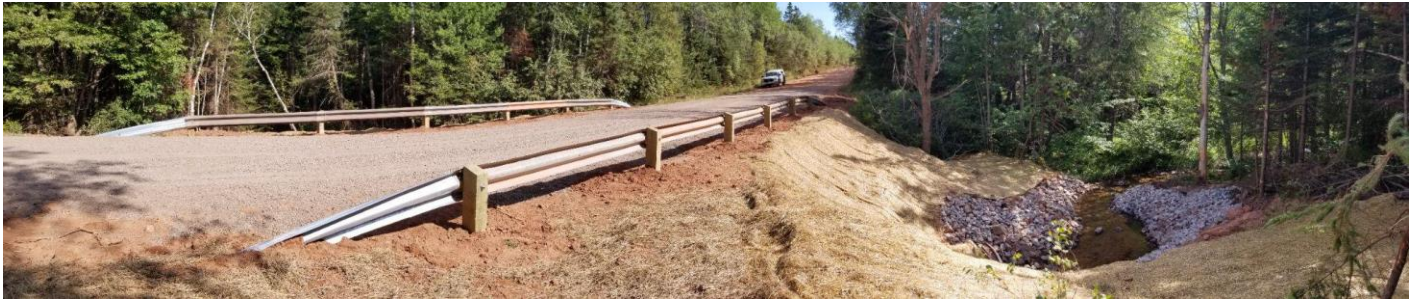
Figure #. Panorama photo of upstream side of culvert

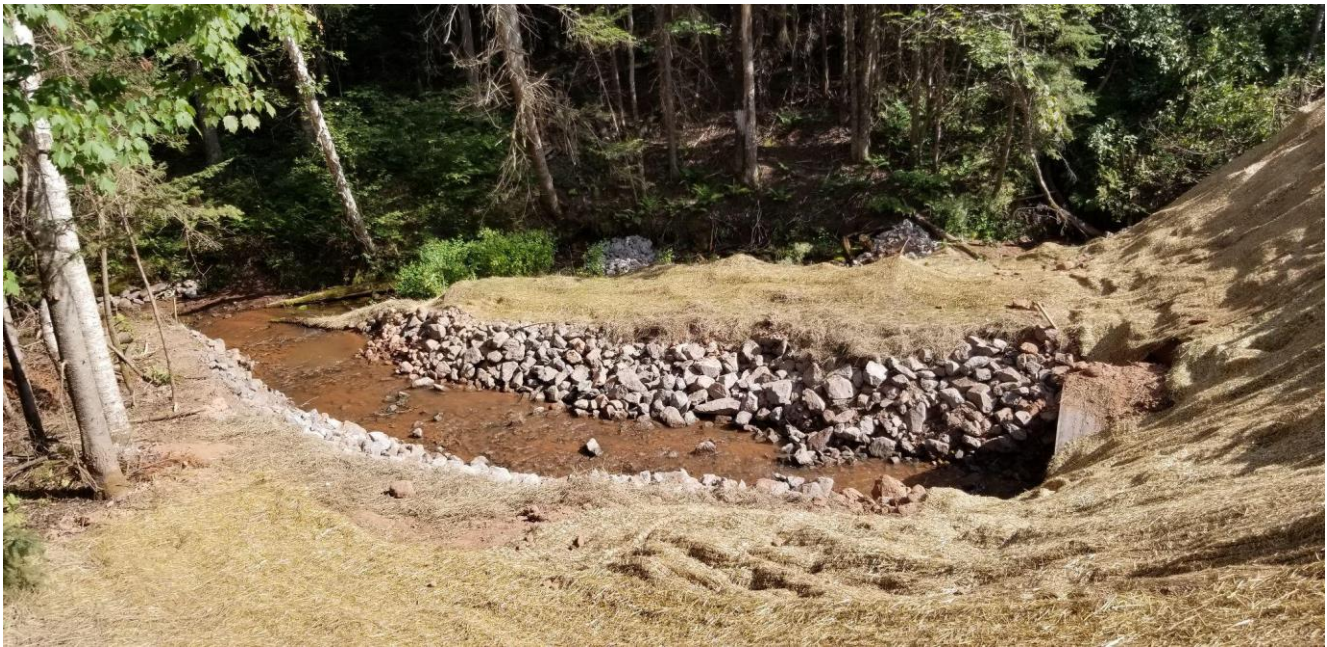
Figure #. Downstream side of culvert

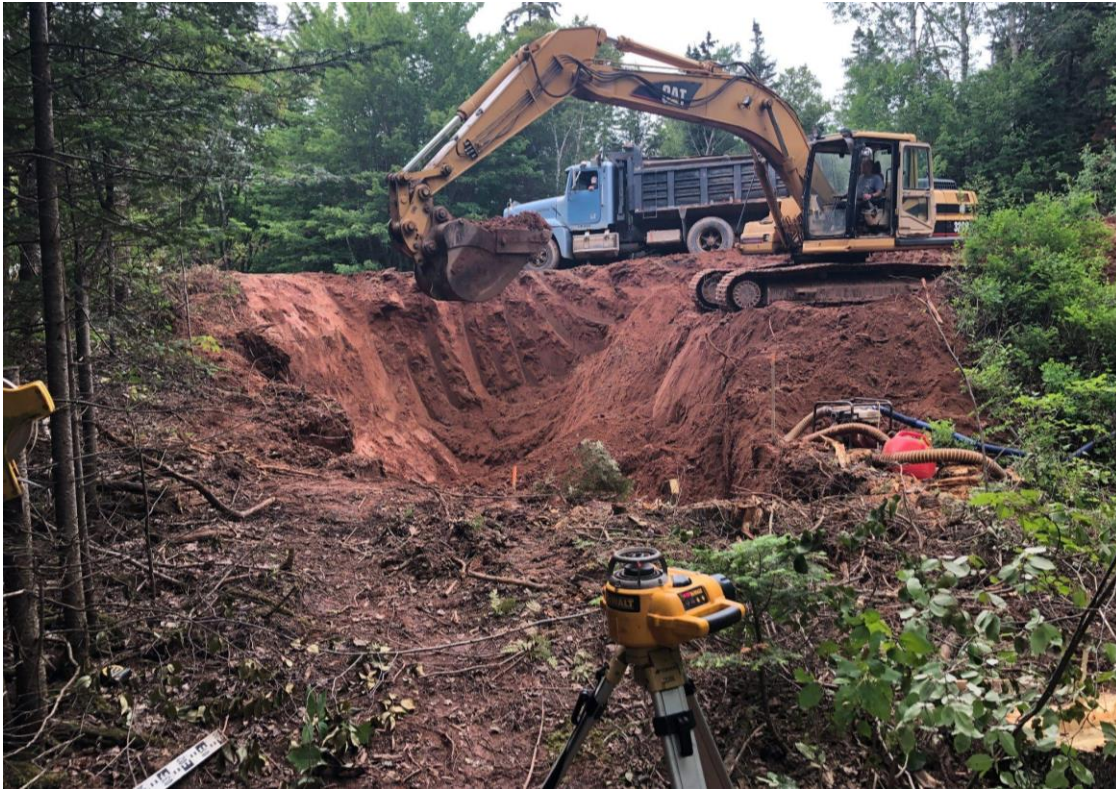
Excavator loading material into dump truck, survey equipment and water pumps in foreground. Jobsite viewed from upstream.

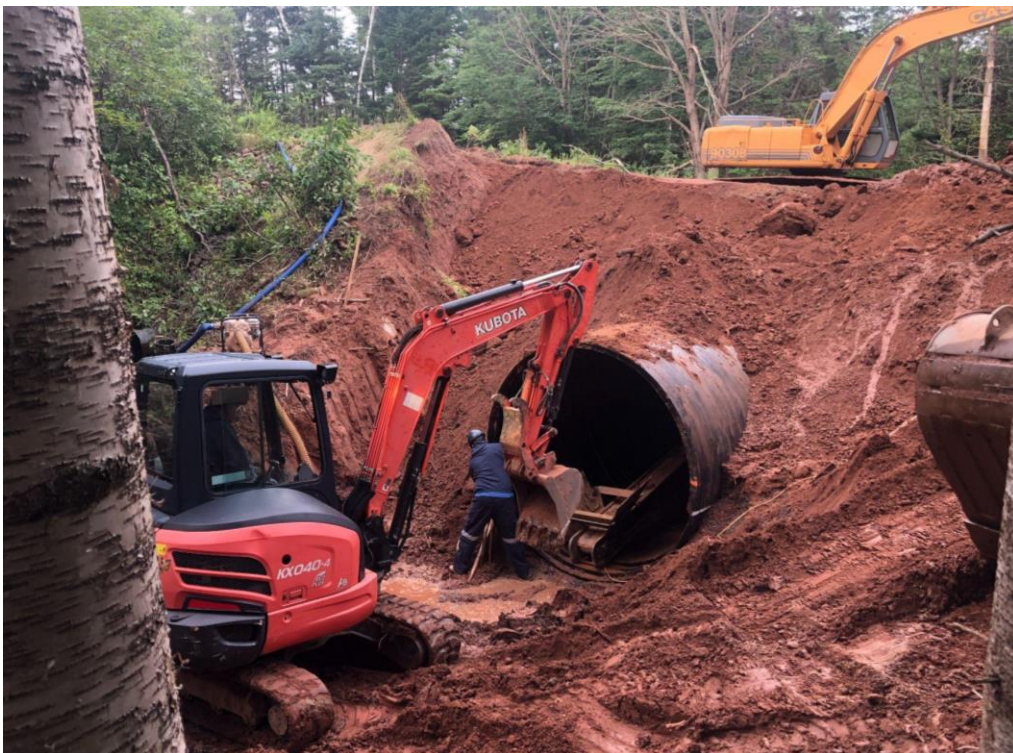
Mini excavator being used to load material onto conveyor to backfill the culvert to the appropriate level of embedment. Large excavator working in background on the downstream end of the culvert. Jobsite viewed from upstream.

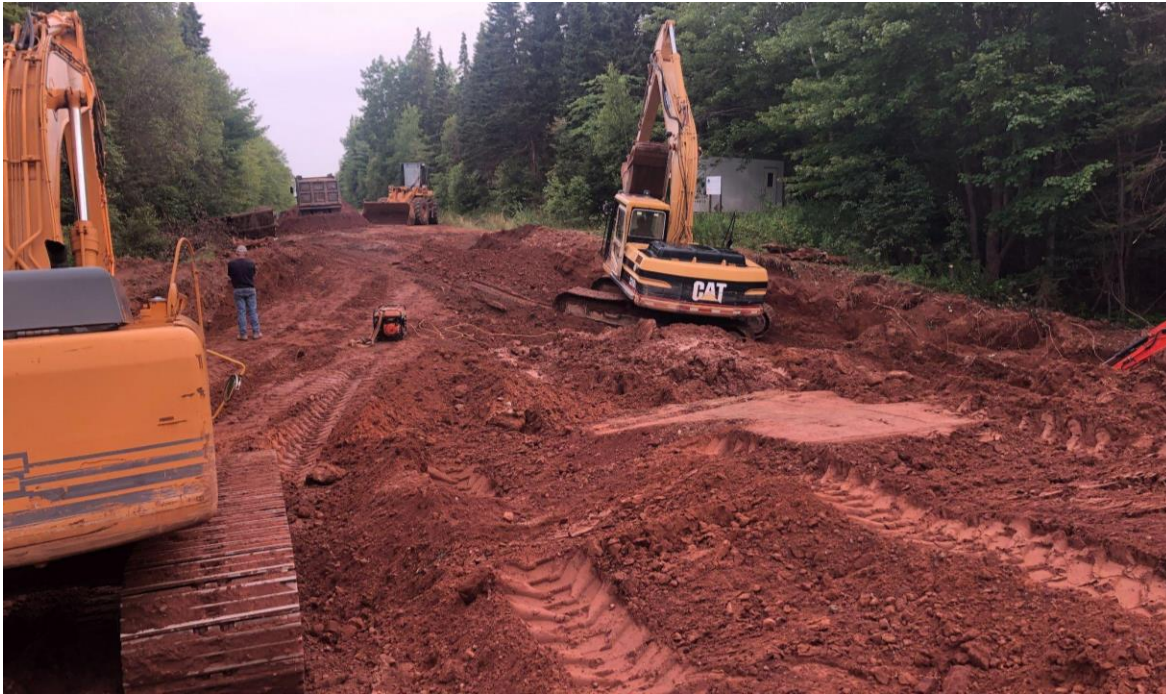
Two large excavators, one mini excavator (only partly visible on right of photo - orange arm extended), one loader, and one dumptruck all operating simultaneously. 2021-08-04. Jobsite viewed from the southern edge.

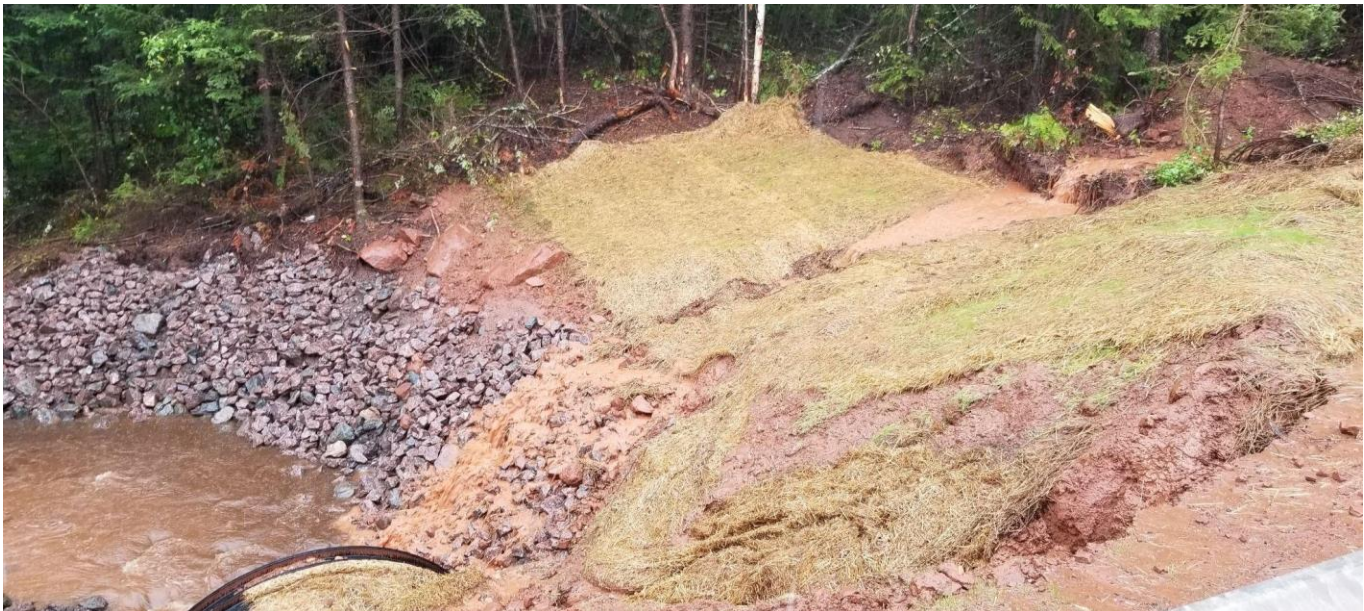
Silty water running from ditch northwest of culvert, through the upstream side of the work site

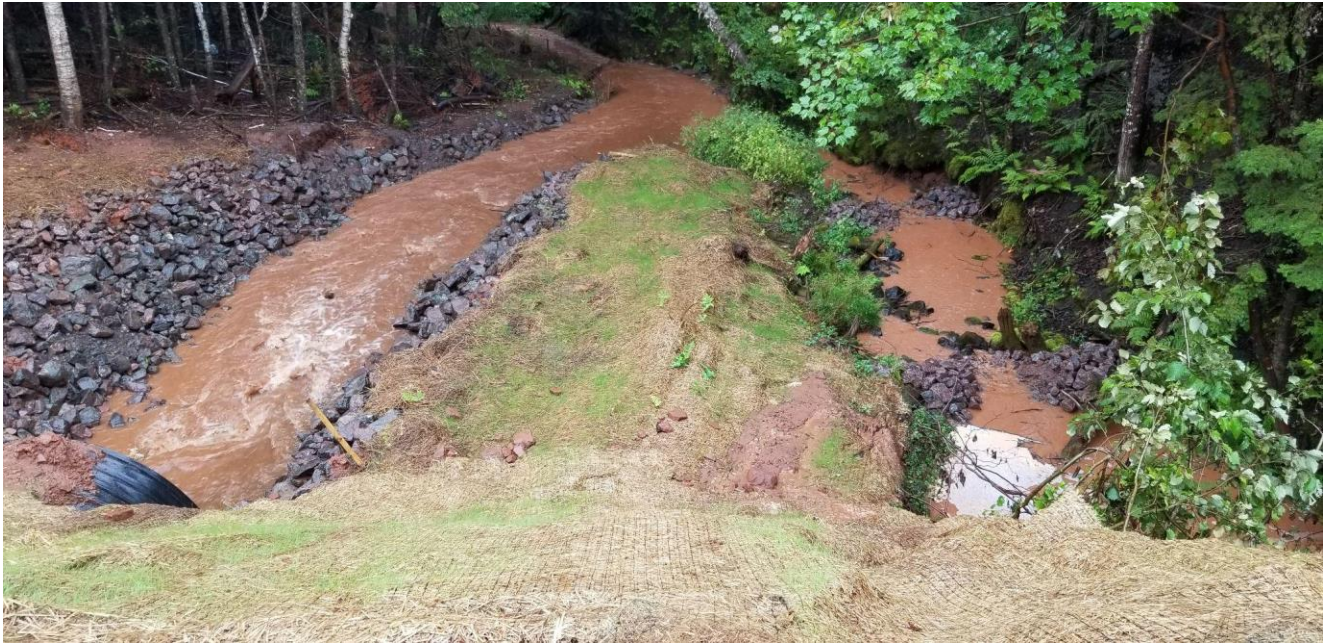
Downstream side of worksite as seen from road

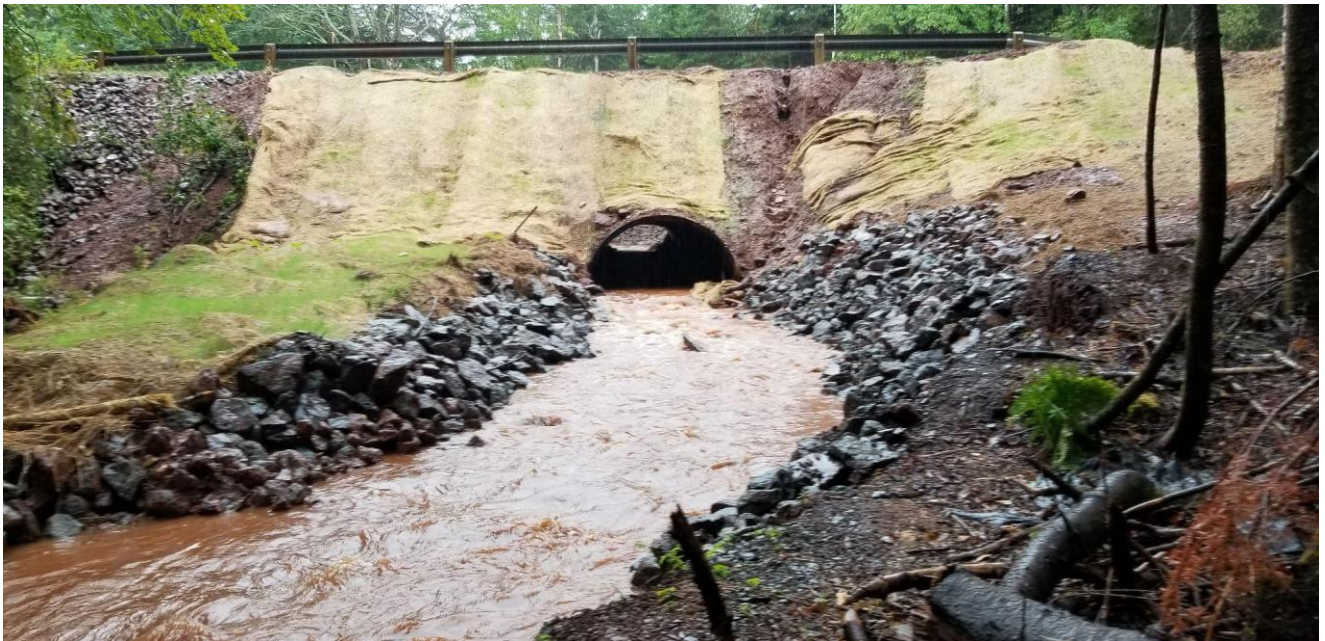
Downstream side as seen from stream. Some of the straw matting washed down the slope.

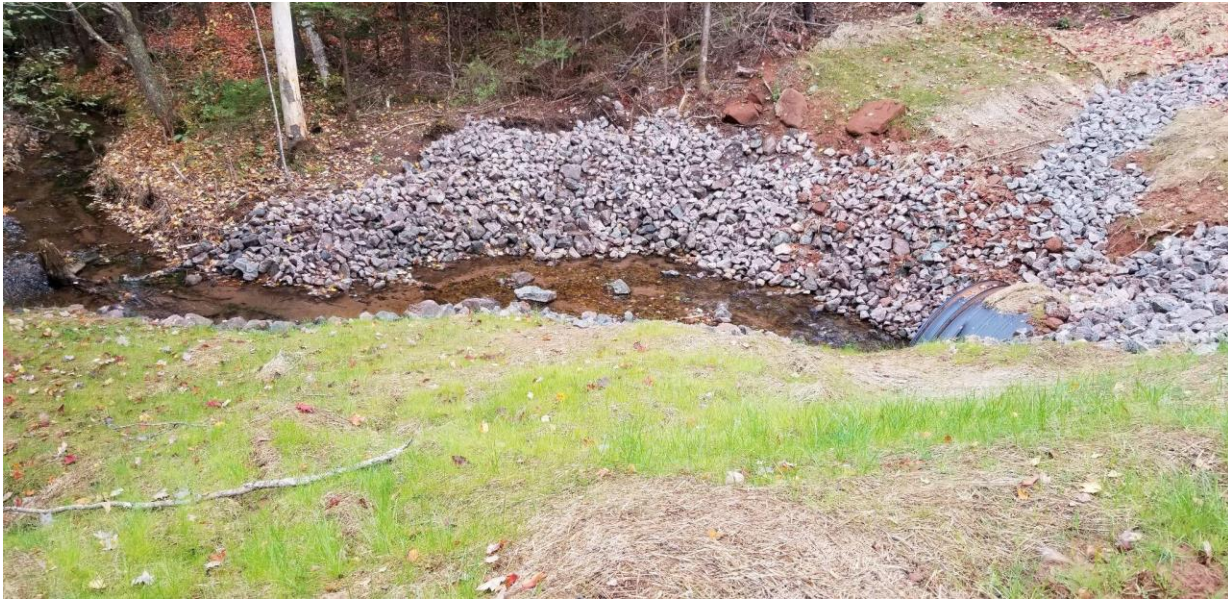
October 21, Grass growing on upstream side, and extra rock added where runoff from ditch to the north enters the stream

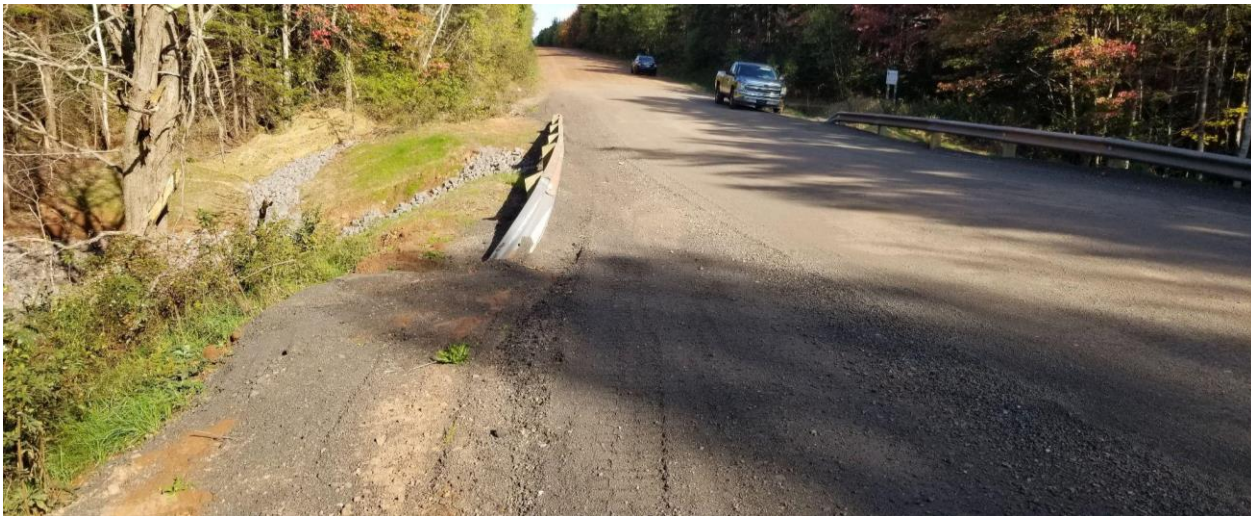
Oct 21 after additional asphalt millings were added to edges of road

TIE plans to complete additional erosion control work next week > gabion baskets, rock dams, excavate silt traps in ditches, put millings (aka crushed asphalt) across a wider section of the road because the shoulders are very soft right now, etc.
