WINTER RIVER - TRACADIE BAY WATERSHED ASSOCIATION

Final Report 2017-2018 Work Year

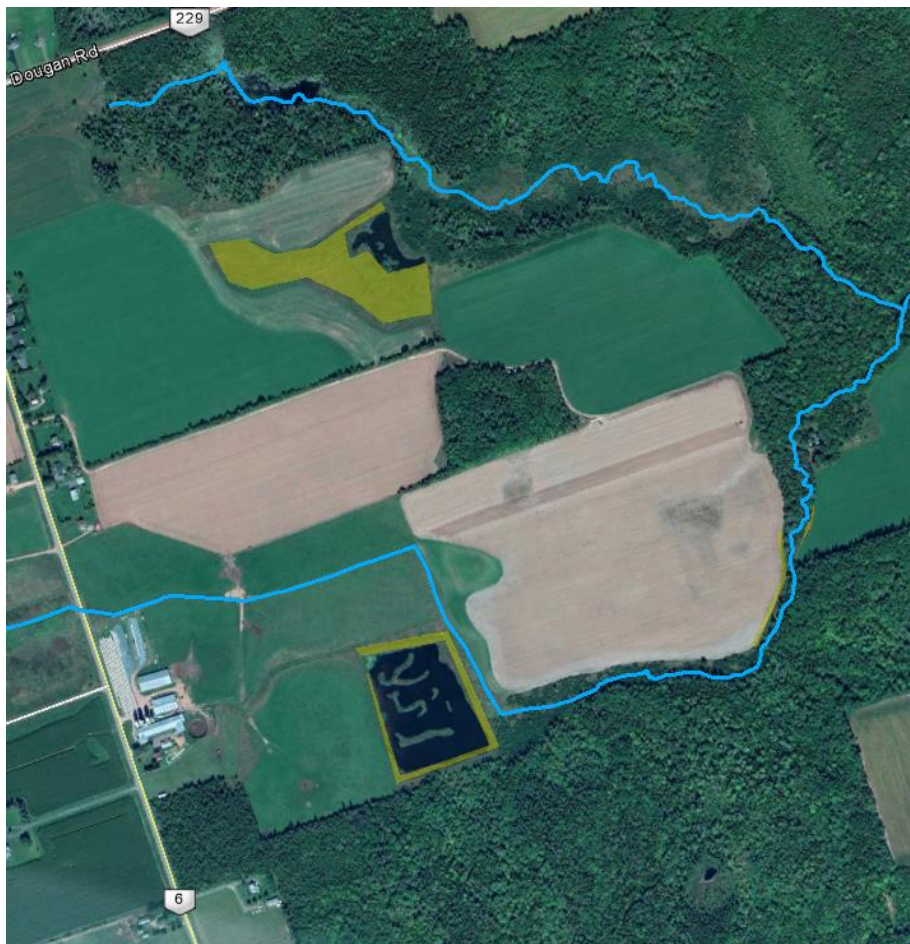
Figure 2. Tree planting areas around Black River.

The Bysterveldt's farm along the Black River was selected for tree planting in 2017. The planting areas on the property included two ponds constructed by Ducks Unlimited, along with the riparian zone of Black River. More shrubs were planted in fall after a culvert replacement project was complete. The trees and shrubs provide habitat diversity for waterfowl, improve bank stability to prevent erosion, and decrease soil erosion from adjoining fields.

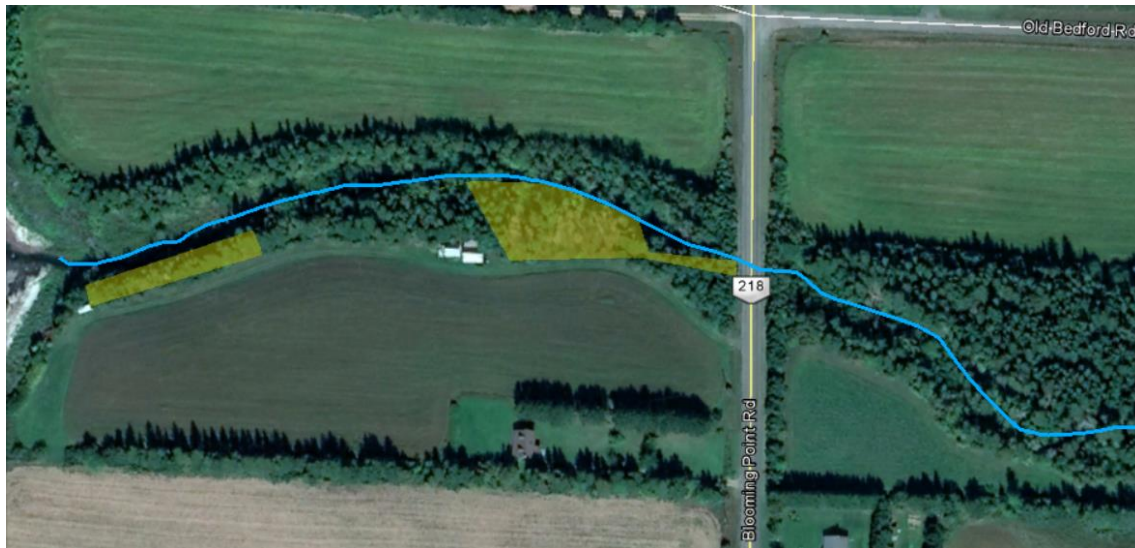
Figure 4: Beaton's Creek planting locations

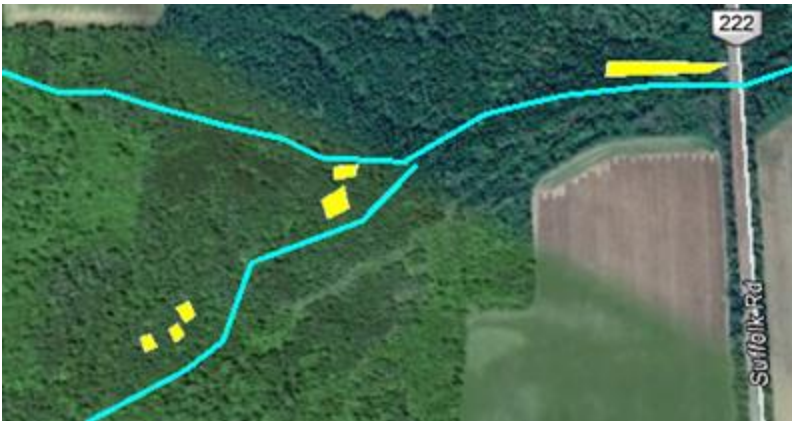
Figure 5: Tim's Creek planting areas

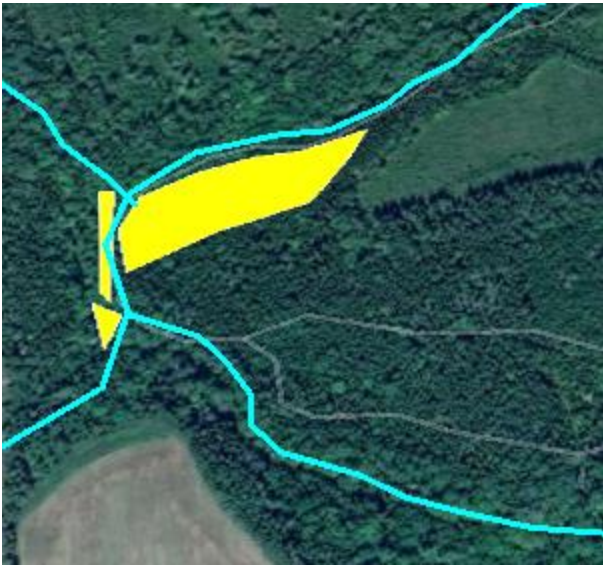
Figure 6. Areas near Winter River Trail, where trees and shrubs were planted in 2017

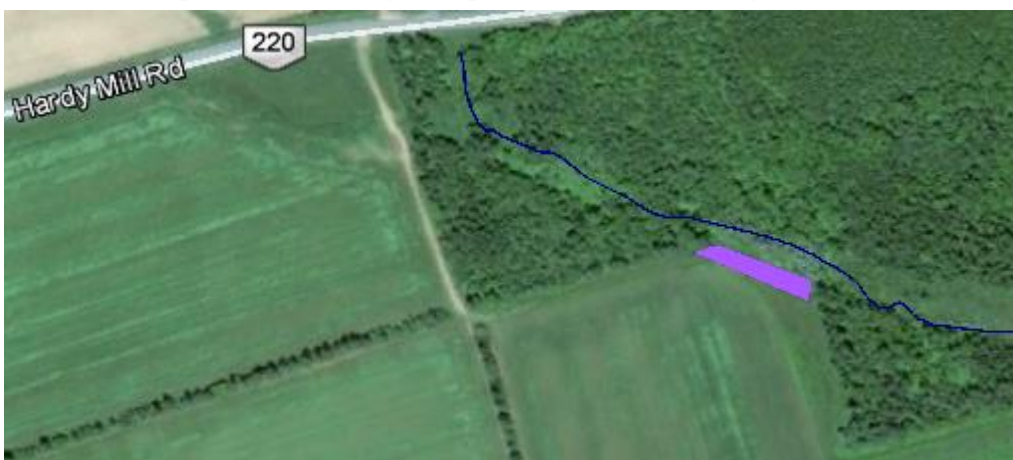
Figure 8: The area planted along the Pater branch, near the silt fence

The Pater Branch silt fence prevents runoff from crop fertilizers and pesticides from entering the stream at the Pater Branch. Behind this silt fence trees have previously been planted. A well was installed, but is not in use, which causes the ground to be a very wet environment. Tree and shrub species that thrive in wet environments were planted.

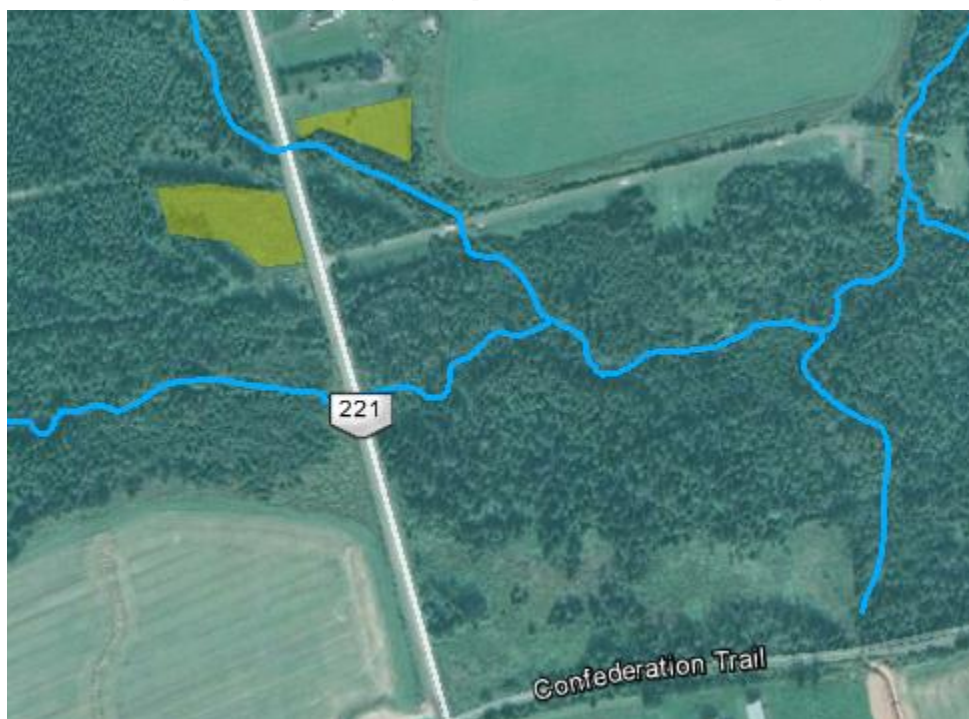
Figure 9: Tree planting areas on City of Charlottetown owned sites on Union Road

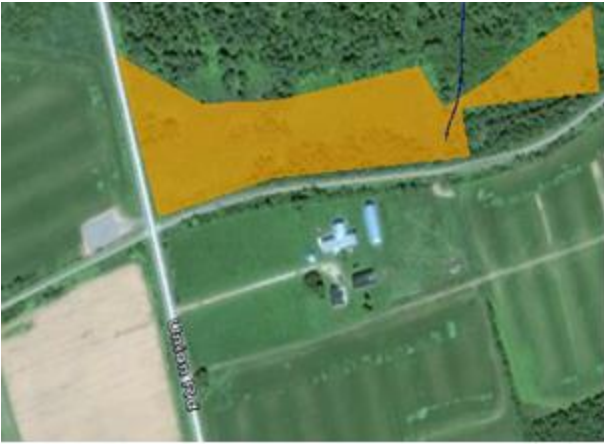
Figure 10: Area planted by student volunteers

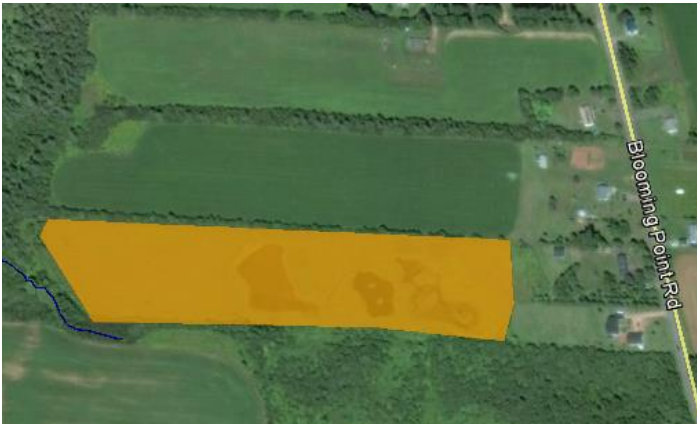
Figure 12: Highlighted is planting area at Scott Lyon's property.

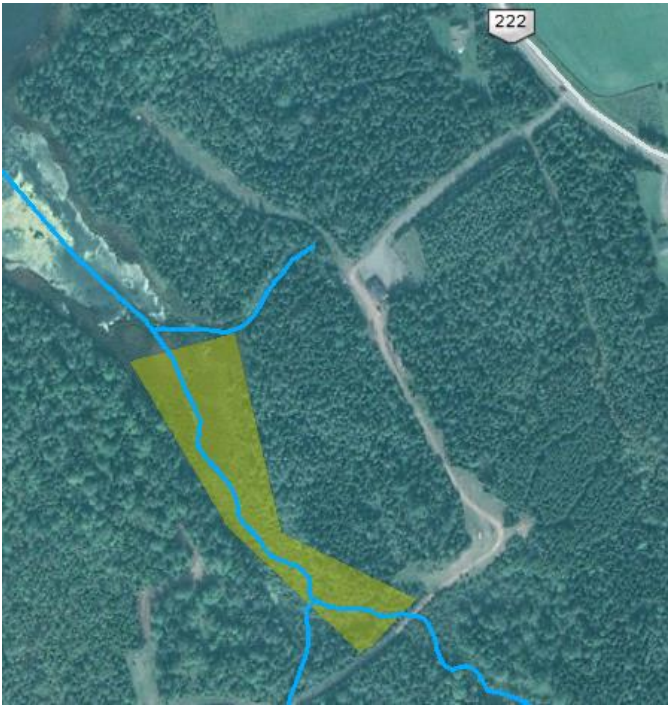
Figure 13: Area planted at Suffolk pumping station

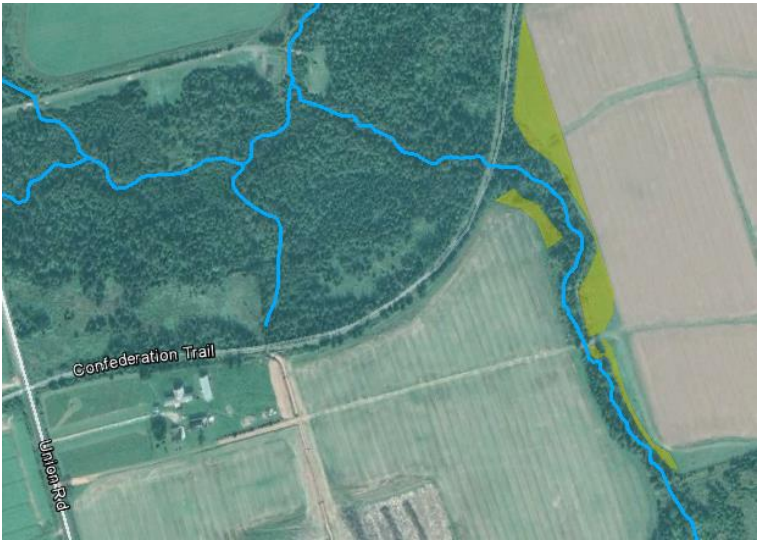
Figure 14: Location where Vanco Branch was planted

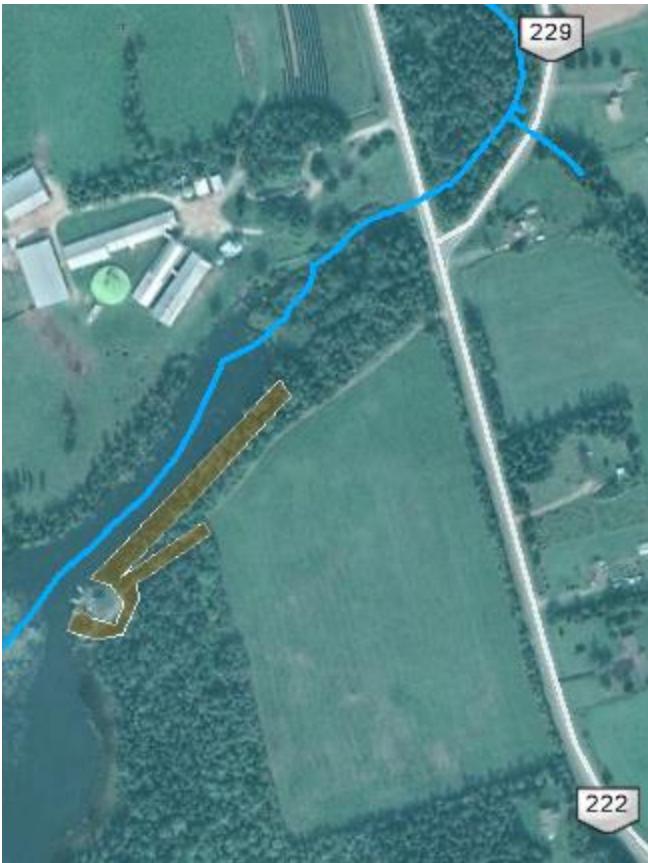
Figure 16: Forest enhancement areas at Officer’s Clubhouse – tree planting and cutting standing dead trees.

Upon inspection, we found the site had many different tree species growing already on the property including multiple life stages of Balsam Fir, Sugar Maple, Red Maple, Red Oak, American Beech, Grey and White Birch, American Mountain Ash and Spruce. This area had wetland, shade and open area to plant a variety of shrubs and trees. There are several boat launches, a cottage, and an access road to the property, so we selected areas where these tree species would thrive, not close to the building or in anyone's way. Shrubs were planted to provide food for wildlife and help stabilize the bank. Officer's Pond is located on the Suffolk Road.

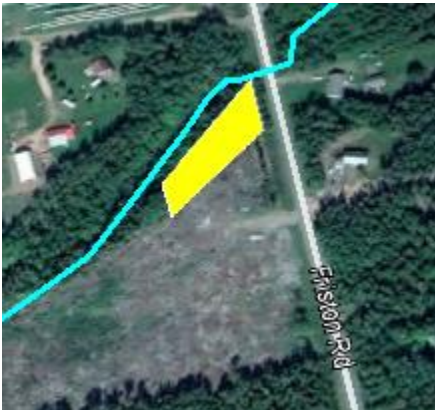
Figure 17: Represents the area planted at Friston South location fall 2017

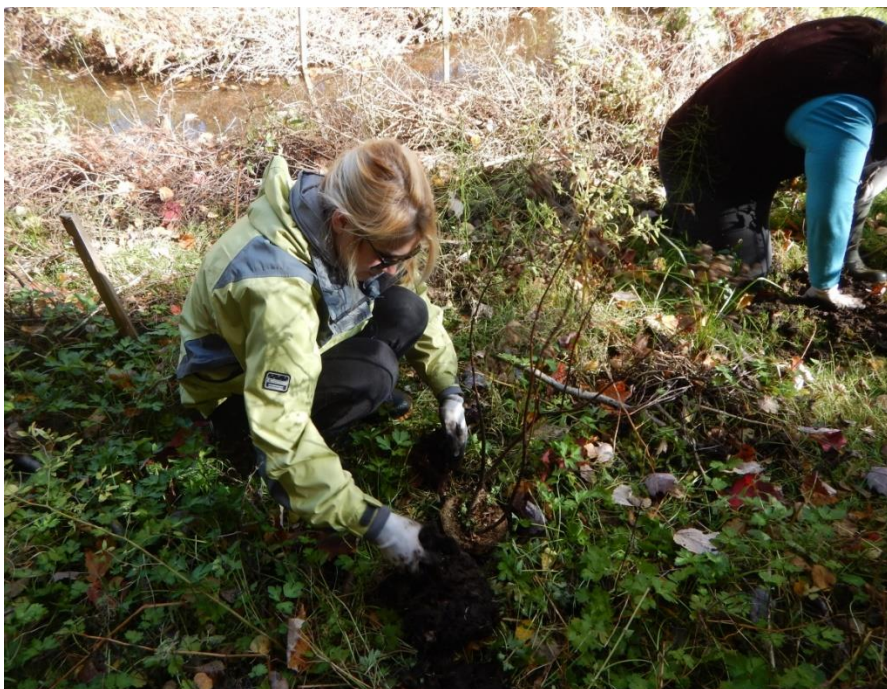
Figure 18: Staff member, Vanessa, planting on top of successful brush mat in Friston South

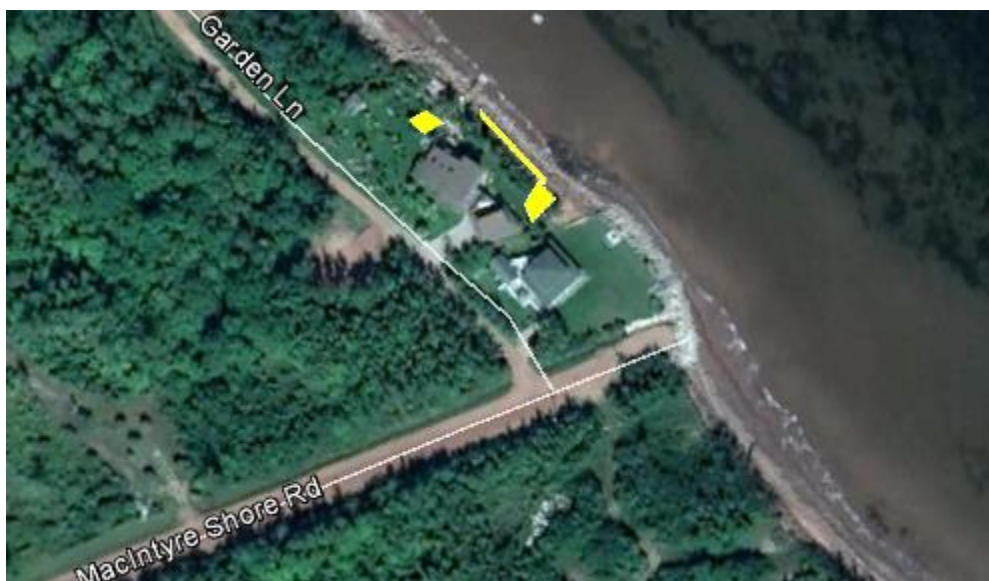
Figure 19: This image highlights in yellow the area planted at the property on 11 Garden Lane

This property is located on 11 Garden Lane, just off the MacIntyre Shore Rd and is a waterfront property overlooking Tracadie Bay. This area is projected by the UPEI Climate Lab to experience a lot of erosion in future decades. The fall crew planted White Spruce along the banks to help stabilize and protect the banks from erosion. There were also native shrubs planted to feed the many birds and wildlife in the area.

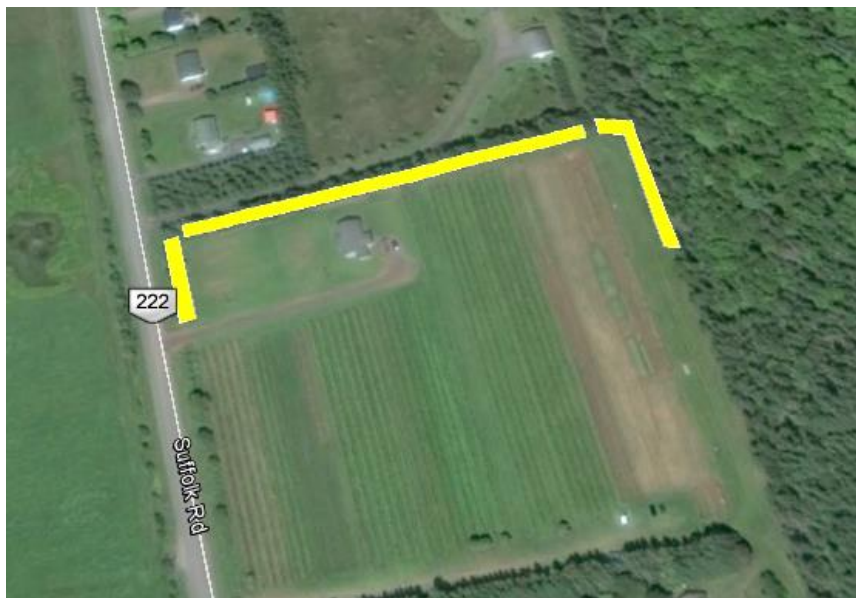
Figure 20: Highlighted area show planting at 654 Suffolk Rd in fall 2017

The homeowner volunteered to help plant at this location. The planting was done along the hedgerow that separates this mainly agricultural property, from residential neighbors. Some shrubs were also planted close to the ditch for wildlife habitat.

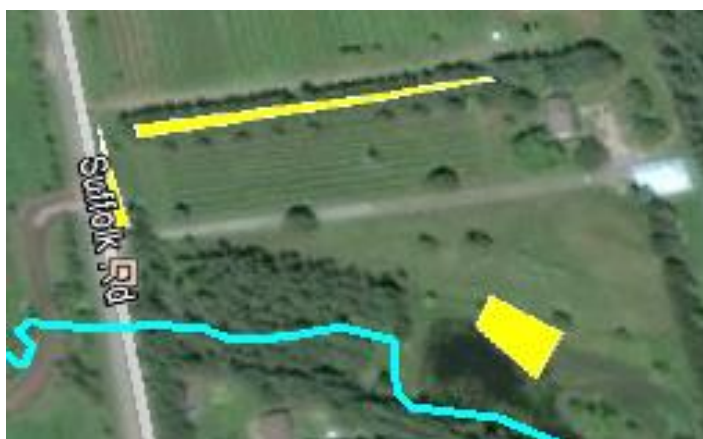
Figure 21: Tree and shrub planting areas at 630 Suffolk Rd

In a project to test the success of planting smaller trees, staff planted some #15 plug sizes of White Spruce along an existing hedgerow. This is a property that is regularly used as an experimental site, due to easy access and willing landowners. Leftover moisture-loving shrubs were planted near a ditch on the property and by the pond, for wildlife food and to help stabilize the pond bank.

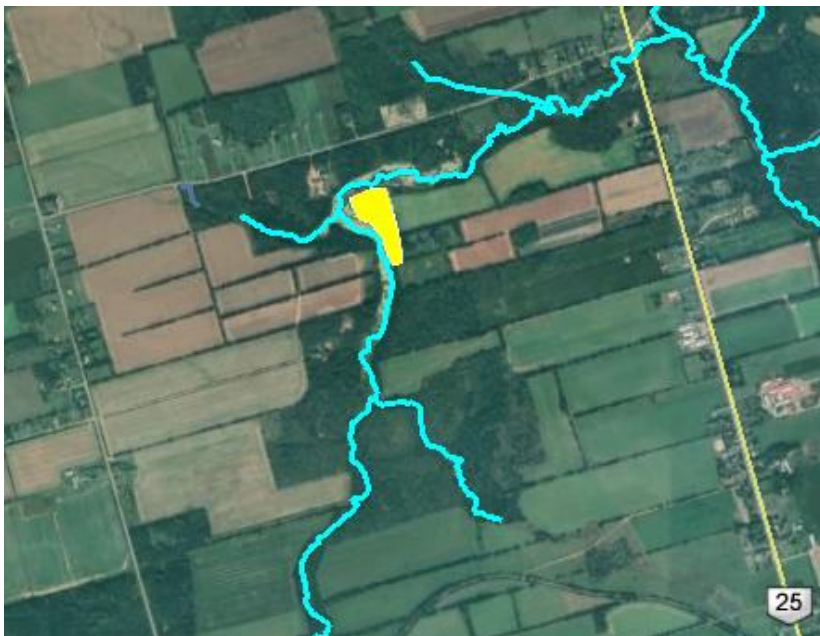
Figure 23: Map of area planted at Hardy Mill location.

The crew travelled by canoe, to access the property on the opposite side of the Hardy Mill Pond, to plant trees and shrubs within the 15m buffer zone. This will provide bank stability and cover for fish.

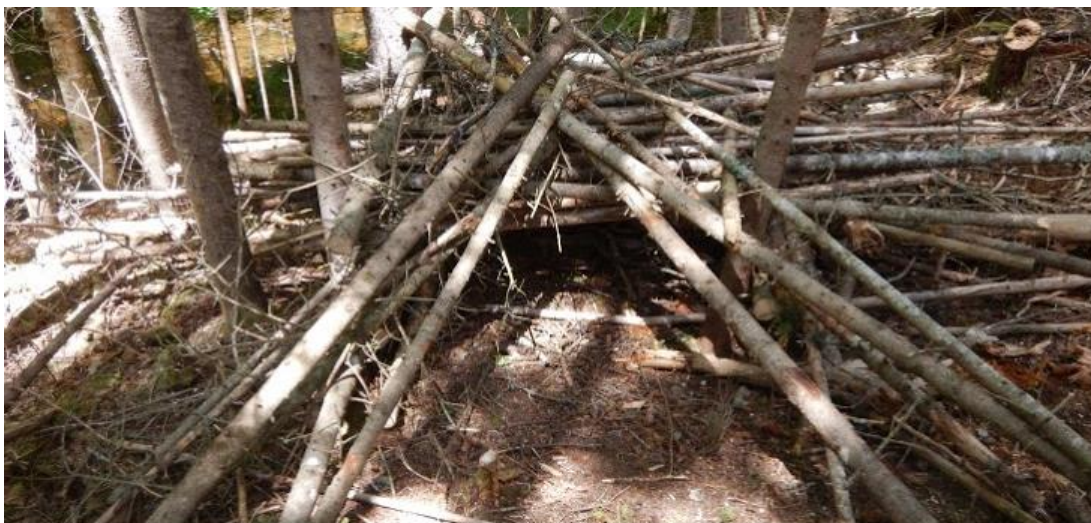
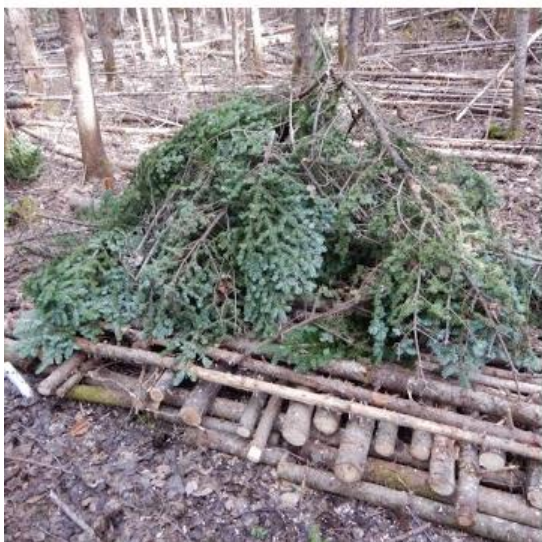
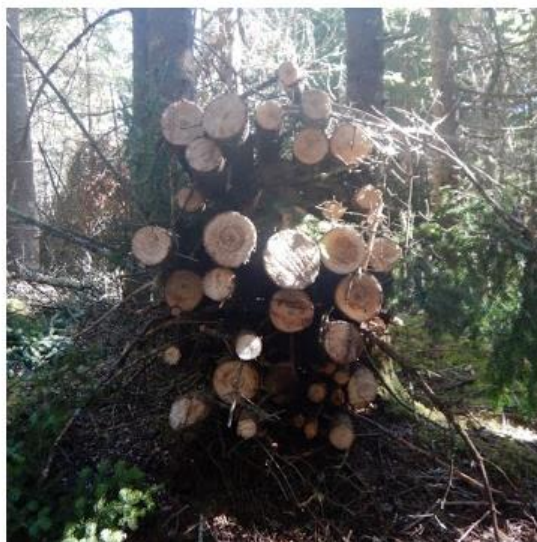
Figure 24: Examples of debris piles for wildlife

Felled trees were piled whole, or cut into smaller sections and piled, creating debris piles for wildlife. A variety of piles were made, some able to cater to larger wildlife species, while others were constructed to create habitat for insects. Another reason for creating large piles is to prevent a fire hazard from leaving excessive amounts of dead trees spread throughout the forest floor. In the fall of 2017 these patch cuts were planted with a variety of tree species (see section 3.1.3 for more information on tree planting).

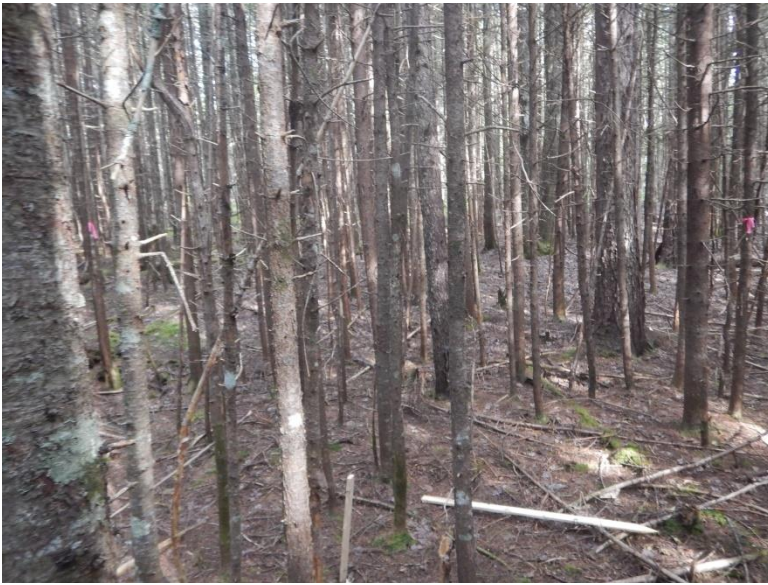
Figure 25: The standing dead trees along Tim's Creek

Monocultures were established many years ago, of White Spruce along Tim's Creek and Balsam Fir along the Winter River trail. Since the trees are all around the same age, large numbers of them are now dead or dying. While some standing dead trees can be beneficial for wildlife, the large quantities of small standing dead trees are more hazardous than beneficial. They pose a hazard for people using the popular Winter River Trail, and they also discourage biodiversity in the surrounding forest by reducing sunlight in the area. To open the forest floor to sunlight for other species of plants, many of the standing dead trees were removed. Seven patch cuts of approximately 10-meter by 10-meter in dimension were cut along Tim's Creek. Seventeen similar patch cuts were created on the Winter River trail section. Special attention was paid to remove the standing dead trees that could fall in the stream potentially blocking fish passage. The trees that could fall on the trail were also a priority.

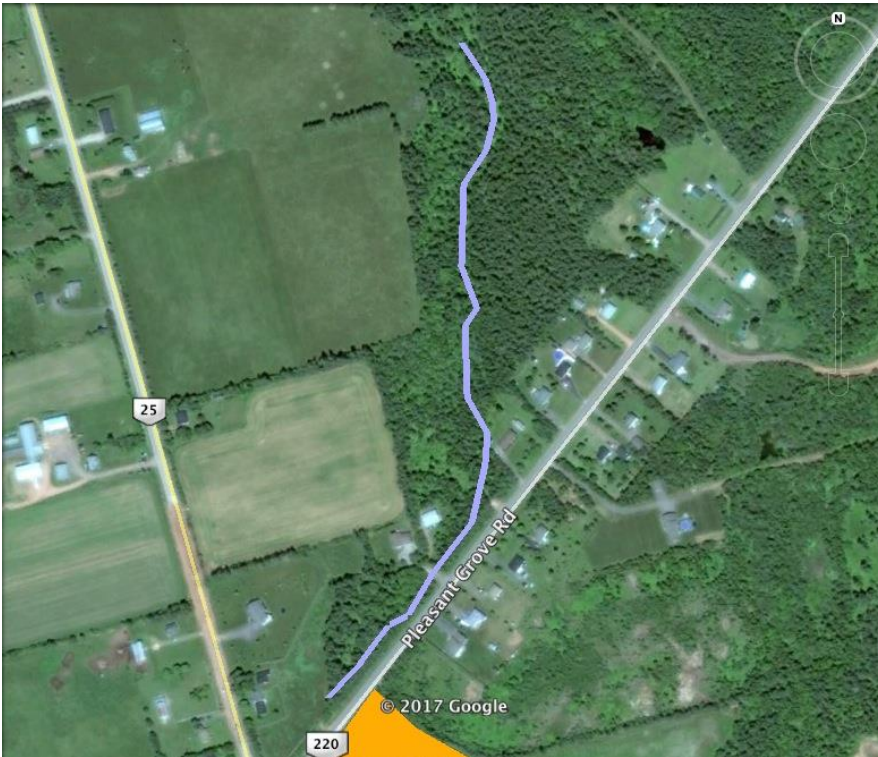
Figure 27: Section of MacLauchlan Branch cleared this summer season

Figure 28 through to Figure 36 show each section of stream that was cleared during the summer of 2017. Some sections had been cleared in previous years but required maintenance. Other sections, such as Beaton's Creek, were filled with many blockages as they had never had any enhancement work completed by WRTBWA. The difference in ease of fish passage and lack of blockages in previously cleared streams demonstrates the importance of stream clearing for riparian health. Figure 37 and Figure 38 show the major difference at Beaton's Creek before and after blockage removal.

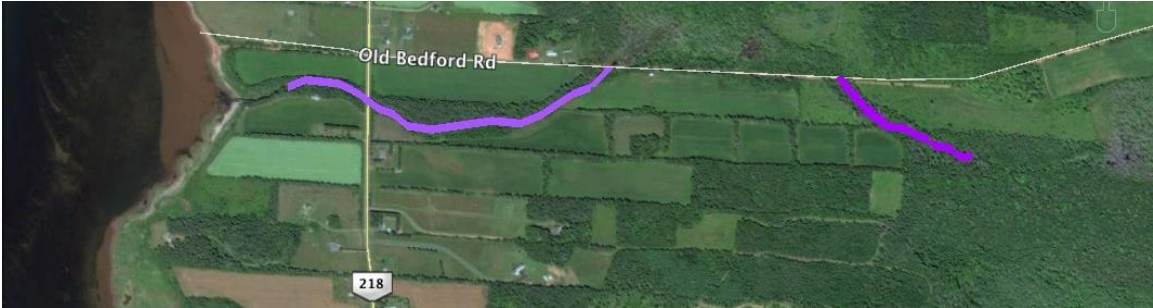
Figure 28: Section of Beaton's Creek cleared

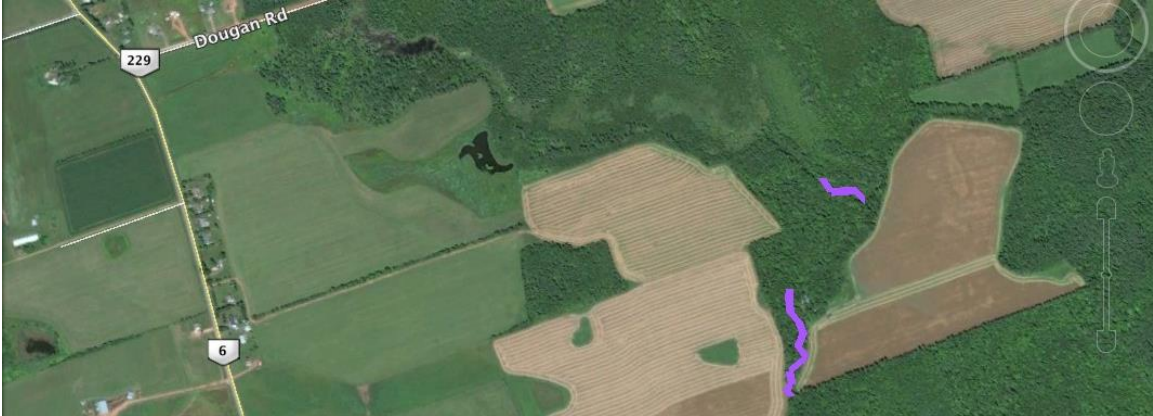
Figure 29: Two sections of Black River cleared

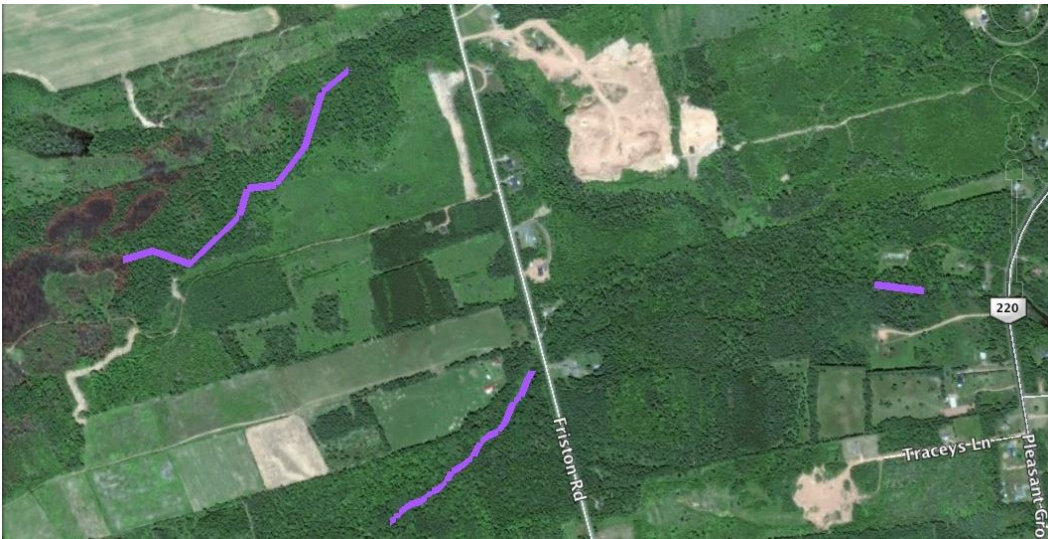
Figure 30: Sections of Friston Branch cleared this season

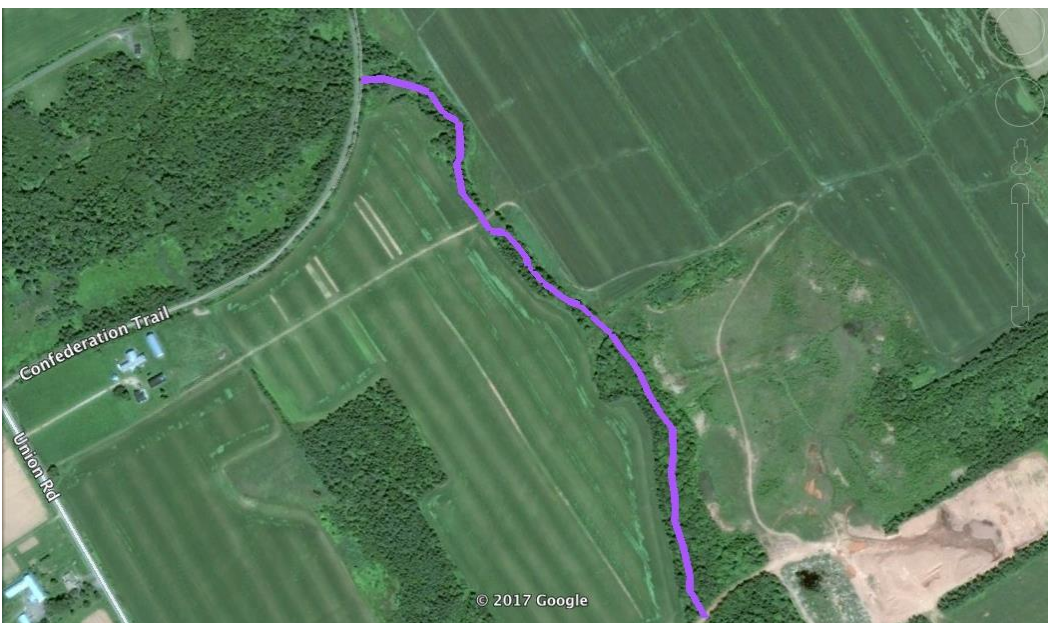
Figure 31: Section of Vanco Branch cleared.

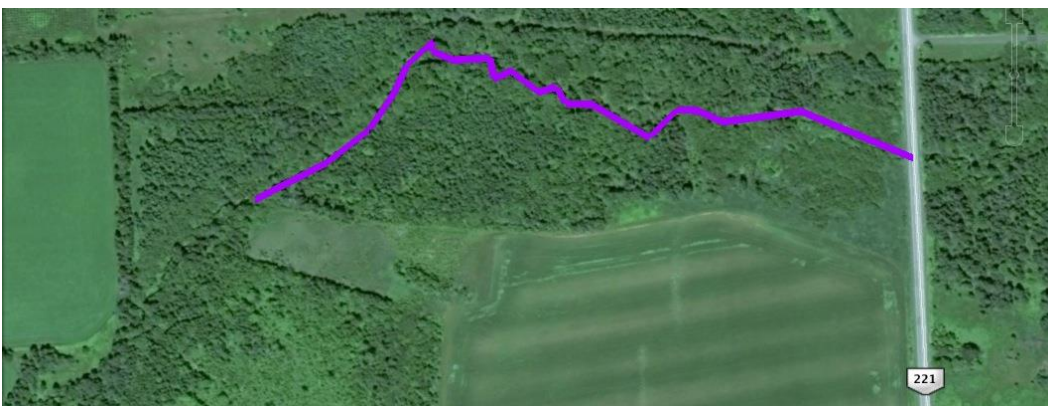
Figure 32: Cudmore Branch clearing

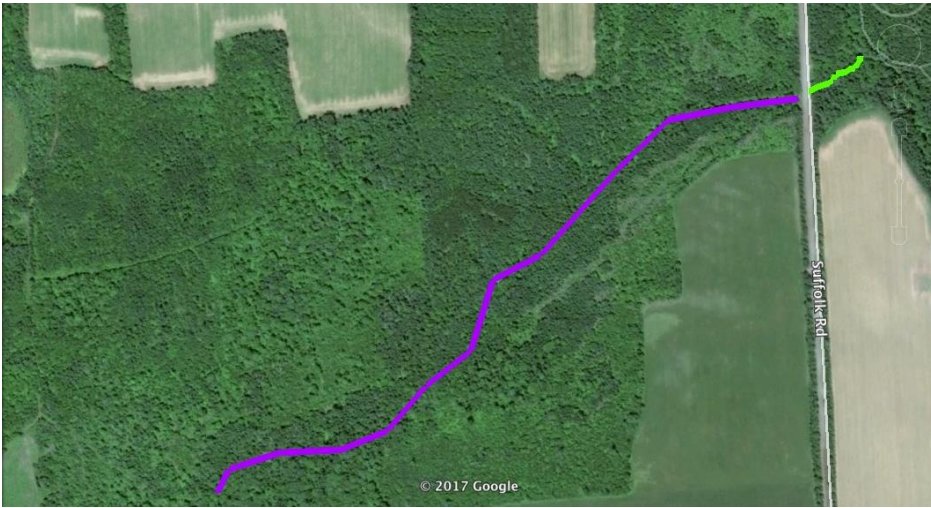
Figure 33: Section of Tim's Creek (upper) in purple and Tim's Creek (lower) in green that were cleared

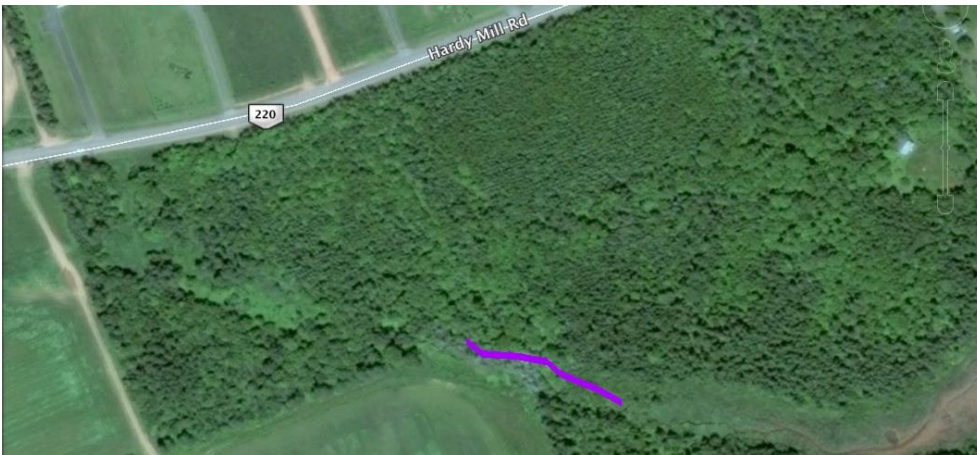
Figure 34: Pater Branch area that was cleared

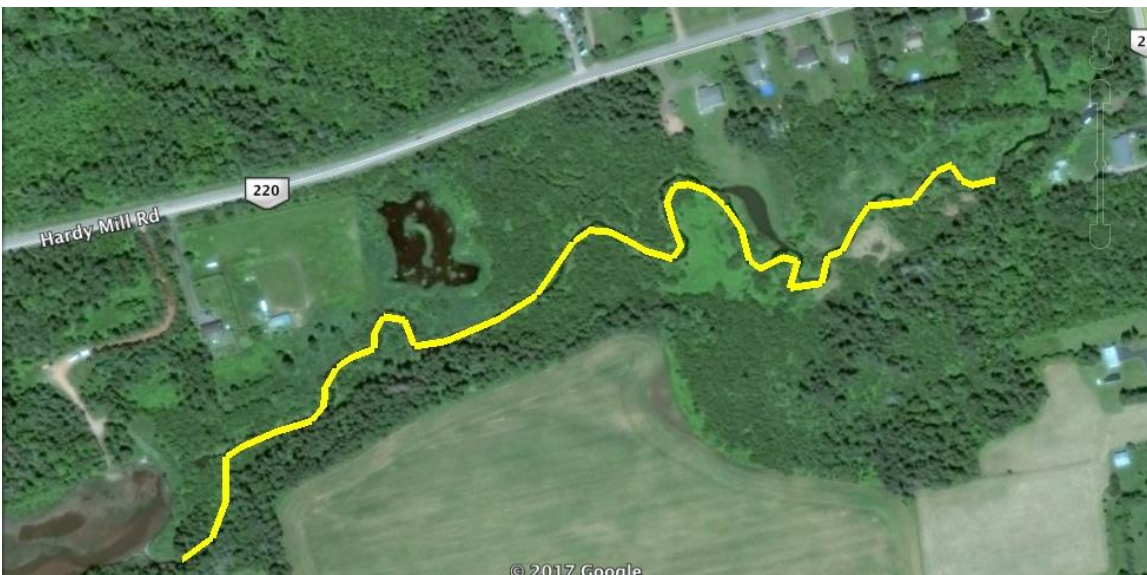
Figure 35: Winter River main branch maintenance clearing

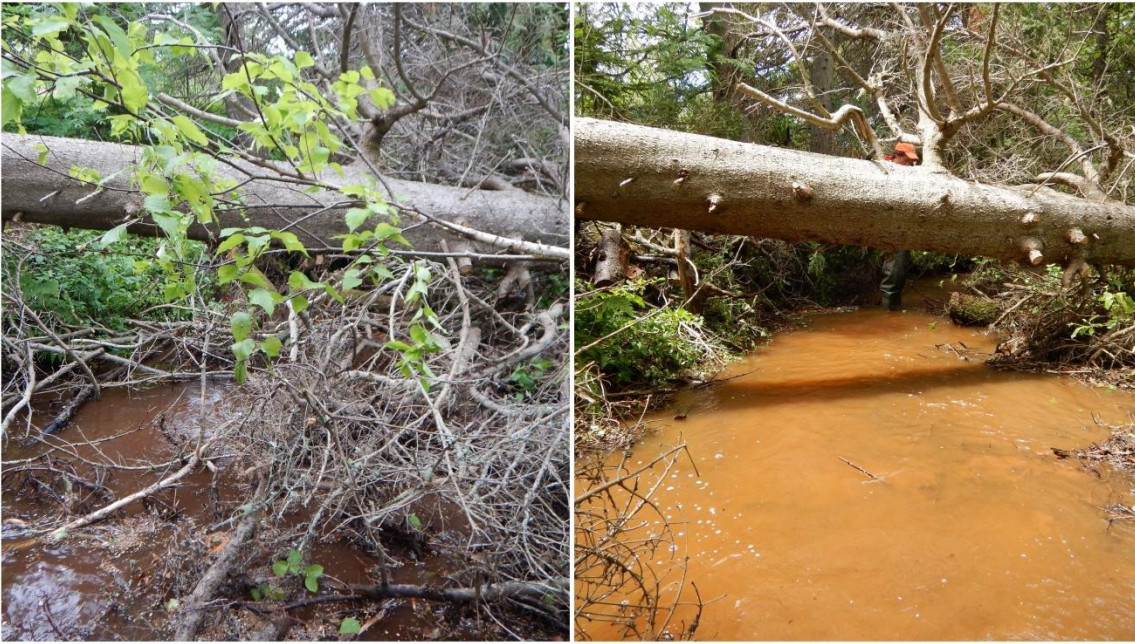
Figure 36: Before and after a blockage removal at Beaton's Creek

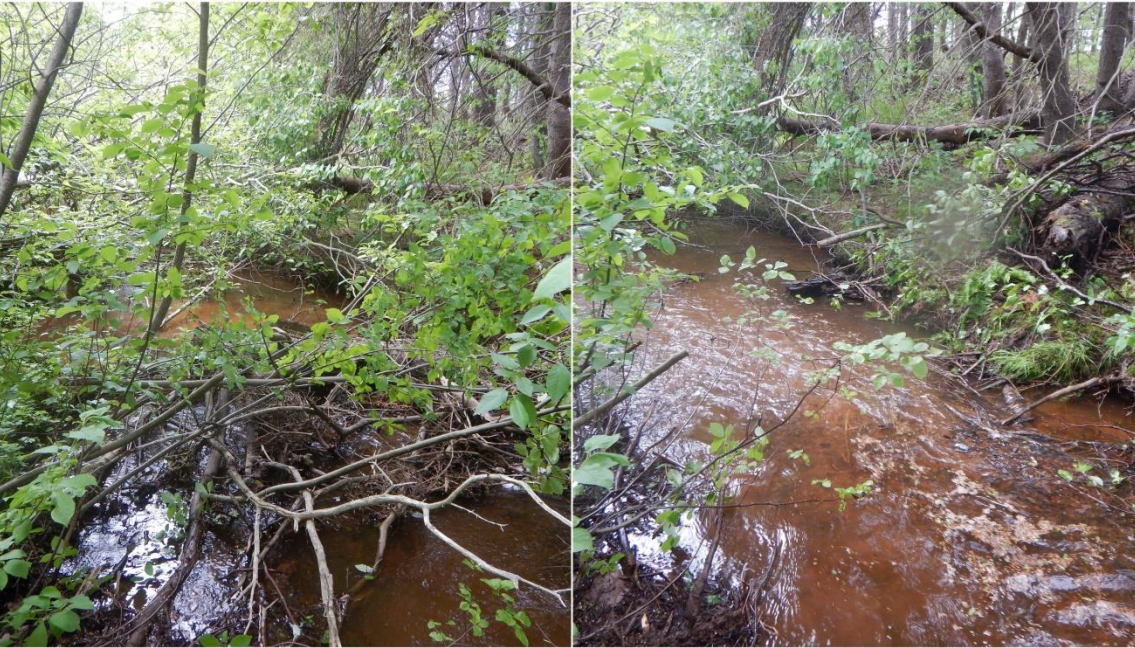
Figure 37: Before and after another blockage removal at Beaton's Creek

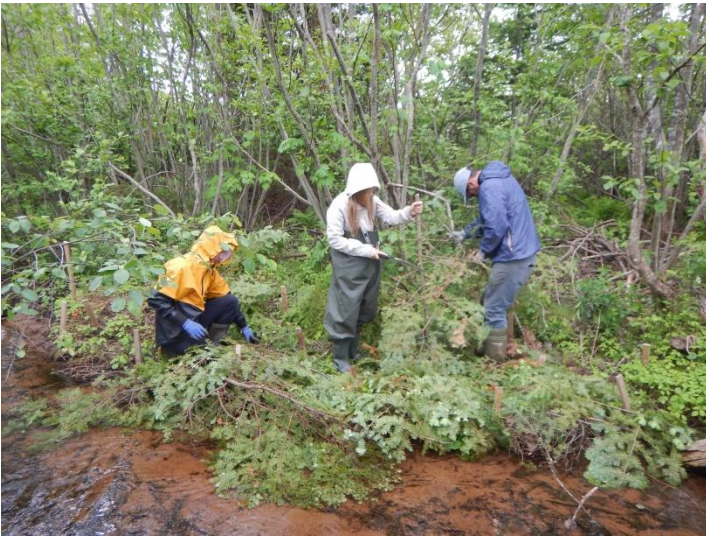
Figure 38: The field crew placing brush and cutting stakes to build a brush mat along Friston North

Over the summer season, the crew installed 25 new brush mats and updated 16 previously built brush mats. 15 brush mats were installed at Black River, 3 were installed at Cudmore, one at Winter River below Hardy's and one on the Winter River Main Branch. Three brush mats were upgraded at Friston North, one on Cudmore Branch, two on Friston South, five on MacLauchlan Branch in Pleasant Grove, three on Tim's Creek and two at MacAulay Creek.

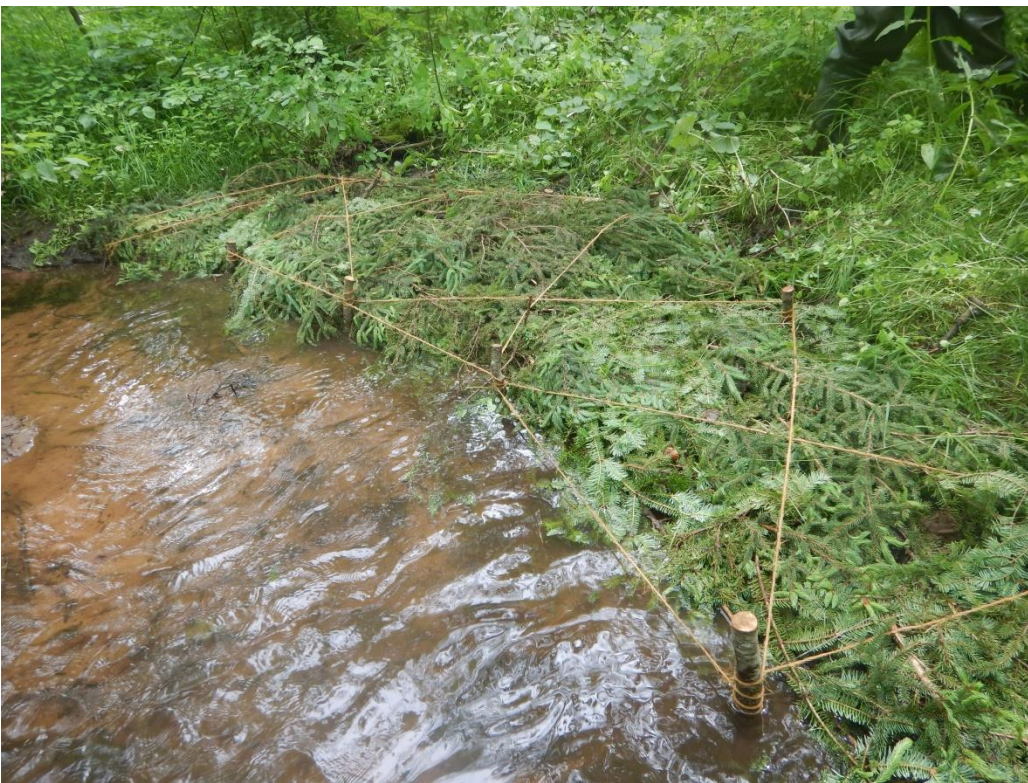
Figure 39: An example of a brush mat constructed along Black River

Brush mats were constructed along the upstream and downstream end of a culvert along Black River. The culvert is being removed in the future, which may create temporary weak stream banks, leading to increased sediment in the water. The brush mats upstream will decrease the amount of sediment that is carried to the culvert area in the first place. The brush mats downstream from the culvert will trap some of the sediment created by the culvert removal.

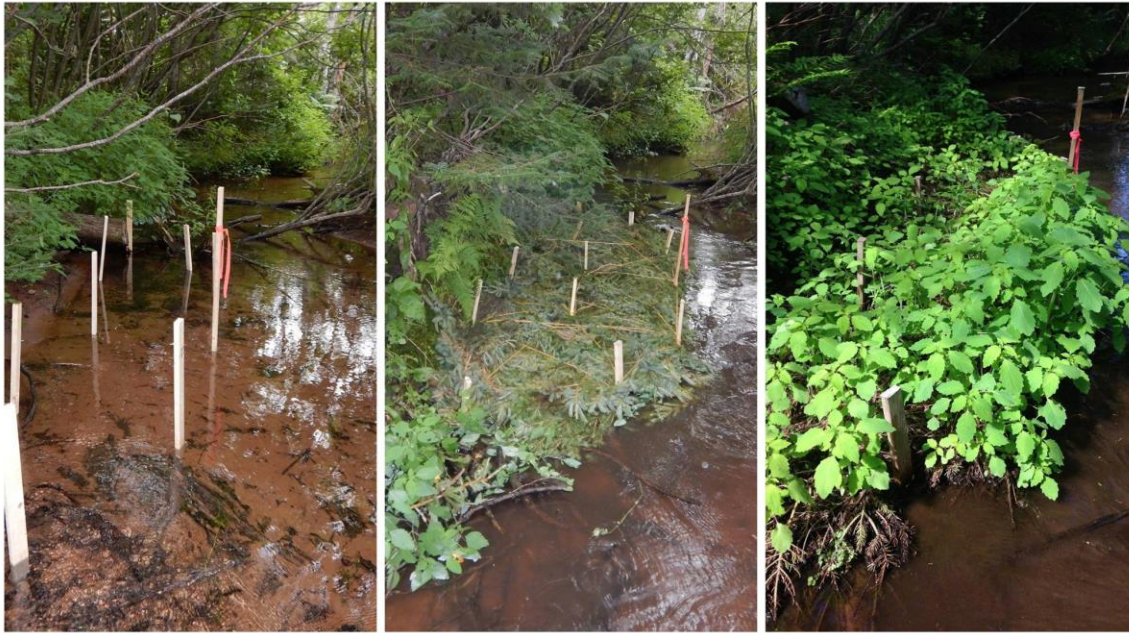
Figure 40: From left to right: A) stream with stakes in 2016 B) immediately after brush mat construction in 2016, and C) one year after construction (2017).

Figure 41 shows the positive long-term effects of brush mats. This section of the stream was too wide and contained a lot of sediment, and the banks were exposed. Fish prefer to spawn in areas free of sediment and with more cobble or rocks. The brush mat collects sediment which provides a rich substrate for plants to begin to grow. The picture shows jewel weed taking root in the old brush mat. The bank is now extended further into the stream and the sediment functions as soil instead of creating silt to cover stream bottoms.

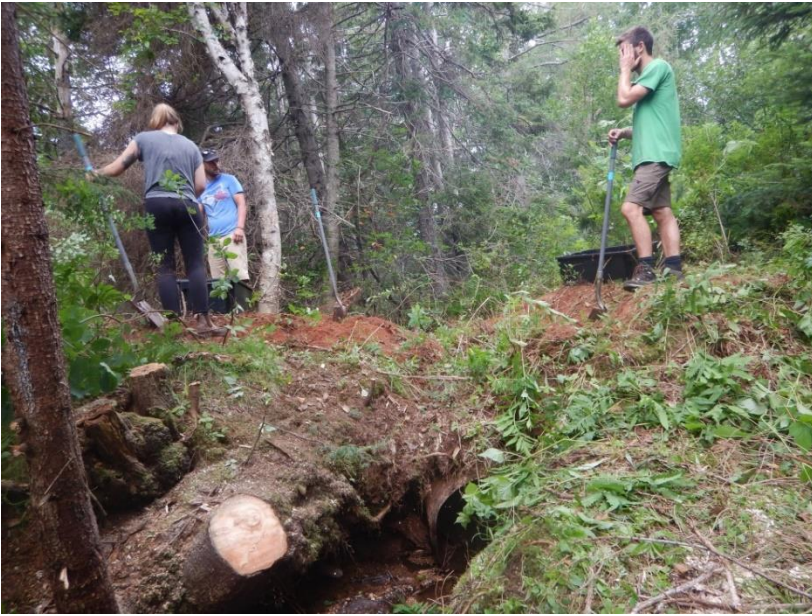
Figure 41: Before culvert removal, the trees have been removed from the area.

In July 2017, the crew removed an old unused culvert from Piper's Creek off Blooming Point Road. The culvert was impeding fish passage and causing blockages to build up near the upstream section of the culvert. First the team removed trees and shrubs from the area around the culvert. Then they dug down to the culvert. The dirt that was removed was placed in bins that were drug to either side of the stream to create piles that would be less likely to wash back into the stream. The culvert was removed from the stream. The banks were excavated to create a stable shape with a 30-degree angled slope. Then the banks and dirt piles were covered with jute mesh to temporarily hold the loose soil in place. Grass seed was applied to both banks and dirt piles for longer term stabilization.

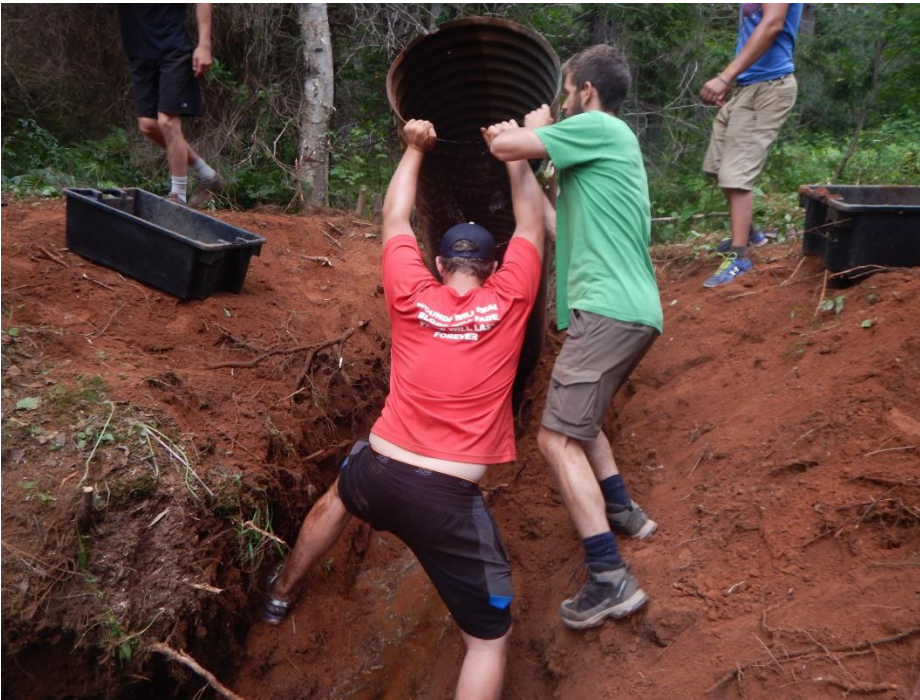
Figure 42: The removal of the culvert

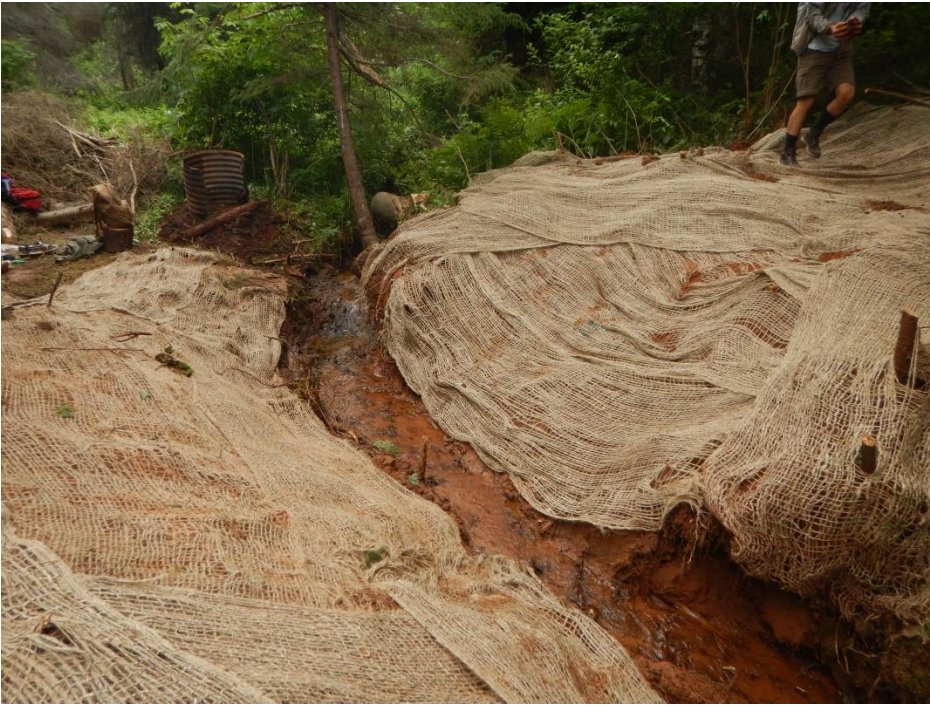
Figure 43: After culvert removal, jute mesh covers the banks until grass is established.
