WINTER RIVER - TRACADIE BAY WATERSHED ASSOCIATION

Final Report 2017-2018 Work Year

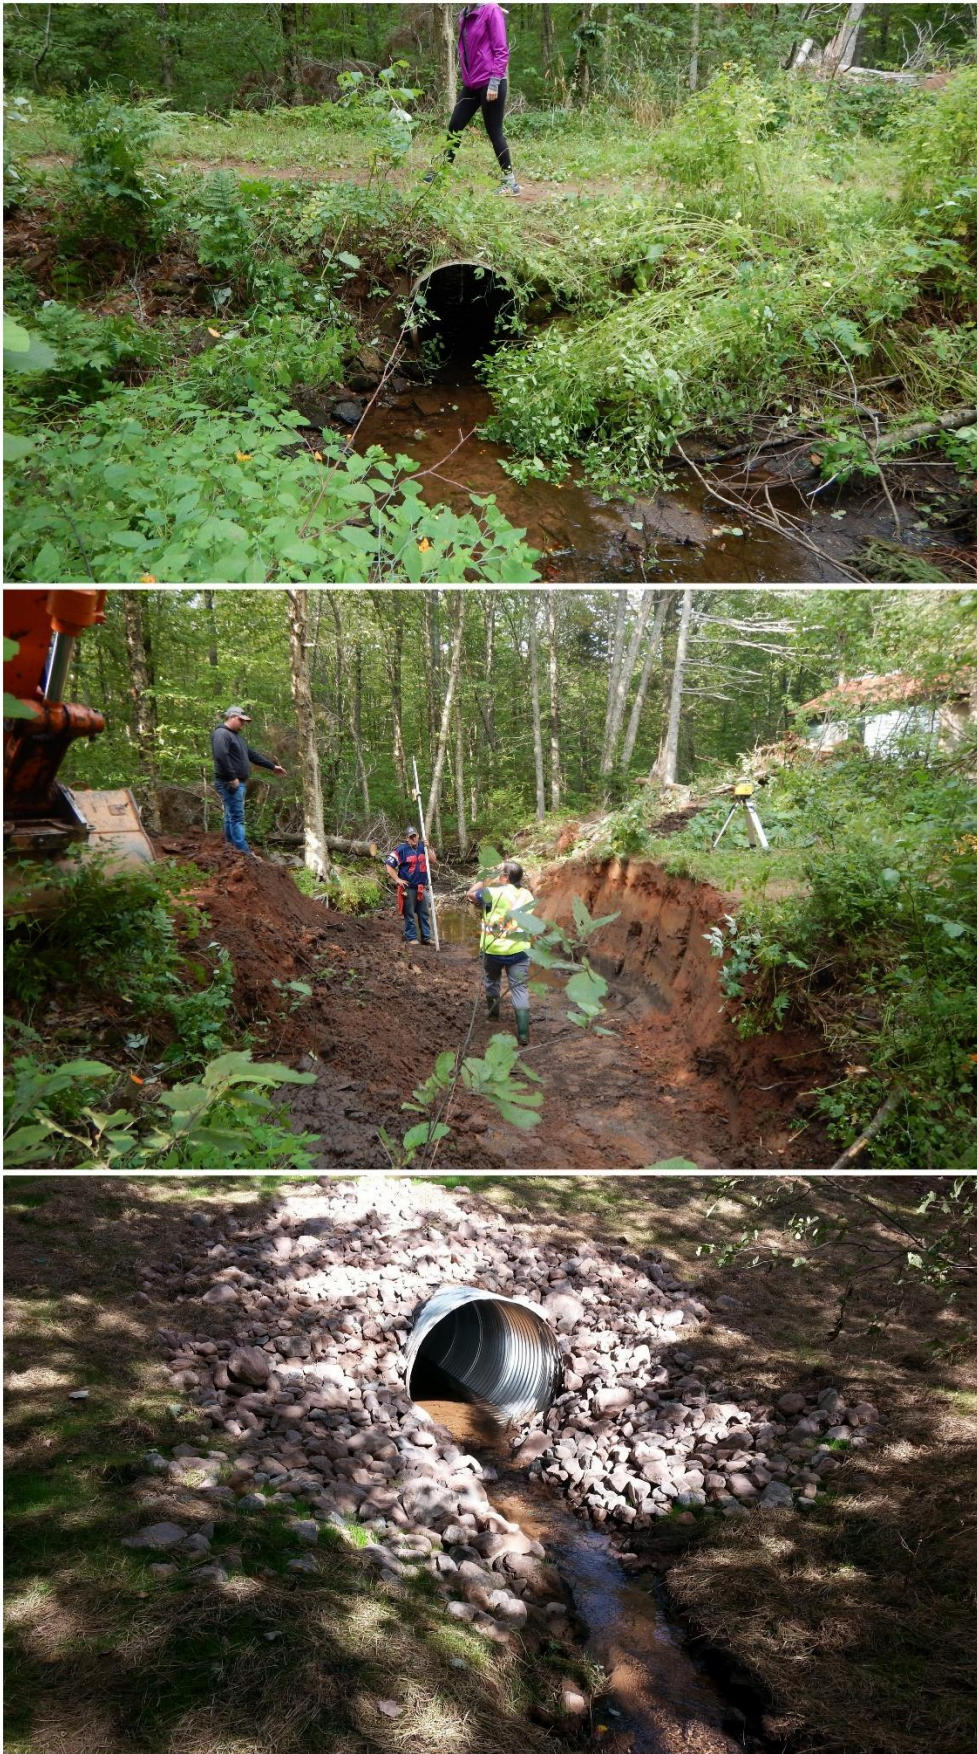
Figure 44. Before, during, and after culvert replacement - upstream side.

During stream assessments in 2015, staff identified many culverts that were a problem for fish passage. One problem culvert was located on Black River and over the course of 2016 staff worked with the landowner to plan a project that would meet their needs as well as improve fish passage. We helped the landowner to secure partial funding for this project through the Department of Agriculture for construction to occur during 2017. Sarah Wheatley, the watershed coordinator, managed this project planning including research, designs, and permitting. In September, Sarah was onsite during the whole construction period to supervise the contractors and make sure that the resulting culvert would meet fish passage design parameters and the needs of the farmer. Matt and Vanessa assisted with transporting materials to the site and helping with grass seeding and hay mulching for site stabilization after construction was complete.

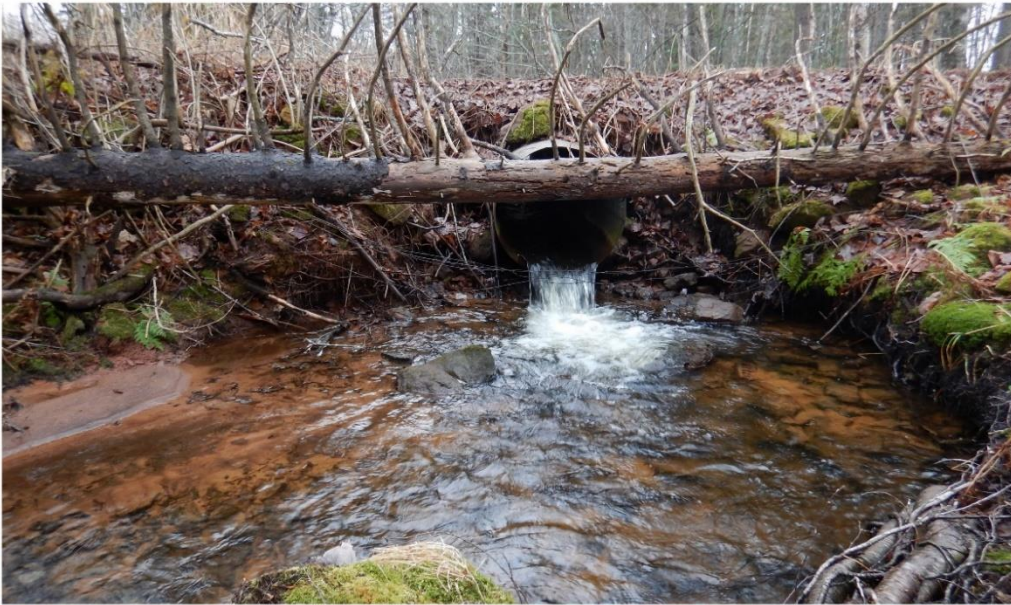
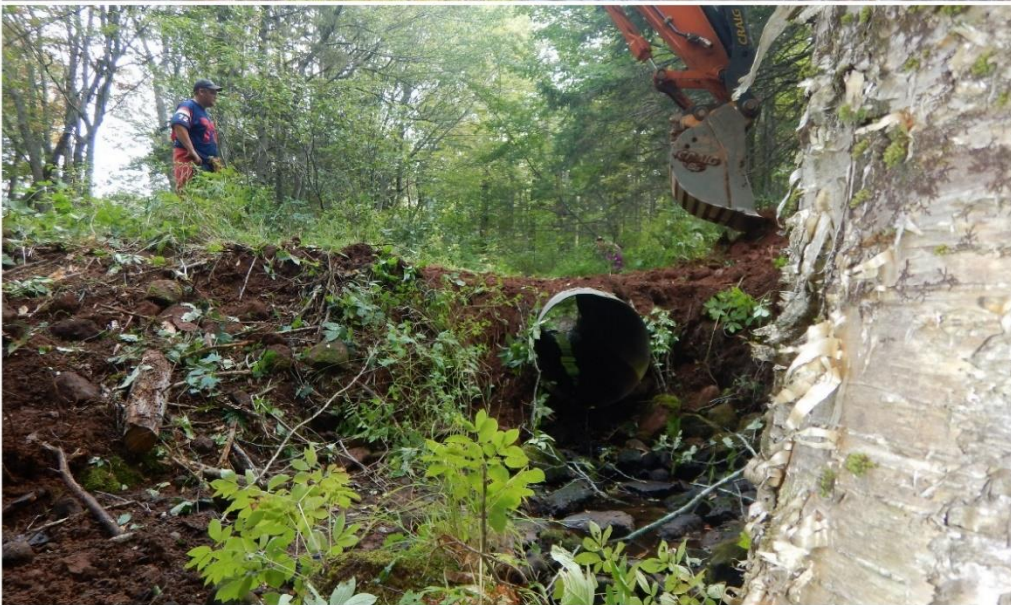
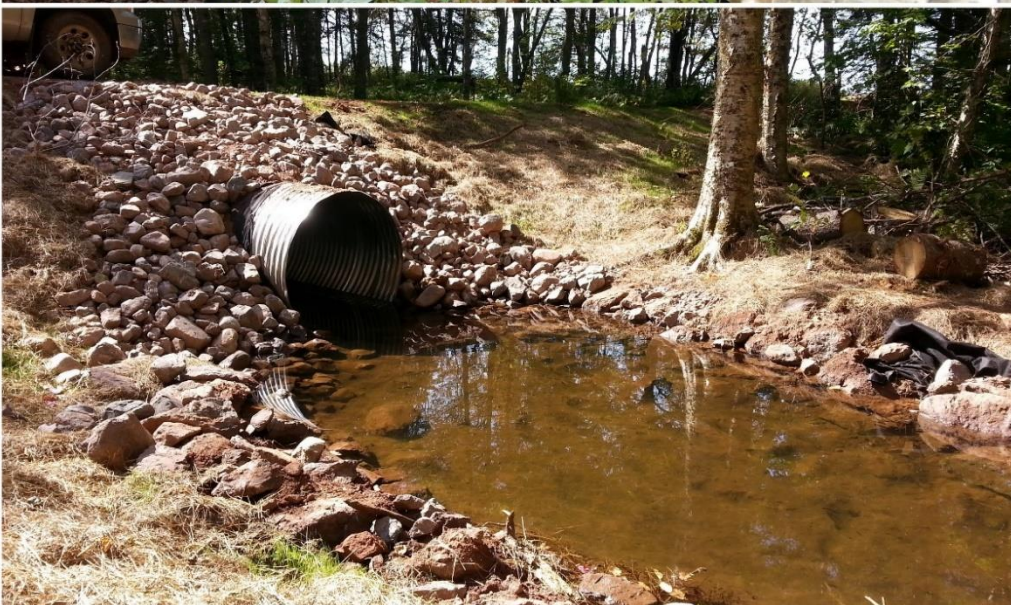
Figure 45. Before, during, and after culvert replacement - downstream side.

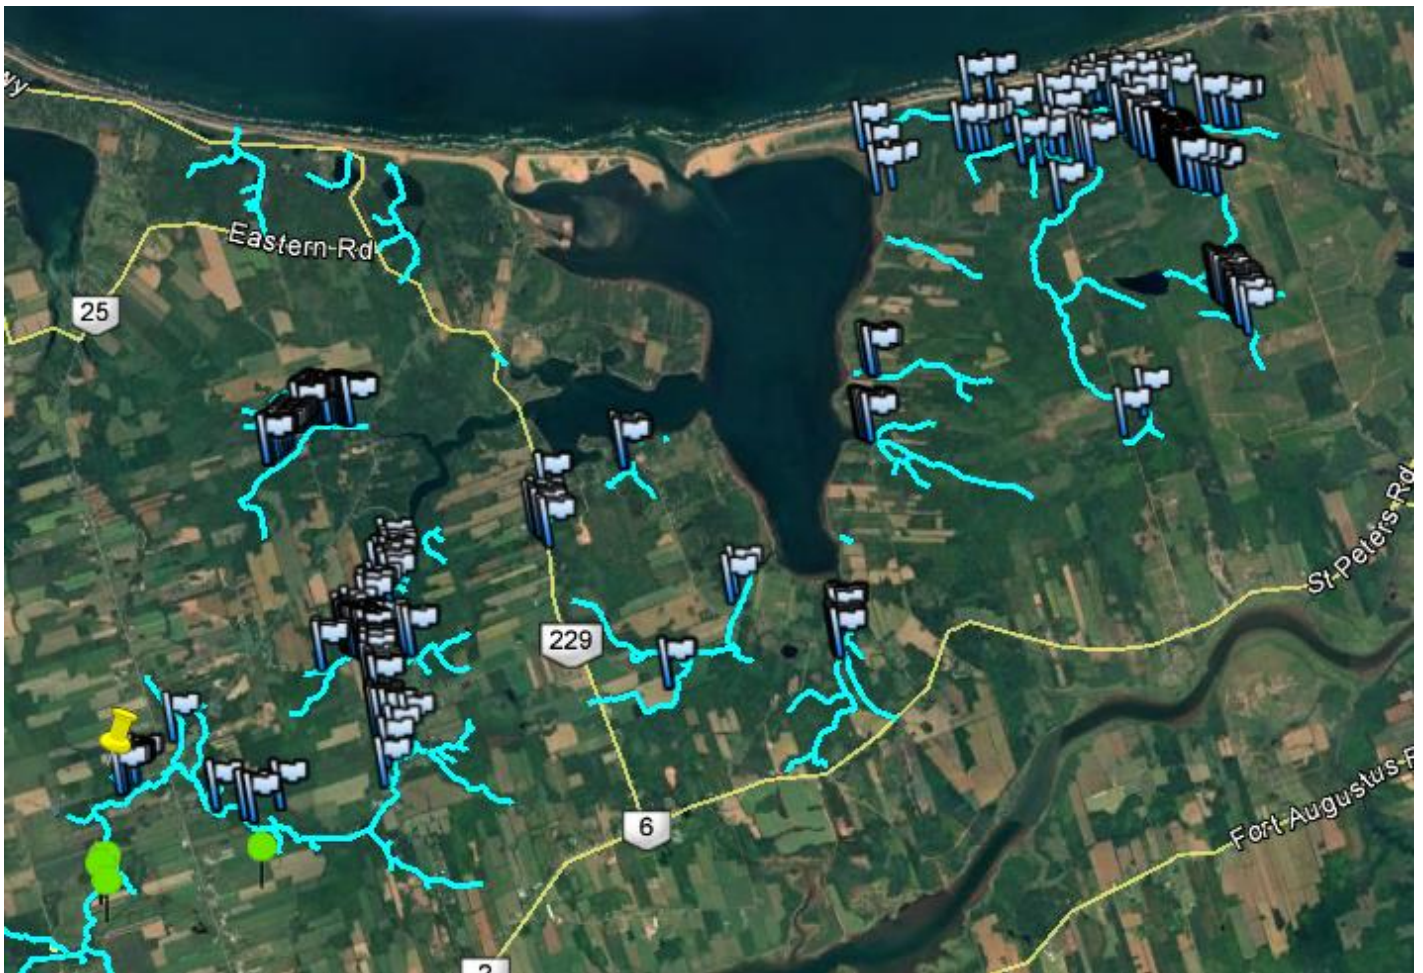
Figure 51. All waypoints of stream assessments carried out in 2017 work year

2017 stream assessments were conducted at Deroche Pond, Anderson Branch, Winter River Main Branch, Peters Creek, Court's Island, Beaton's Creek and Mazer's Branch. When walking the stream, observations are prioritized under the following categories: fish passage issues, fish habitat features, fish spawning areas, blockages, beaver activity, wildlife, vegetation, springs, siltation deposits, planting areas, erosion, buffer zone violations and redds. While these are the primary areas of concern, there is also an "other" category for other features of interest. As crew are walking through and observing the stream and surrounding area needing work, a GPS waypoint is made and notes are taken describing the waypoint; a total of 311 GPS waypoints were entered through the season. All GPS waypoints are uploaded onto maps in the office and notes are organized into a spreadsheet. Depending on time of year, crew available, and urgency it is then determined when to fix the issue. Most work to the stream is done in the most natural way possible, so as not to disturb flora or fauna. For further details on the 2017 stream assessments please refer to google earth and excel file.

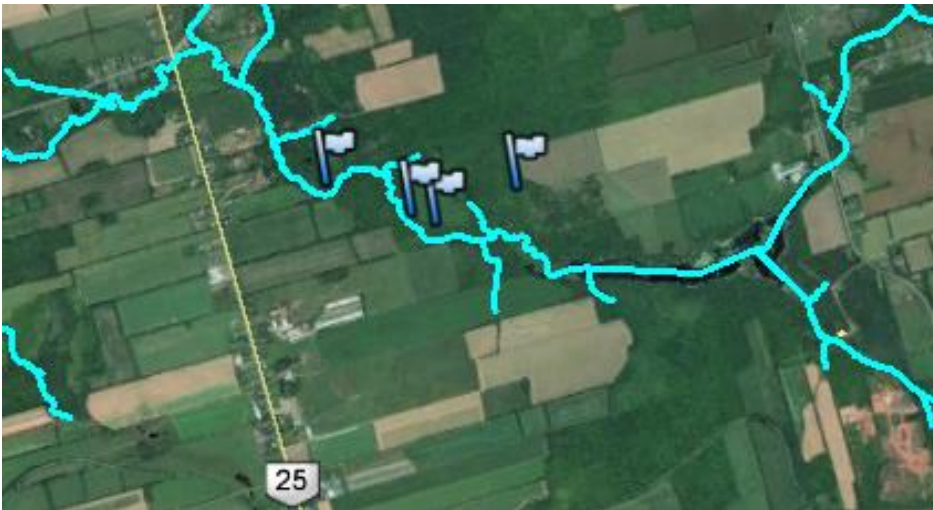
Figure 52. Main branch of Winter River near Officer's Pond beaver waypoints

When walking through the Winter River- Tracadie Bay streams, beaver activity is quite common. Below are maps with waypoints which indicate beaver activity. Beaver activity can be defined as any area where nature's engineers have altered the stream to suit their needs. The beaver-free zone located in the Winter River and tributaries will be walked every fall to ensure there are no new beaver settlements. This will ensure that if there are any beavers moving in they can be trapped before causing too much damage to the area.

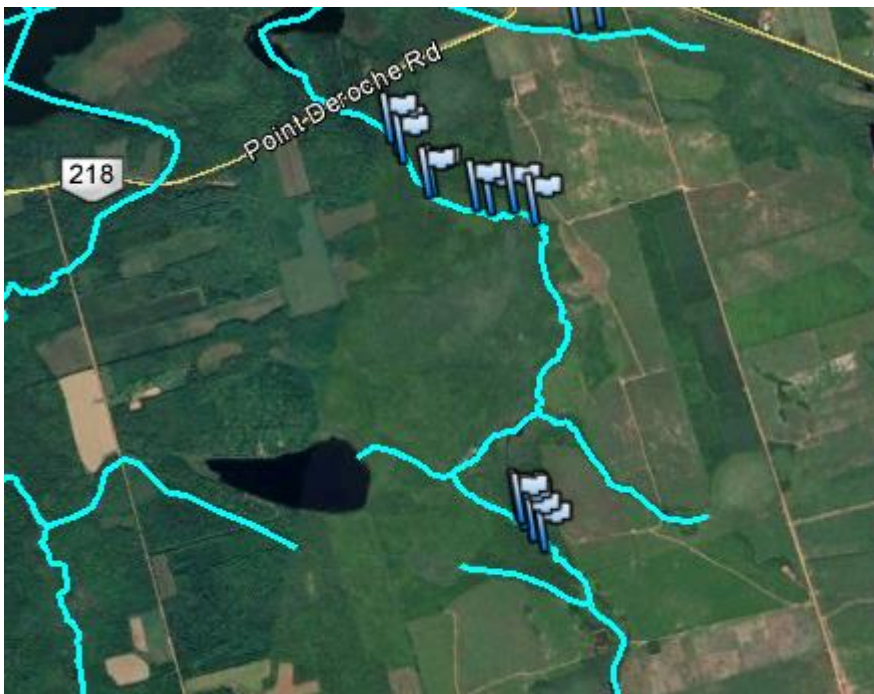
Figure 53. Anderson Branch beaver activity waypoints

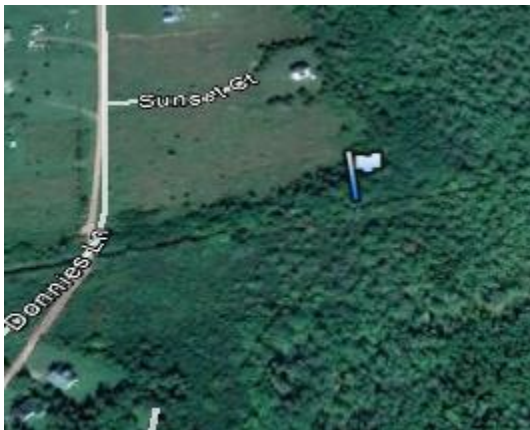
Figure 54. Deroche Pond area, off Donnie's Road – beaver dam in man-made channel flowing into Tracadie Bay.

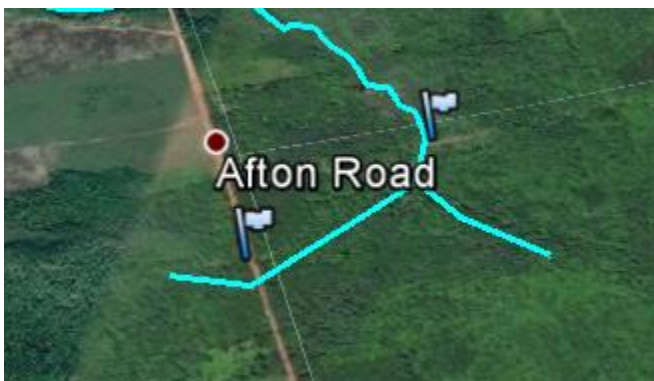
Figure 55. Afton Branch beaver activity

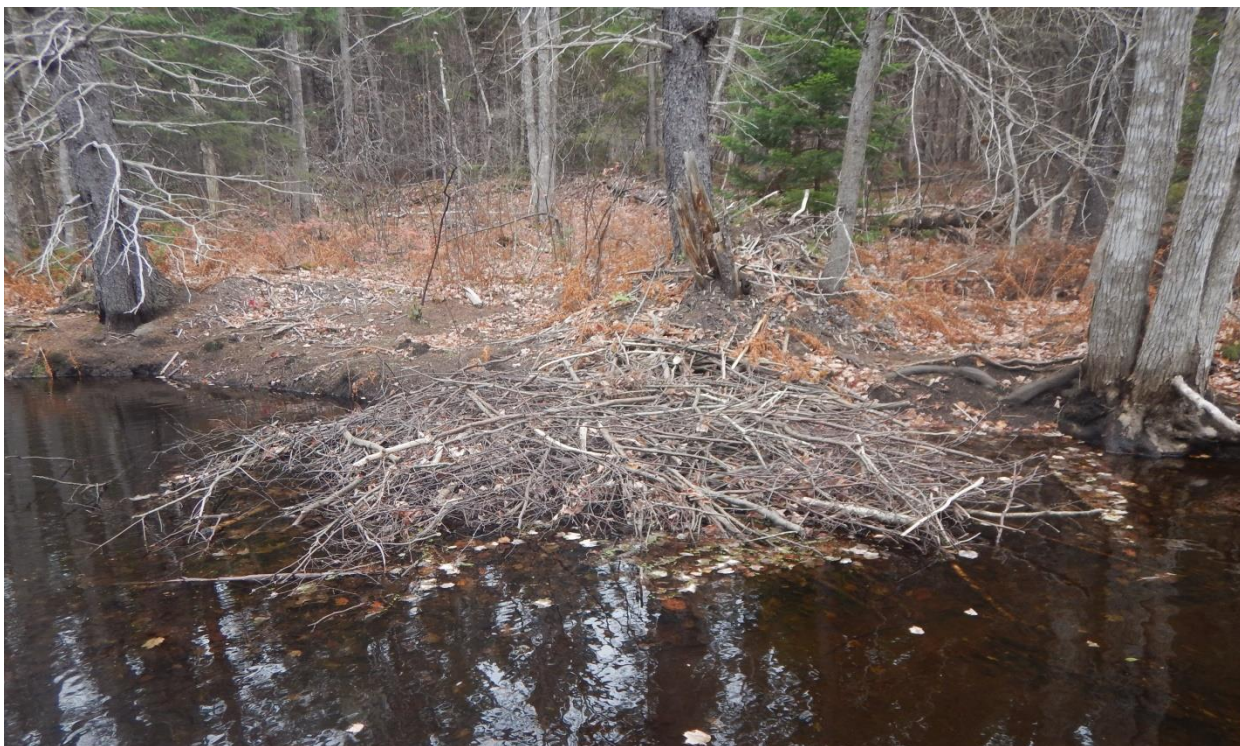
Figure 56. Beaver lodge located in Anderson Branch

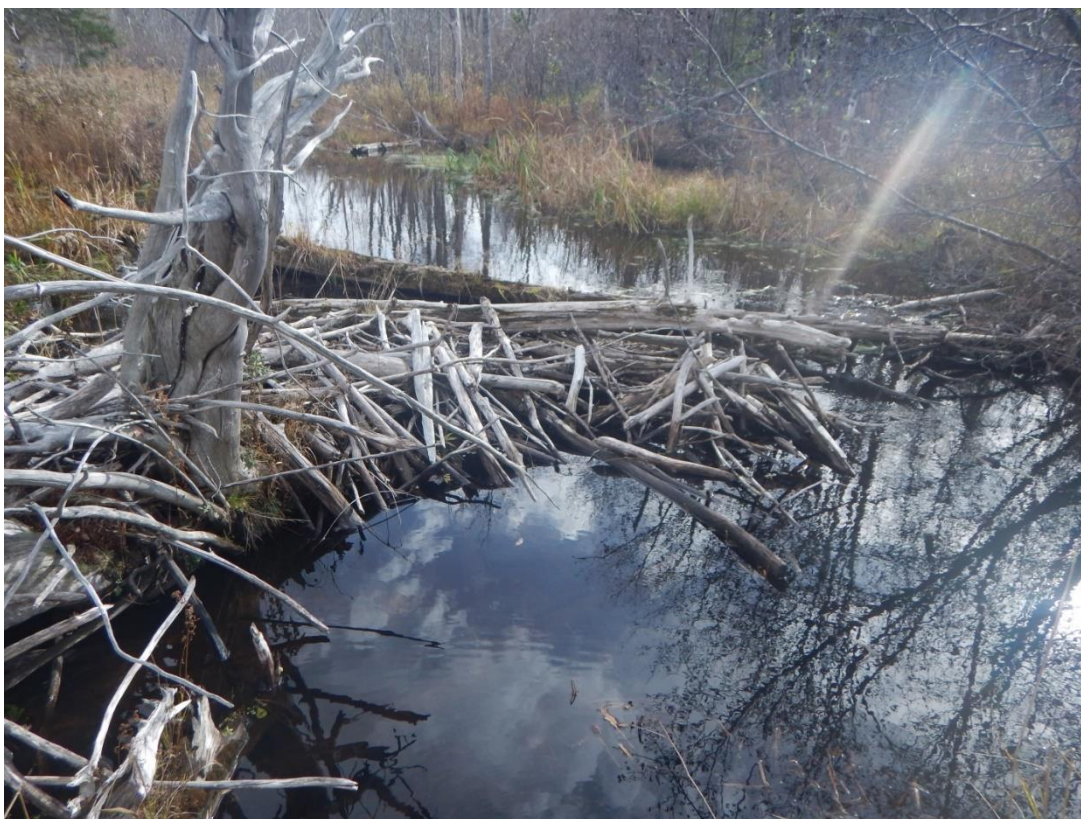
Figure 57. Beaver dam located in Anderson Branch

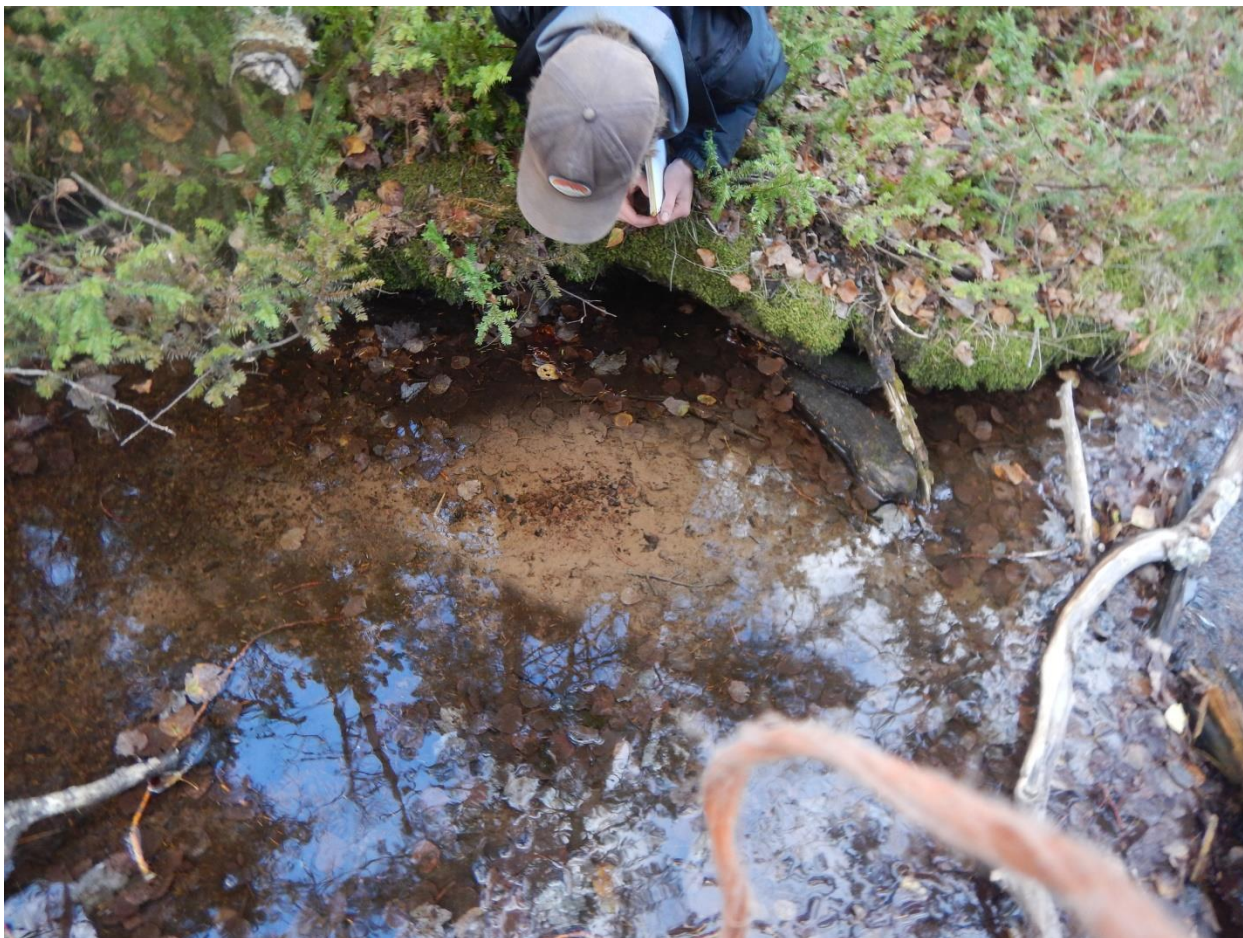
Figure 60. Matt looking at brook trout redd

“Redds” are areas on the stream bed that appear red in color, where debris on the stream bed has clearly been moved. Salmonids lay their eggs on redds. Redd surveys are completed annually usually around mid to late November. These surveys are done to determine the number of spawning areas in the watershed. Afterwards, the data is added to a database to compare year to year. Every time a redd is located, a GPS waypoint is marked, notes are made on cover, any fish observed, how large the red may be, any water cress present, etc. These surveys can prove to be very subjective since, depending on experience level, one may overestimate or underestimate the actual number of redds. The best practice in identifying a redd is to make sure you go out in mid to late November; make sure you are not marking a clear spot where the water channel goes through the stream as it may look similar to a redd; look for circular patterns and trout nearby; and use polarized glasses to help the redd appear more clearly in the stream bed.

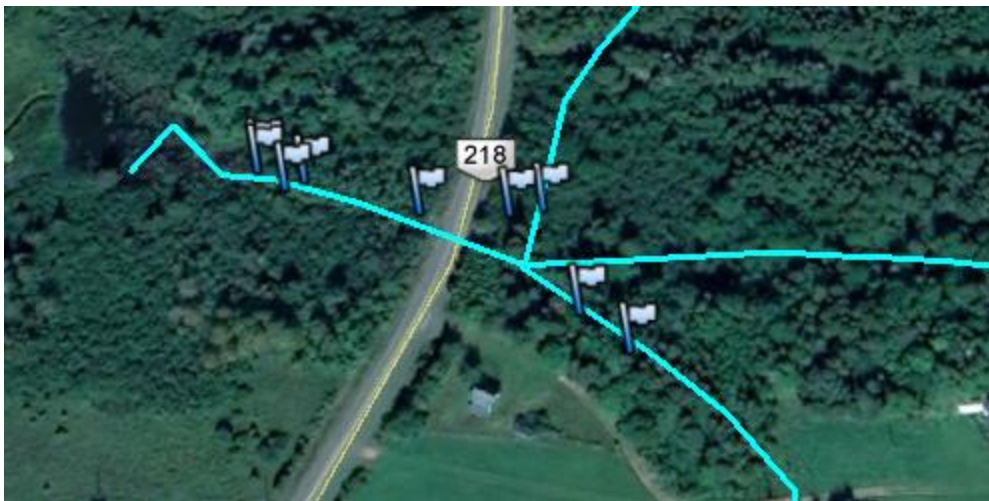
Figure 61. Pipers Creek reds 2017

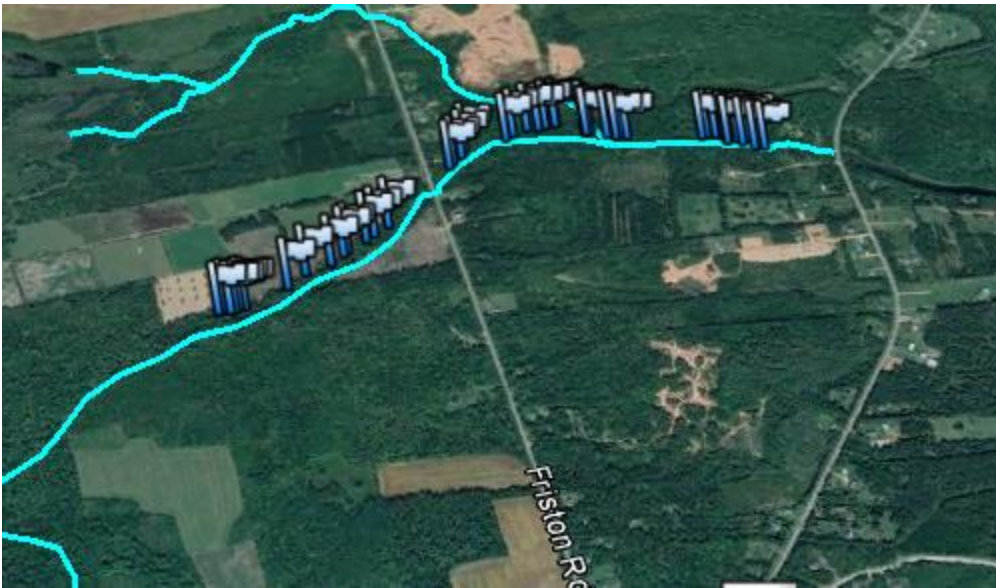
Figure 62. Friston Branch reds 2017

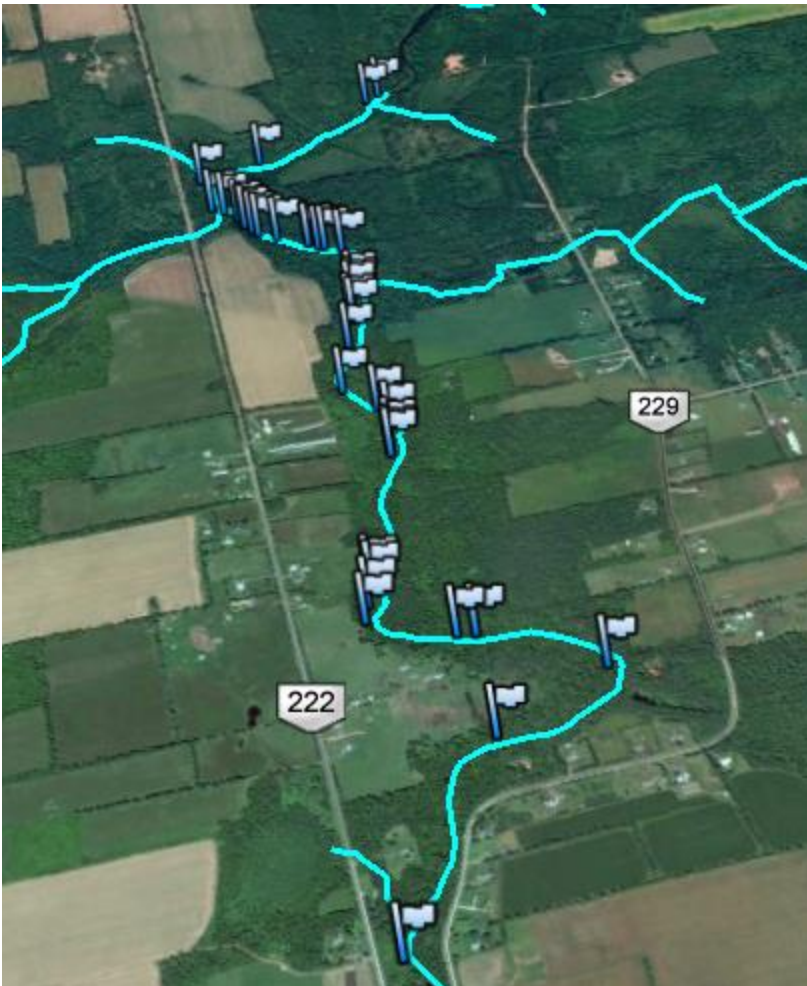
Figure 63. Possible reds at Winter River Main 2017

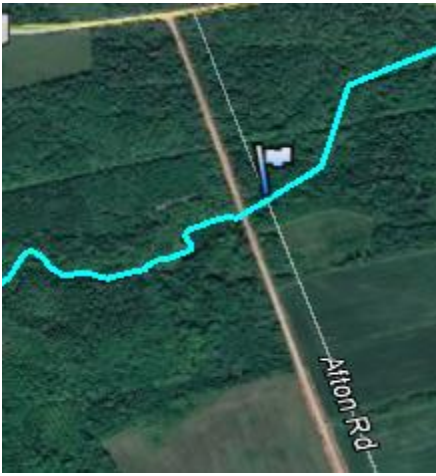
Figure 64. Afton Road branch redds 2017

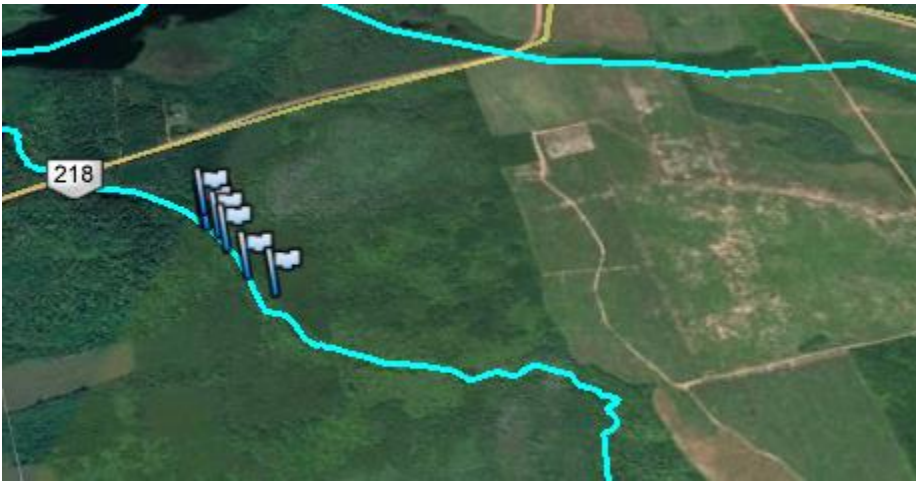
Figure 65. Anderson Branch redds 2017

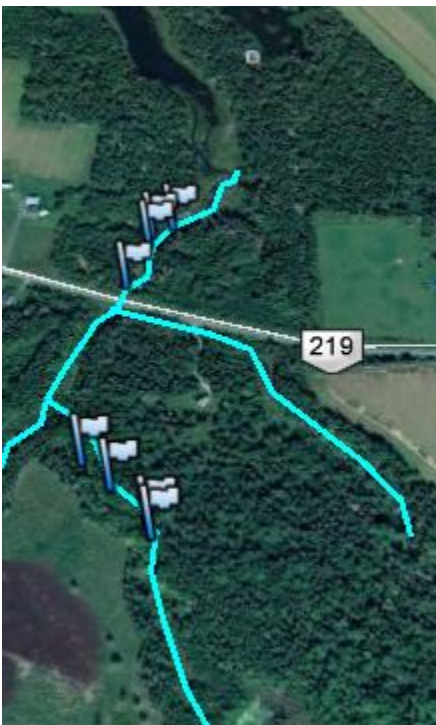
Figure 66. MacAulay's Creek redds

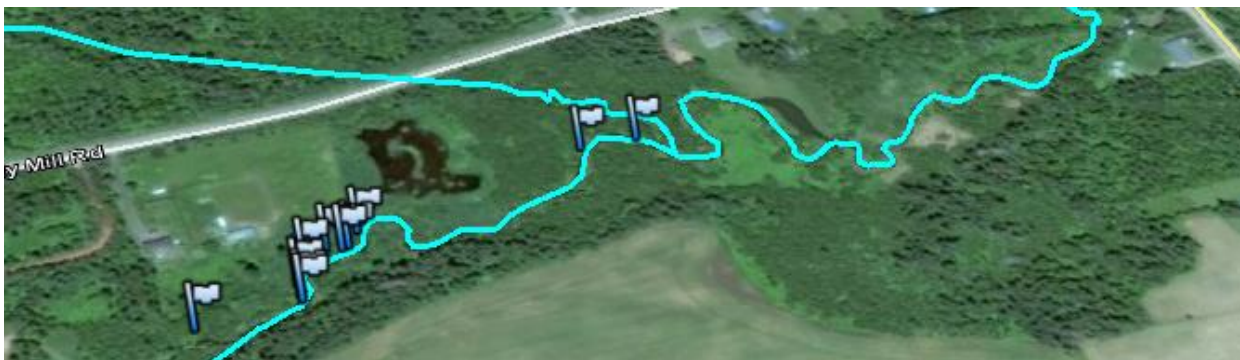
Figure 67. Hardy Mill Pond area reds 2017

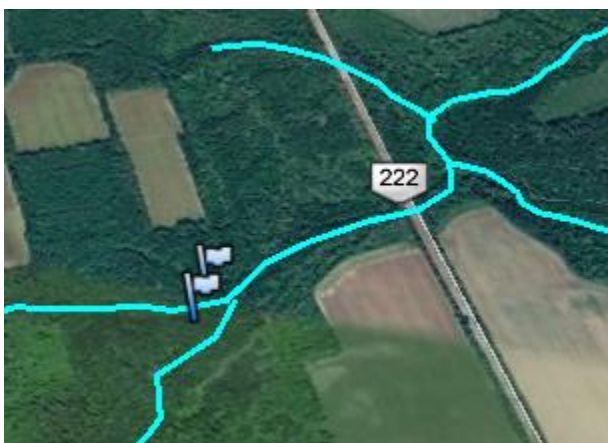
Figure 68. Tim's Creek reds 2017

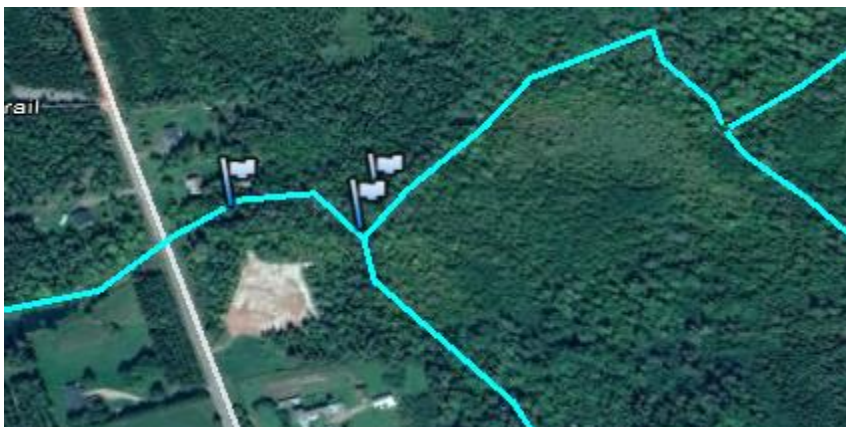
Figure 69. Van Westerneng Branch reds.

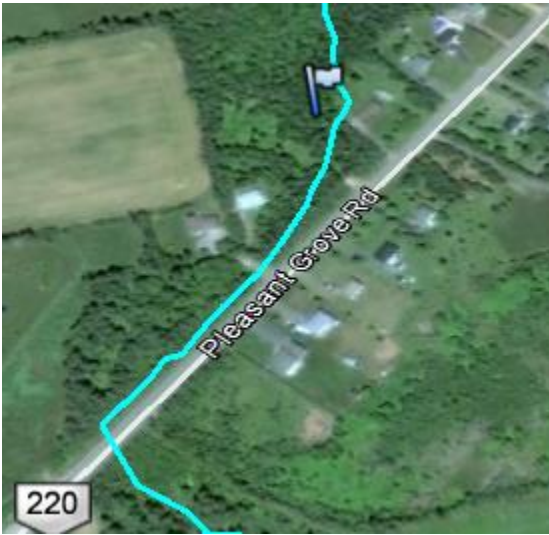
Figure 70. MacLauchlan Branch redd

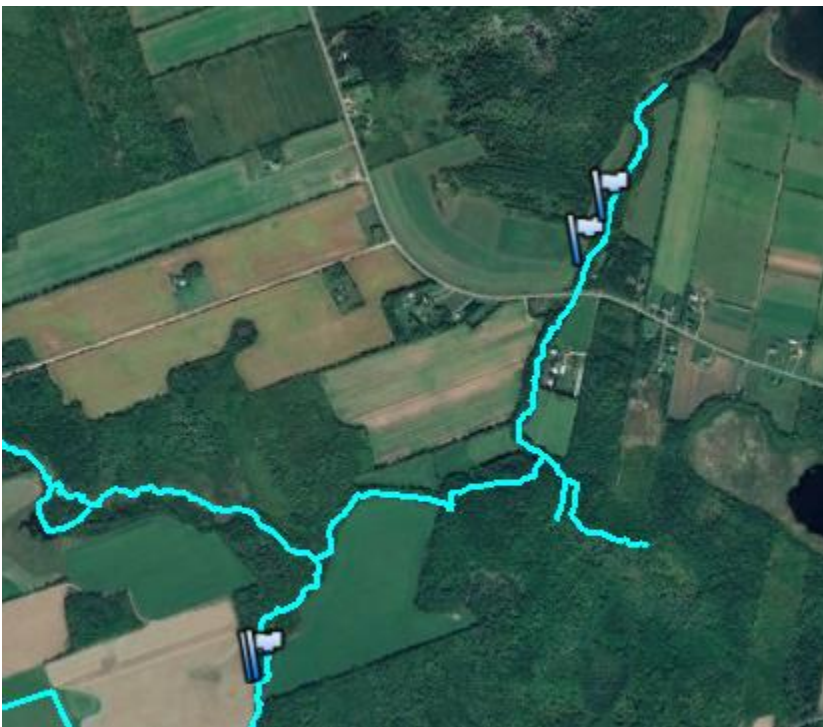
Figure 71. Black River redds

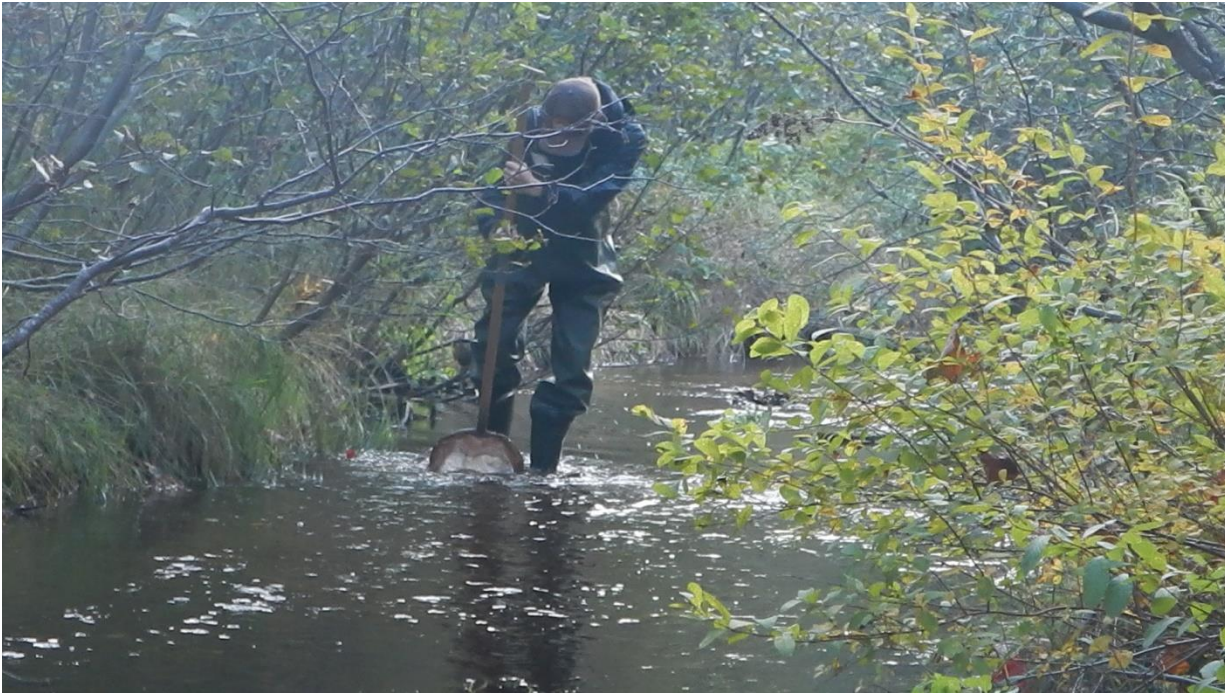
Figure 72. Matt using kick net to collect invertebrates.

CABIN stands for Canadian Aquatic Biomonitoring Network and is a program that was created to monitor the health of freshwater ecosystems. It involves the collection of benthic invertebrates – bugs that live on the bottom of the stream – to identify the water quality in the sampling area. Areas with only very hardy bugs are likely to be experiencing problems, while areas that have lots of bugs that are sensitive to pollution or other impacts indicate that the stream is not experiencing pollution or other issues. Both Matt and Vanessa received CABIN certifications to participate in monitoring. Sarah Wheatley completed the course the year previous. CABIN assessments are completed in the fall. Fifteen locations were sampled in 2017 for CABIN assessments. Sites are selected based on accessibility and sections of stream that will represent what is happening in several areas. Since the raw data from this project wasn't received until spring 2018, analysis will continue in 2018.

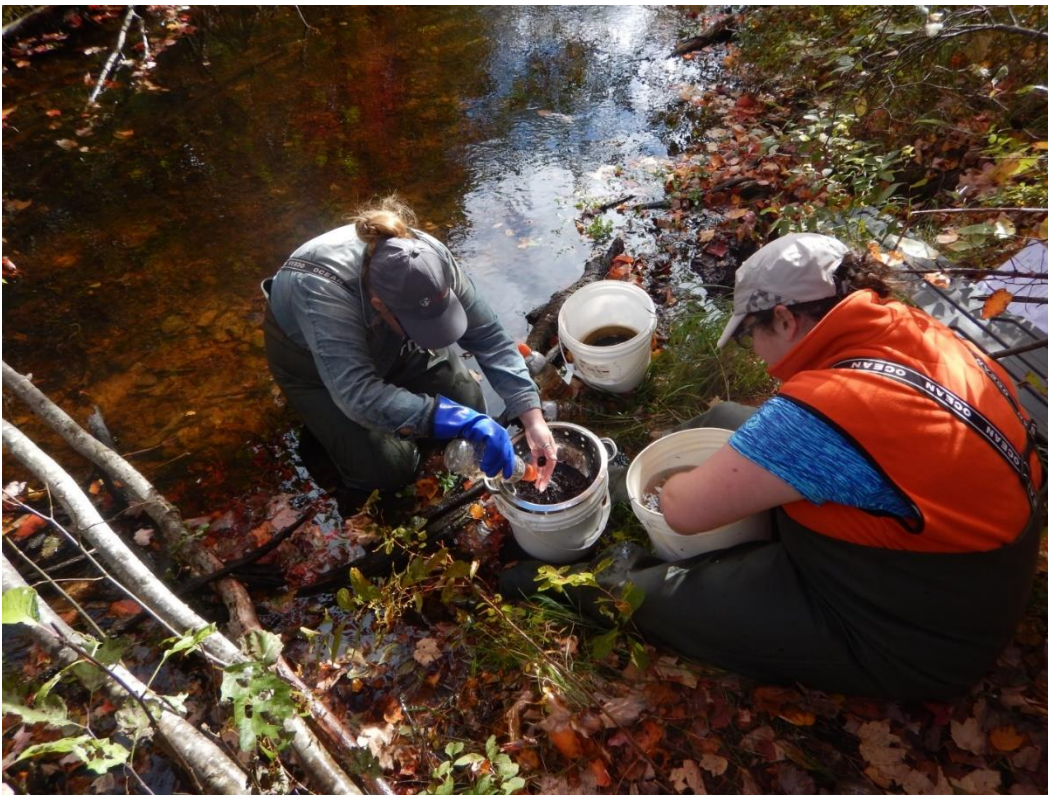
Figure 74. Miranda and Sarah using sieve to rinse benthic macroinvertebrates from rocks and leaves in sample.

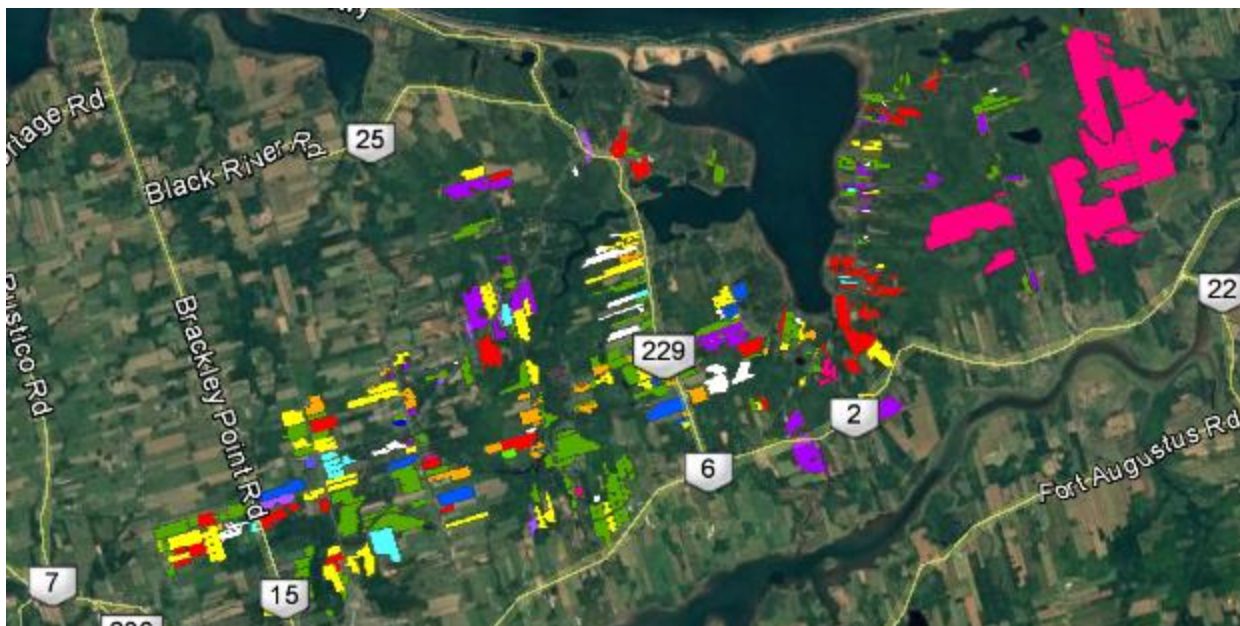
Figure 79: Map of crops, each color represents type of crop growing on that piece of land

Crop Name	Color
Corn	Blue
Soy	Purple
Potato	Red
Perennials: blueberries, apples, raspberries	Pink
Other: Peas, Pumpkin, Buckwheat, Radish	Aqua
Hay	Green
Grain	Yellow
Pasture	Orange
Unused	Grey

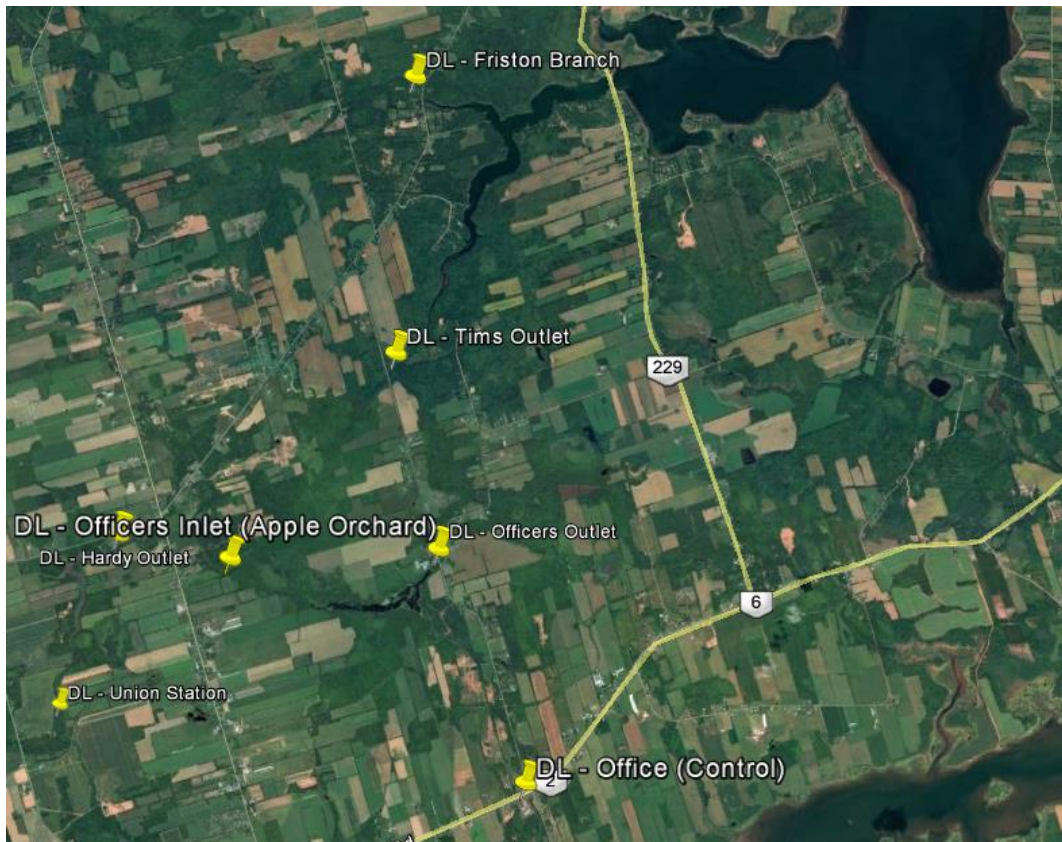
Figure 80. Depth logger locations in 2017.

2017 Depth Logger Locations			
Name	Coordinates	Serial Number	Notes
WR @ Union Station	46°18'58.11"N 63° 7'19.10"W	10685267	Below EC station
WR @ Hardy Mill Outlet	46°19'59.82"N 63° 6'48.20"W	10685268	Below Hardy dam
WR @ Officer's Inlet (Apple Orchard)	46°19'50.85"N 63° 5'47.99"W	10685271	Below Apple Orchard
WR @ Tim's Creek Outlet	46°21'7.15"N 63° 4'18.56"W	10685272	Below tributary outlet
WR @ Officer's Outlet	46°19'54.17"N 63° 3'55.49"W	10685269	Below Suffolk dam
Friston Branch	46°22'50.11"N 63° 4'7.99"W	10685270	Above culvert

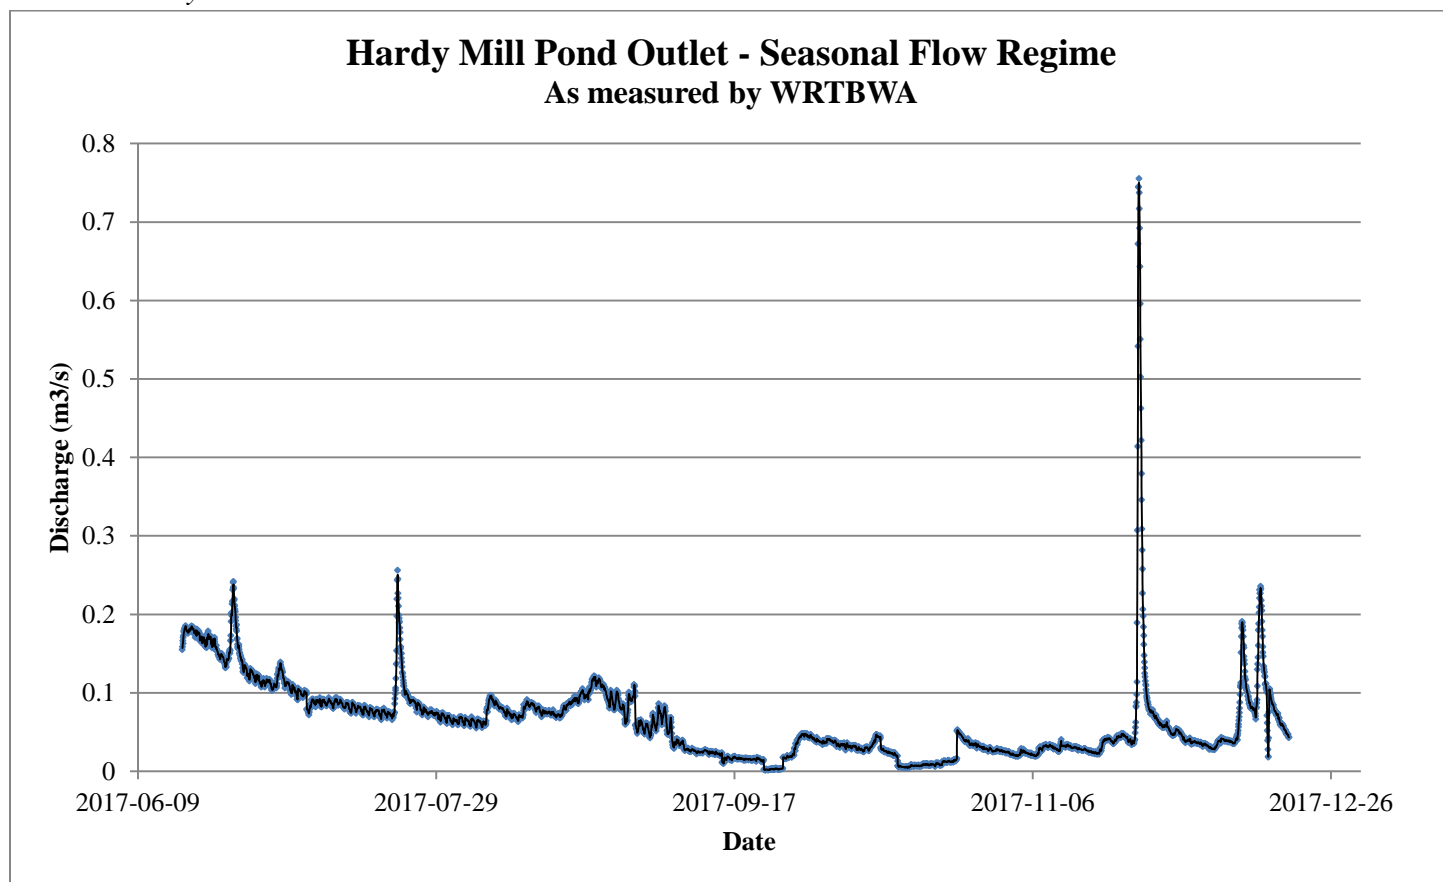
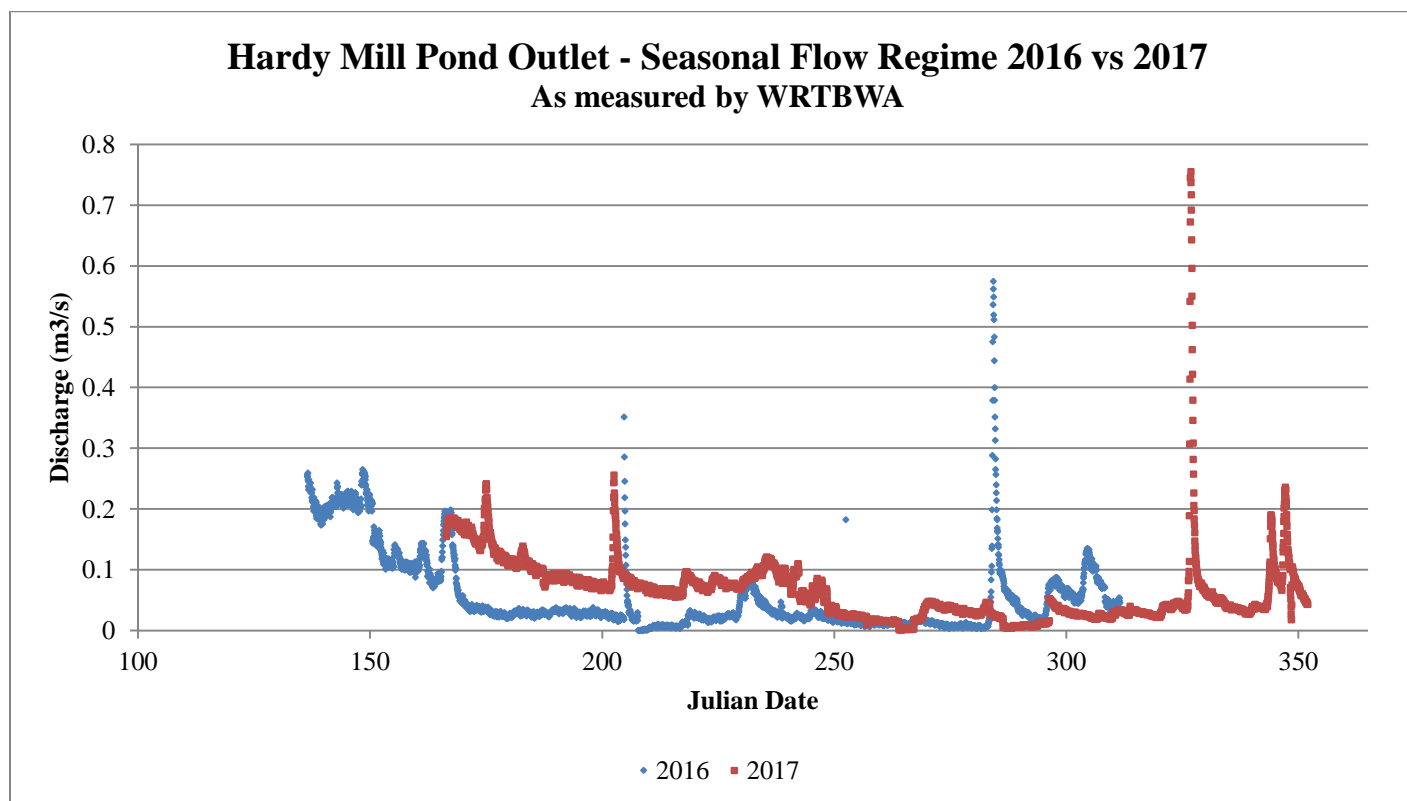
4.7.2.1 Hardy Mill Pond Outlet

2017			2016		
	Discharge (L/s)	Water level (m)	Date (yyyy-mm-dd)	Discharge (L/s)	Water level (m)	Date (yyyy-mm-dd)
Minimum Flow	1.411	0.017	2017-09-22	0.002	0.001	2016-07-26
Median Flow	55.899			28.652		
Maximum Flow	755.124	0.534	2017-11-23	574.731	0.156	2016-10-11

2017	2016
R-B Index:	0.167	0.219
Flashiness (# of high flow pulses):	13	23
High flow threshold (L/s):	167.697	86
R ² Value for water level discharge rating curve	0.591	0.857

The flow at the Hardy's Pond outlet location was normally sufficient to use the flow meter, however in the late fall there were times when the stream was so shallow it was difficult for the flow meter to float without scraping along the stream bed. At times, there were issues measuring the flow at the "Union Station" location, as the flow was so slow that the flow meter was unable to detect movement. At this location we have even seen the orange float upstream while using the "orange method". Officer's Pond outlet had an abnormal sudden drop in flow on September 12 at 10 am. This may be due to people working on the fish ladder just upstream of the logger, or perhaps interference from a buildup of debris on the logger, as this location had an abundance of algae collecting on the logger over the season. The logger at Tim's Creek outlet was placed in a location where flow was difficult to measure properly across the full width of the stream, as it was too shallow and often had debris and rocks blocking flow on one side. In the next season it may be beneficial to measure the cross section and flow at a location near the logger which has consistent flow across the full width of the stream. It is recommended that the loggers be kept at the same location in the following years to increase the R^2 value and have more reliable data.
