WINTER RIVER - TRACADIE BAY WATERSHED ASSOCIATION

Final Report 2017-2018 Work Year

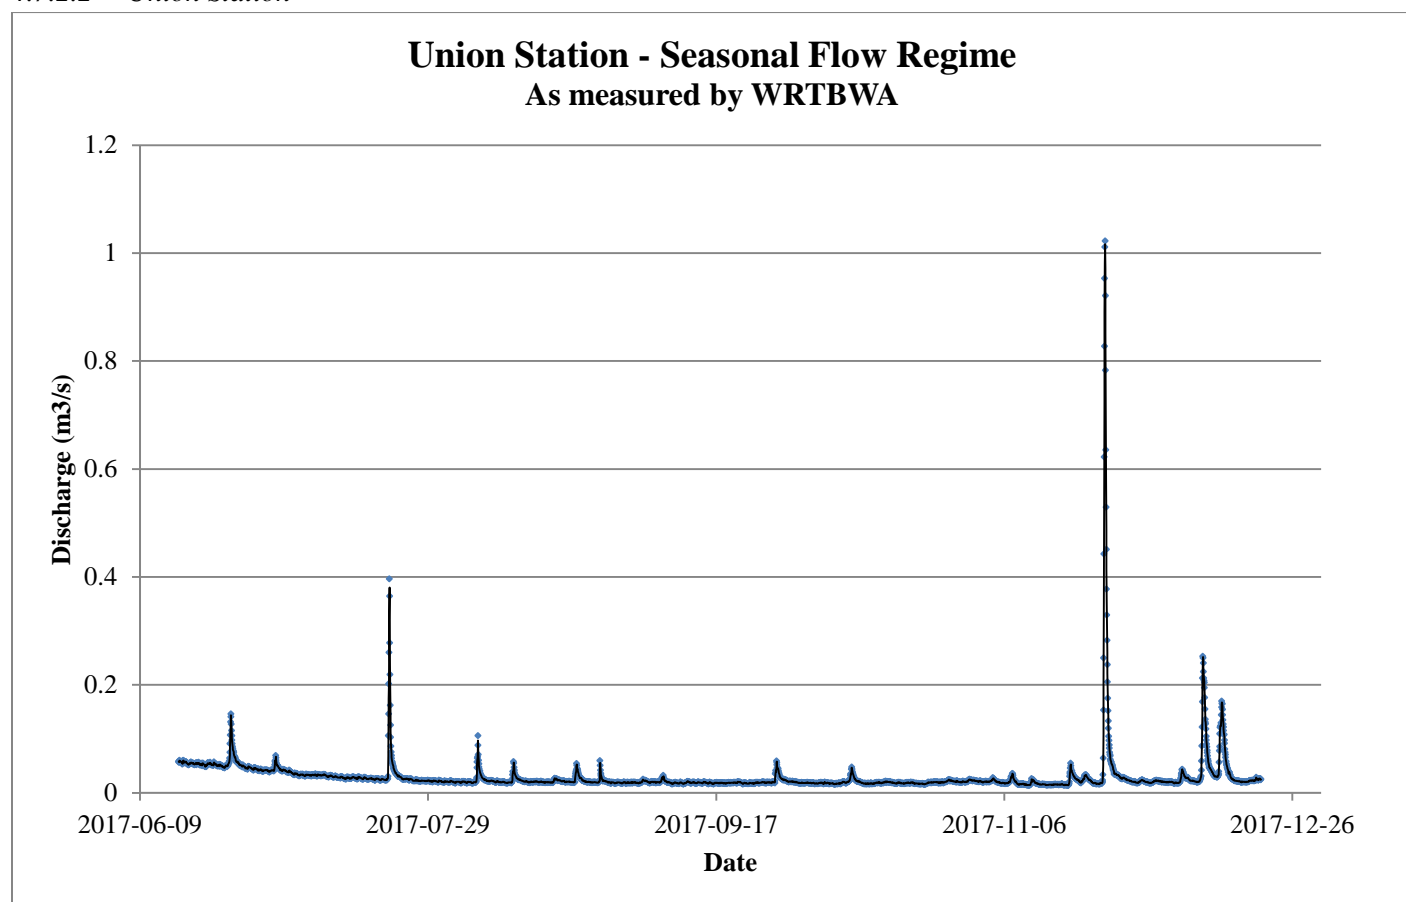
Union Station - Seasonal Flow Regime 2016 vs 2017 As measured by WRTBWA

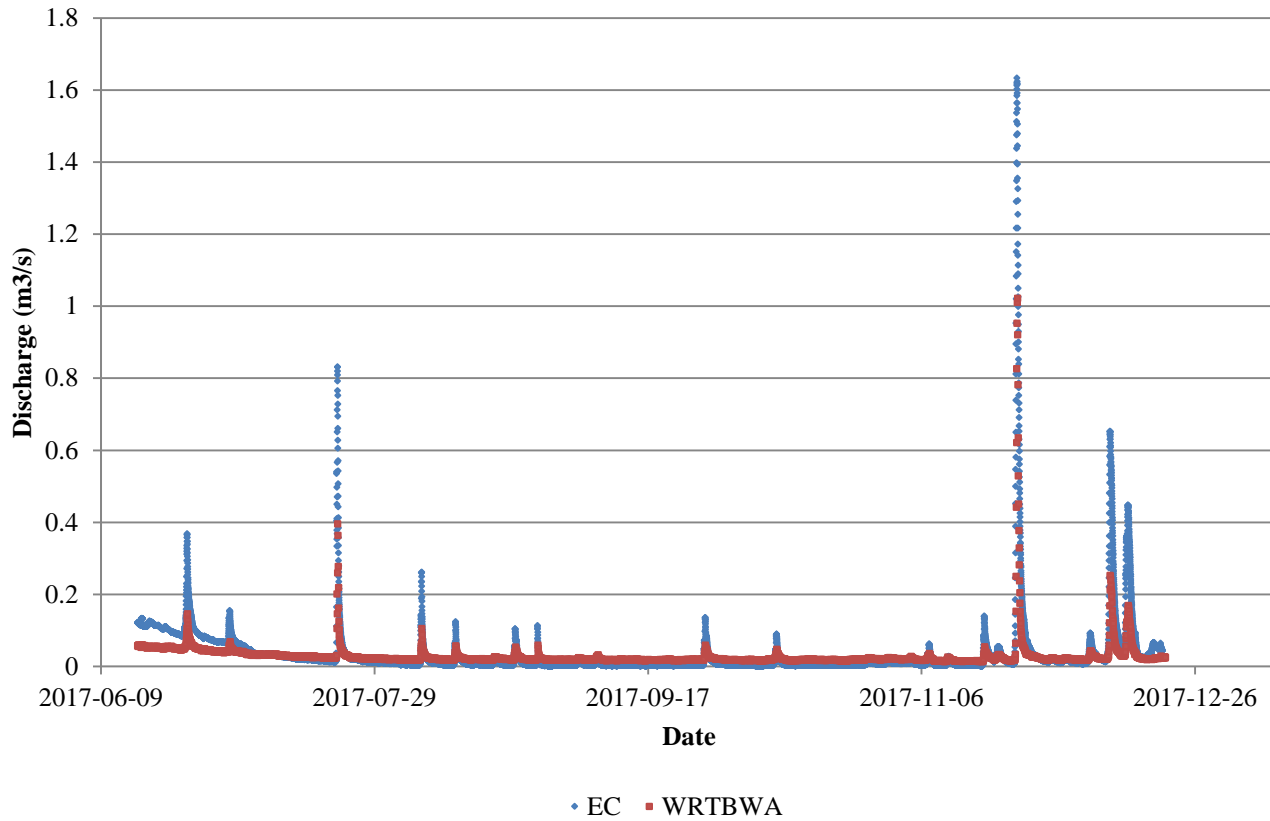
Union Station Discharge 2017 Environment Canada vs WRTBWA

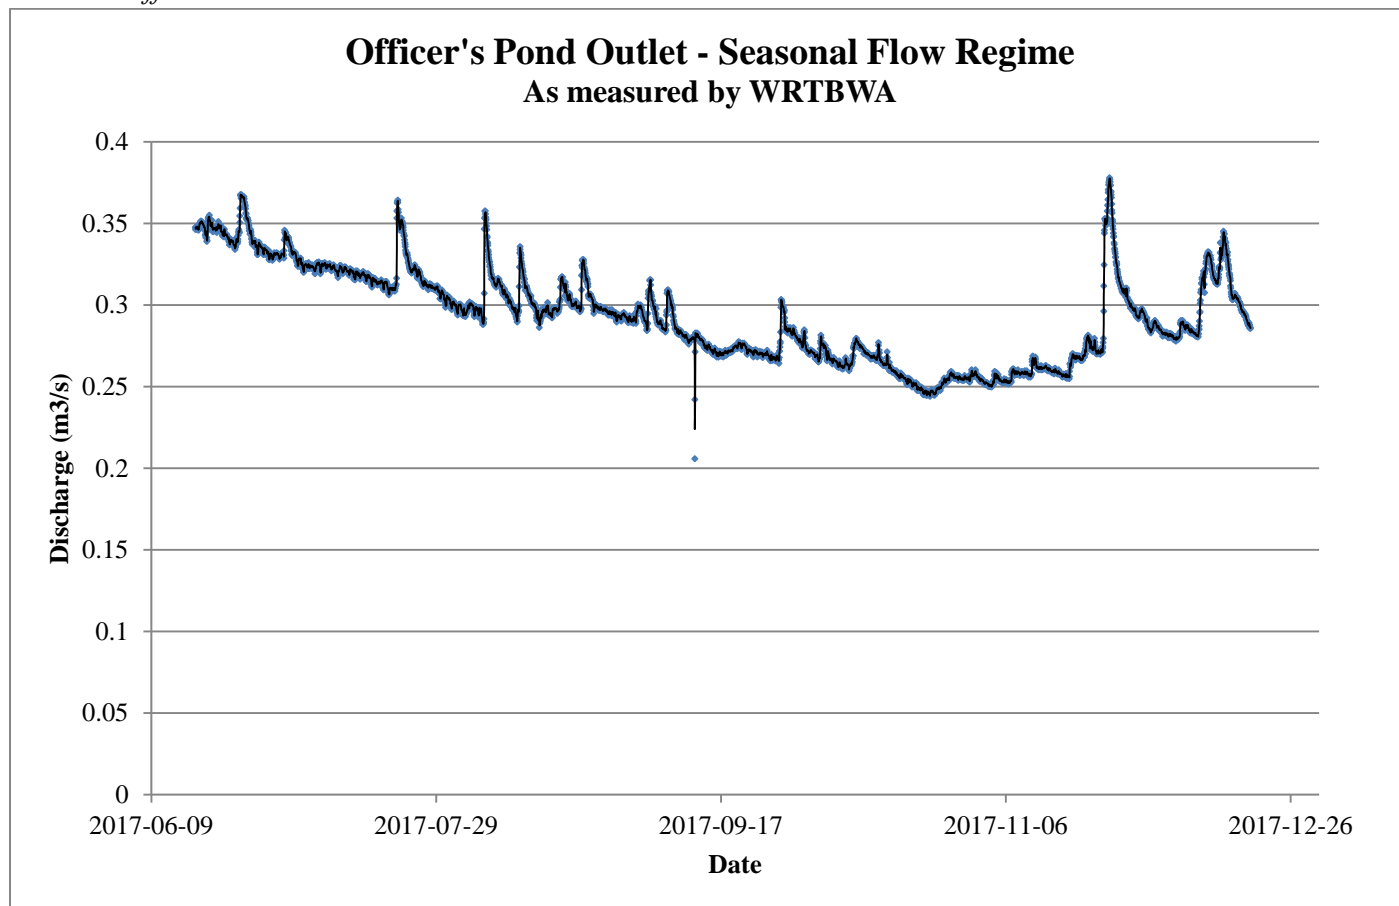
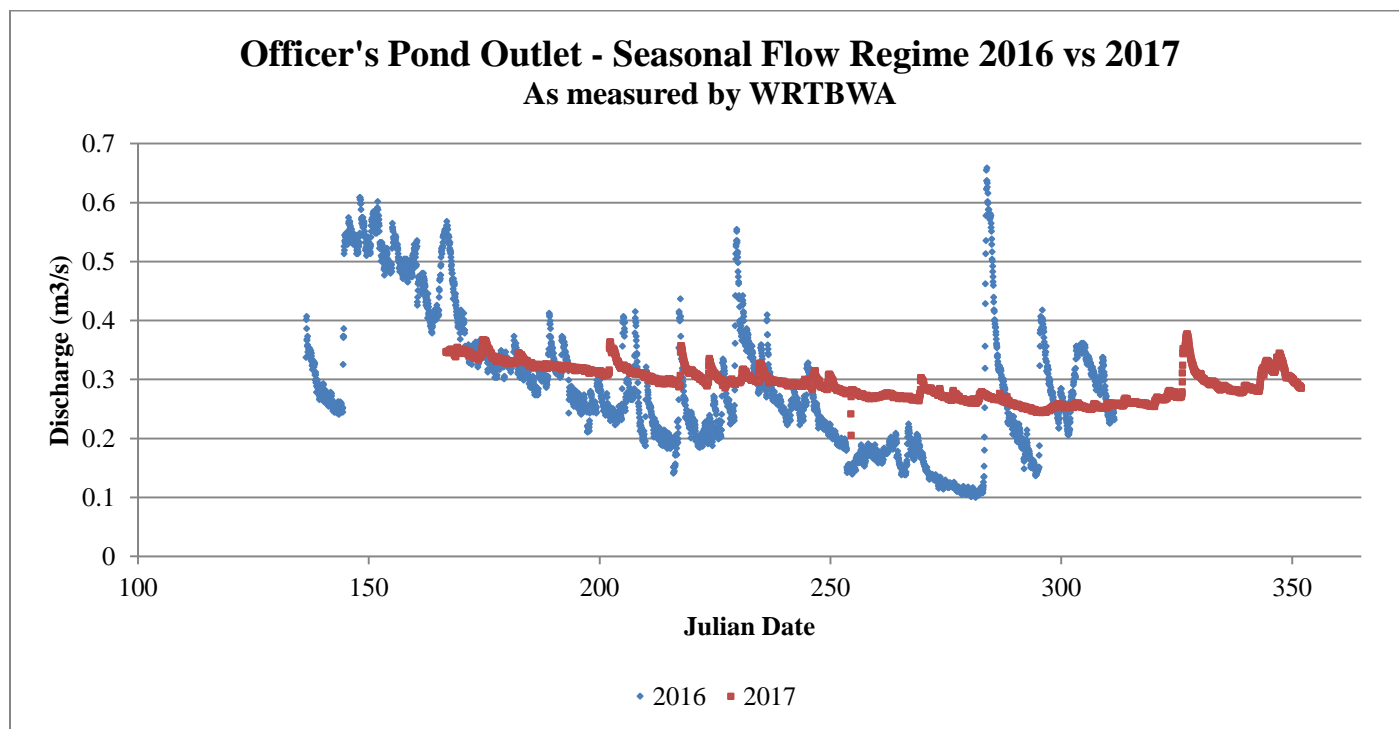
4.7.2.3 Officer's Outlet

2017			2016		
	Discharge (L/s)	Water level (m)	Date (yyyy-mm-dd)	Discharge (L/s)	Water level (m)	Date (yyyy-mm-dd)
Minimum Flow	205.843	0.262	2017-09-12	100.552	0.304	2016-10-08
Median Flow	293.036			270.250		
Maximum Flow	378.011	0.622	2017-11-24	658.938	0.557	2016-10-10

2017	2016
R-B Index:	0.017	0.100
Flashiness (# of high flow pulses):	0	0
High flow threshold (L/s):	879.107	811
R ² Value for water level discharge rating curve	0.058	0.623

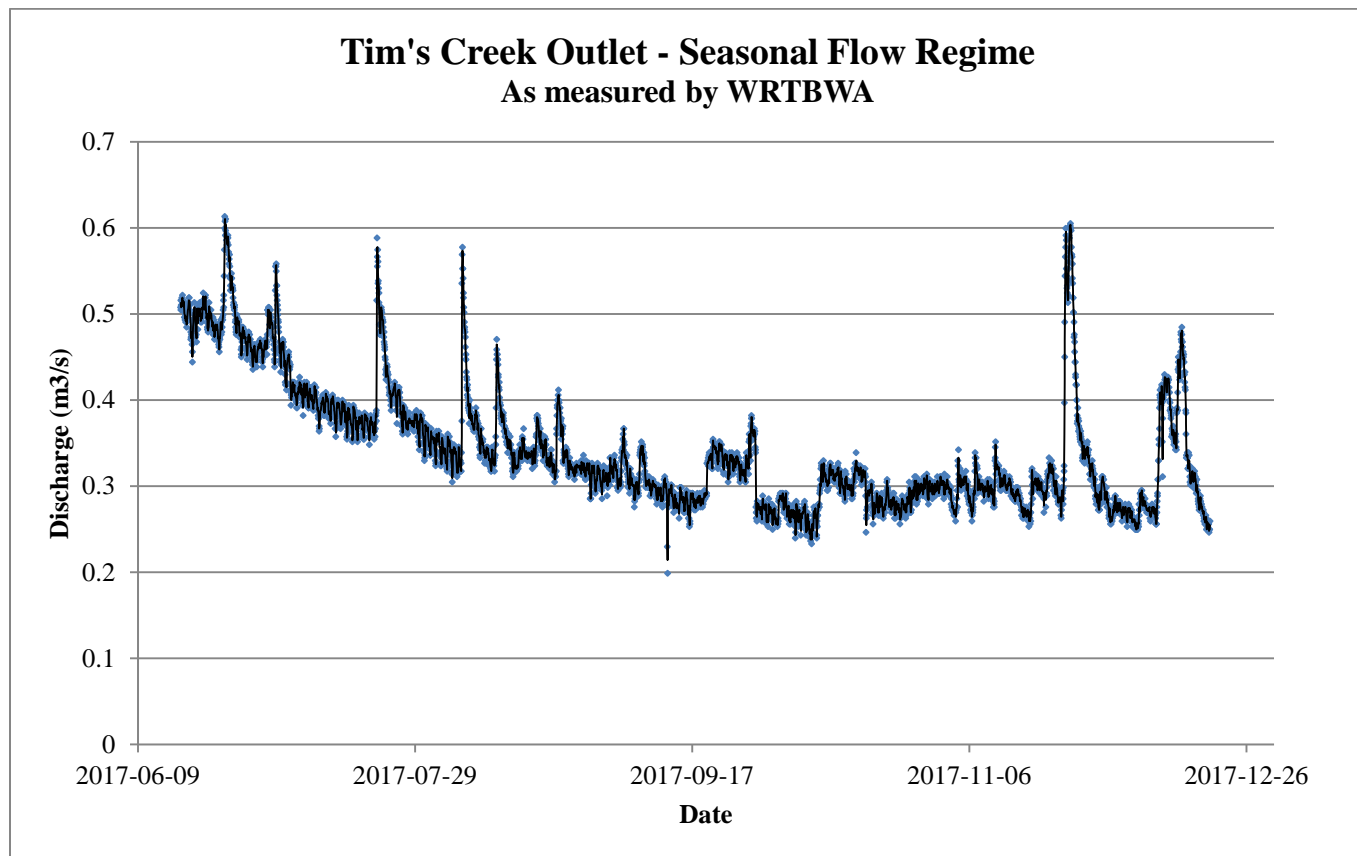
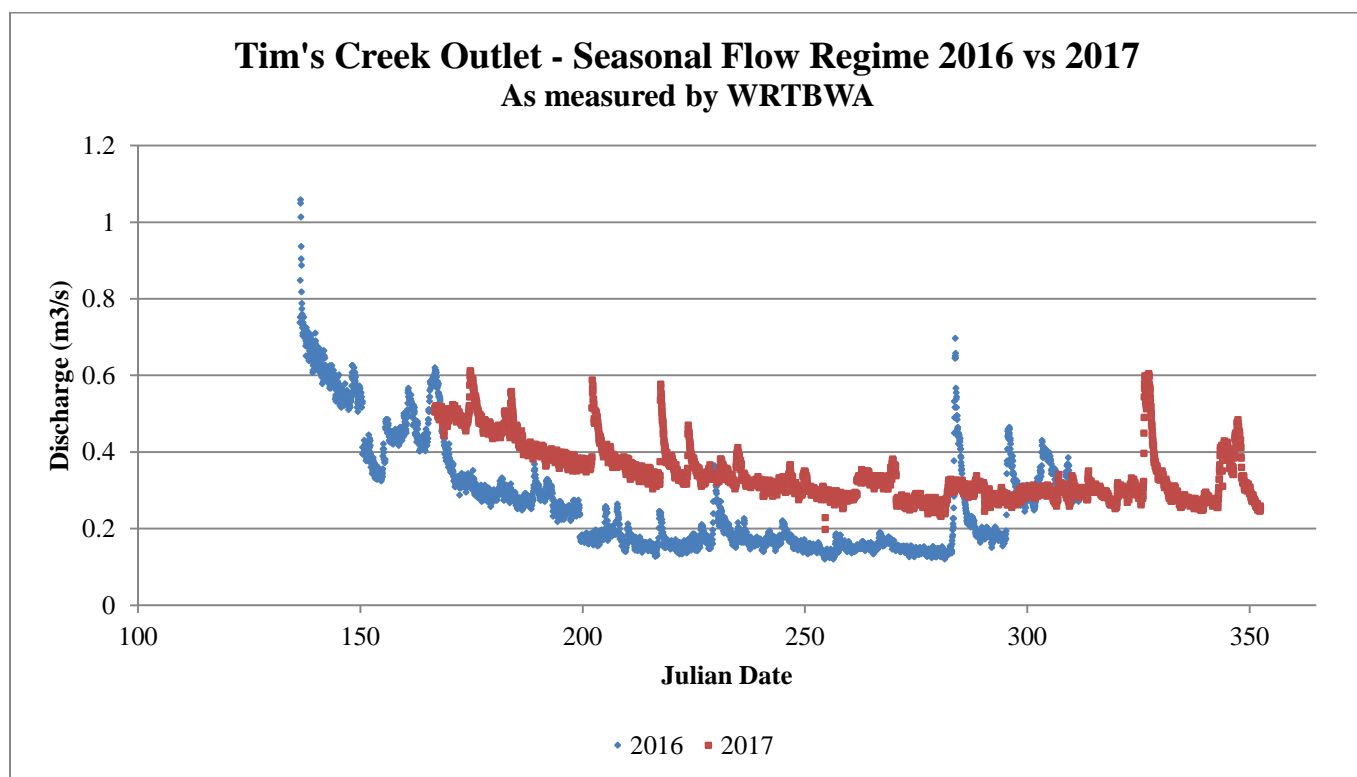
4.7.2.4 Tim's Outlet

2017			2016		
	Discharge (L/s)	Water level (m)	Date (yyyy-mm-dd)	Discharge (L/s)	Water level (m)	Date (yyyy-mm-dd)
Minimum Flow	198.923	0.047	2017-09-12	120.840	0.25	2016-09-11
Median Flow	320.554			215.666		
Maximum Flow	613.277	0.185	2017-06-24	1059.139	0.44	2016-05-16

2017	2016
R-B Index:	0.050	0.083
Flashiness (# of high flow pulses):	0	11
High flow threshold (L/s):	961.663	647
R ² Value for water level discharge rating curve	0.248	0.552

It is recommended that the water-level loggers be installed in the exact same locations in 2018 as they were in 2017, as this will increase the reliability of the data. However, at Tim's Creek the flow is unable to be measured across half of the width of the stream as it becomes too shallow and obstructed later in the season, resulting in an inaccurate representation of the stream's discharge. It may be beneficial to measure the flow and cross section at a location close to the logger which has measurable flow across the whole width of the stream. Rebar should be installed at this location as well to keep measurements consistent.

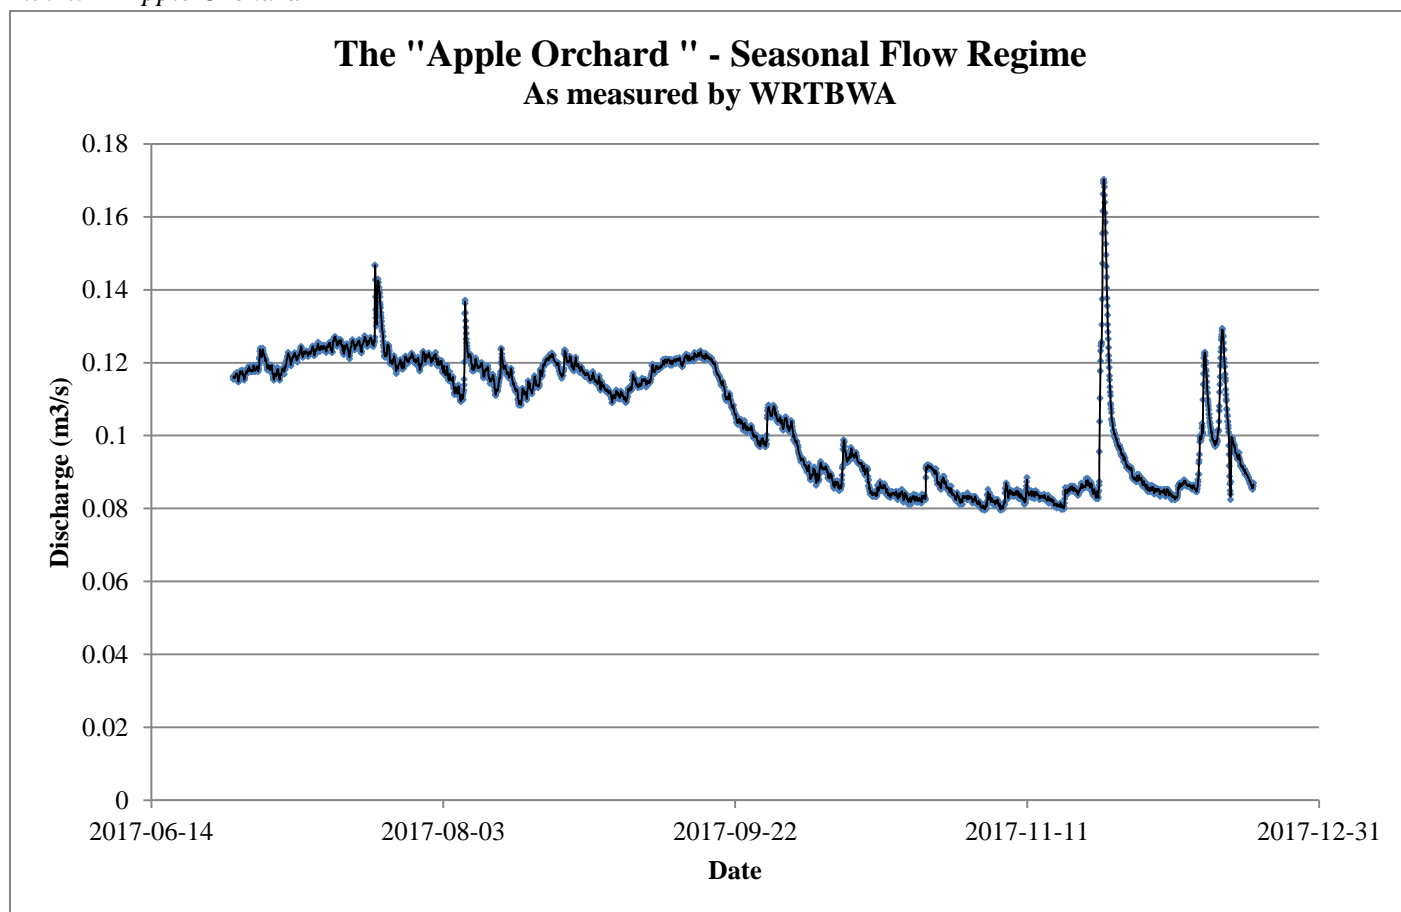
The "Apple Orchard " - Seasonal Flow Regime 2016 vs 2017 As measured by WRTBWA

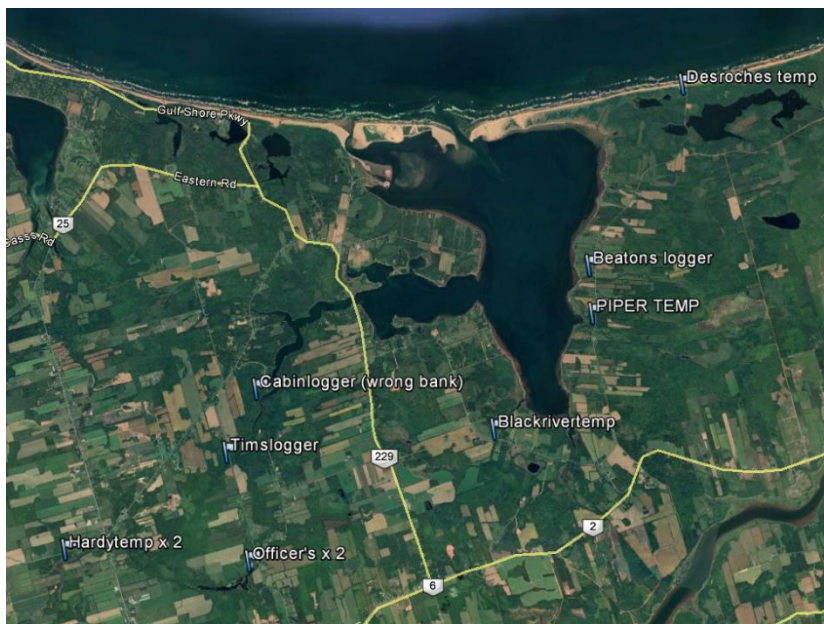
Figure 81. Temperature logger locations 2017.

2017 Temperature Logger Locations			
Name	Coordinates	Serial Number	Notes
Beaton's Creek	46°23'9.62"N 62°58'24.15"W	10731629	Downstream of culvert
Black River	46°21'18.71"N 62°59'57.36"W	10880491	Upstream of culvert
CABIN logger	46°21'45.87"N 63° 3'51.01"W	LOST	Near bank closer to cabin (lost)
Deroche Pond Outlet	46°25'12.40"N 62°56'52.02"W	10731605	Under bridge
Hardy Mill Pond (x2)	46°19'56.92"N 63° 6'58.52"W	Surface: 10880486 Bottom: 10880488	Upstream of dam
Officer's Pond (x2)	46°19'49.36"N 63° 3'58.28"W	Surface: 10880487 Bottom: 10880492	Halfway between farm and fishing lodge
Piper's Creek	46°22'37.09"N 62°58'20.96"W	10880490	Upstream of culvert
Tim's Creek	46°21'2.95"N 63° 4'20.19"W	10731604	Upstream of culvert

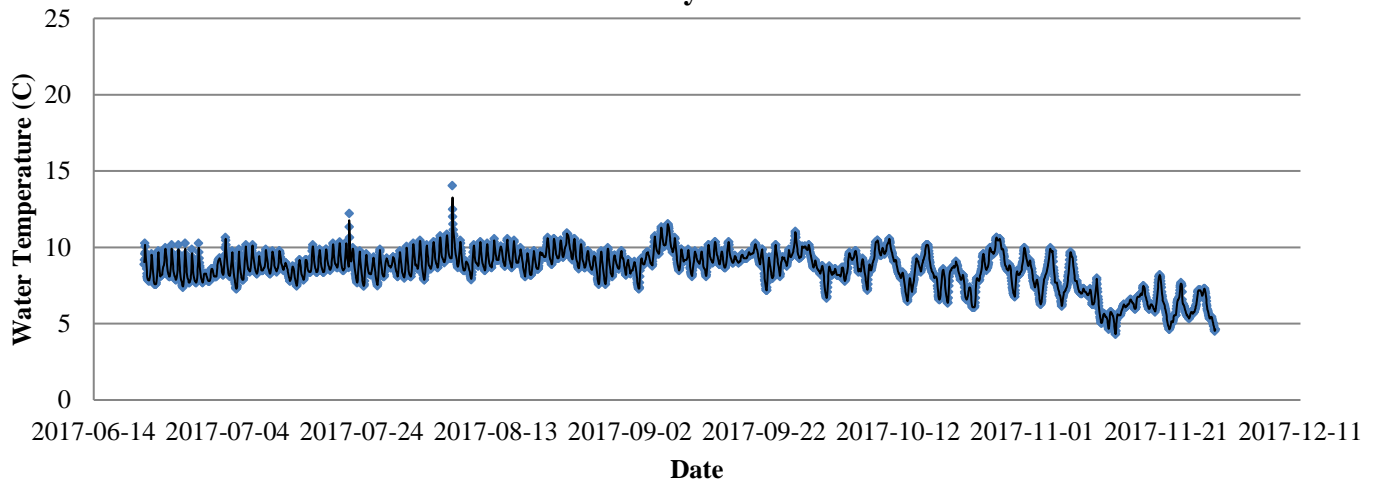
Seasonal Temperature Regime @ Tim's Outlet
As Measured by WRTBWA

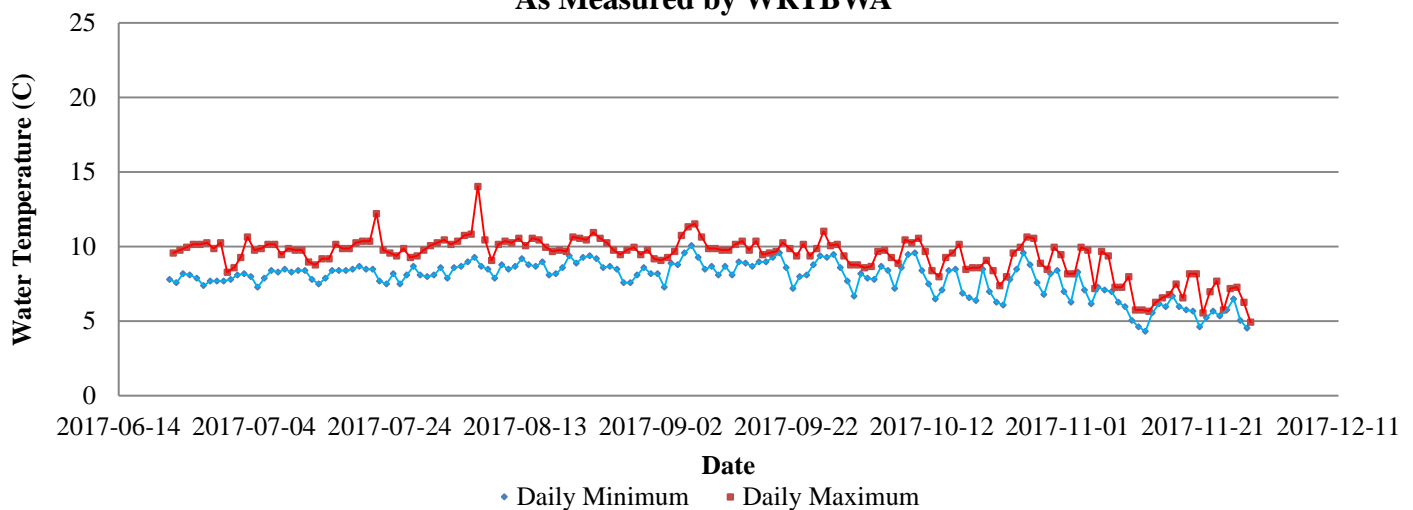
Daily Temperature Regime @ Tim's Outlet
As Measured by WRTBWA

Temperature (°C)	Date
Maximum	14.038	2017-08-06
Average	8.535	
Minimum	4.311	2017-11-13

Percentage of hourly temperature measurements
Optimal Growth for Brook trout (11-18 °C)	0.521%
Tolerant Brook trout range (0-20 °C)	100%
Stress Zone (>20°C)	0%
Longest # of Hours in Stress Zone: 0

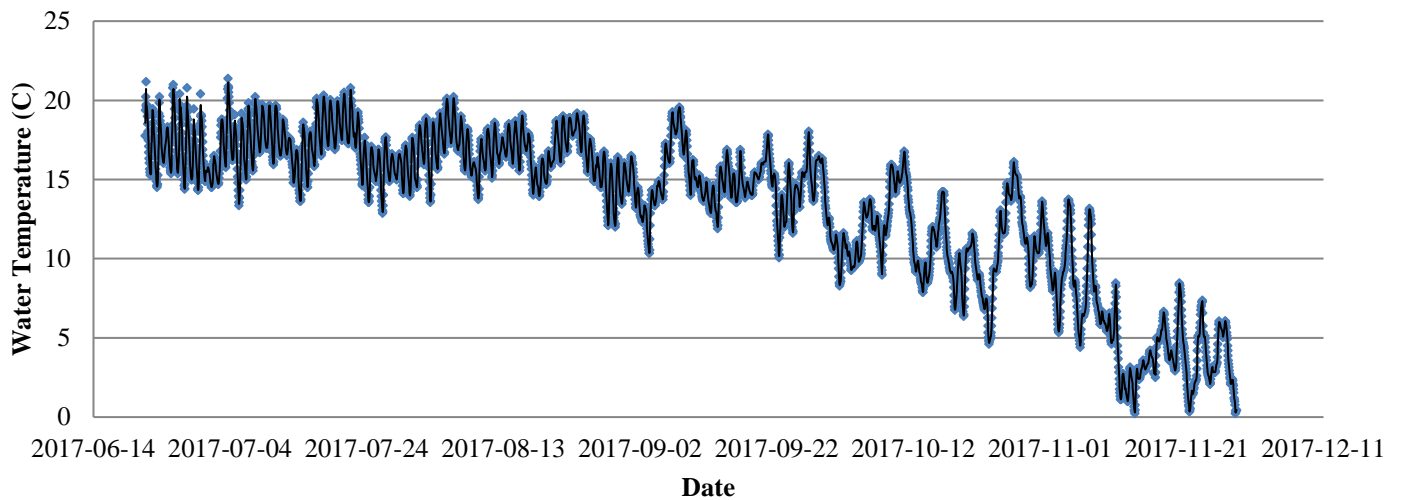
Seasonal Temperature Regime of Beaton's Creek As measured by WRTBWA

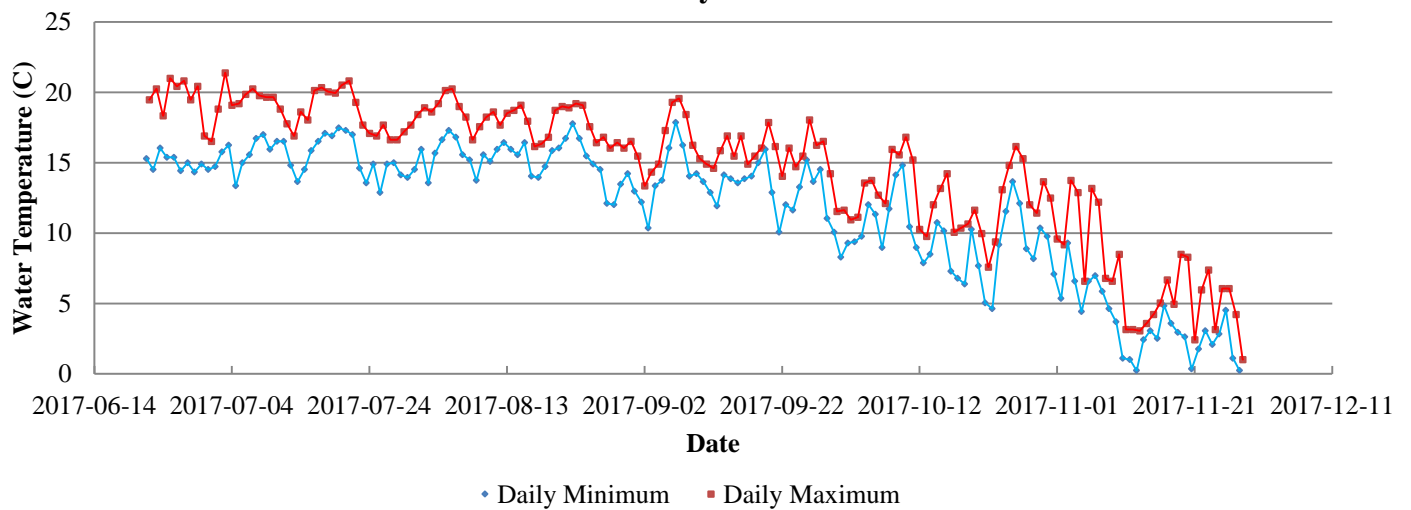
Daily Temperature Regime of Beaton's Creek As measured by WRTBWA

Temperature (°C)	Date
Maximum	21.378	2017-07-03
Average	13.331	
Minimum	0.232	2017-11-13

Percentage of hourly temperature measurements
Optimal Growth for Brook trout (11-18 °C)	60.913%
Tolerant Brook trout range (0-20 °C)	98.931%
Stress Zone (>20°C)	1.069%
Longest # of Hours in Stress Zone: 7

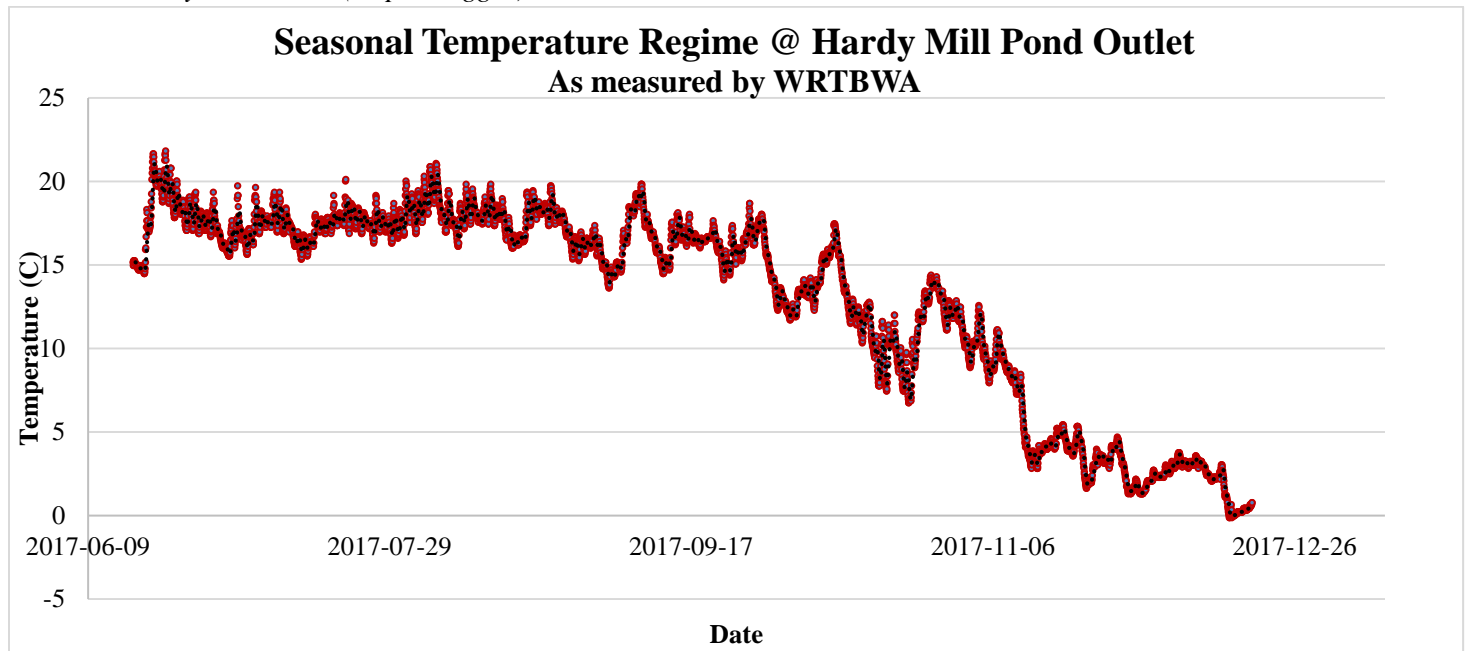
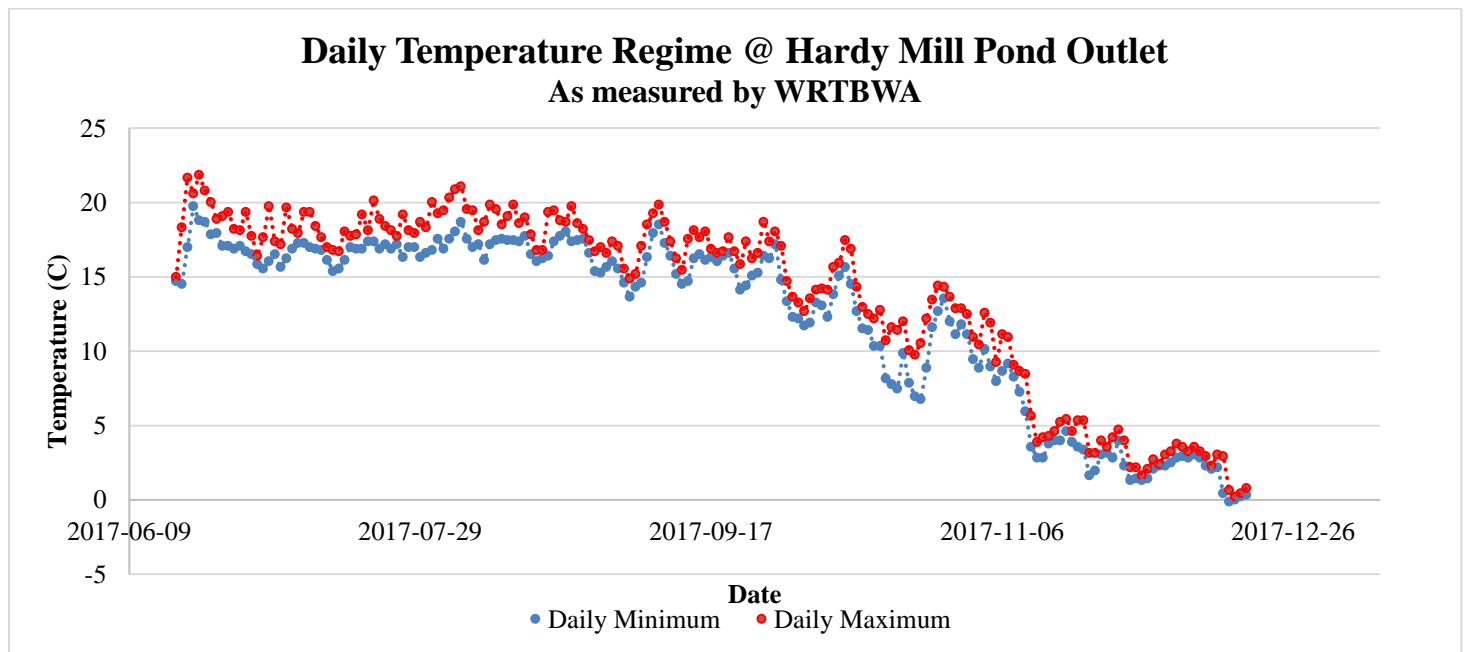
4.8.2.4 Hardy Mill Outlet (Depth Logger)

Temperature (°C)	Date
Maximum	21.855	2017-06-21
Average	13.047	
Minimum	-0.102	2017-12-15

Percentage of hourly temperature measurements
Optimal Growth for Brook trout (11-18 °C)	54.390%
Tolerant Brook trout range (0-20 °C)	98.428%
Stress Zone (>20°C)	1.527%
Longest # of Hours in Stress Zone: 16

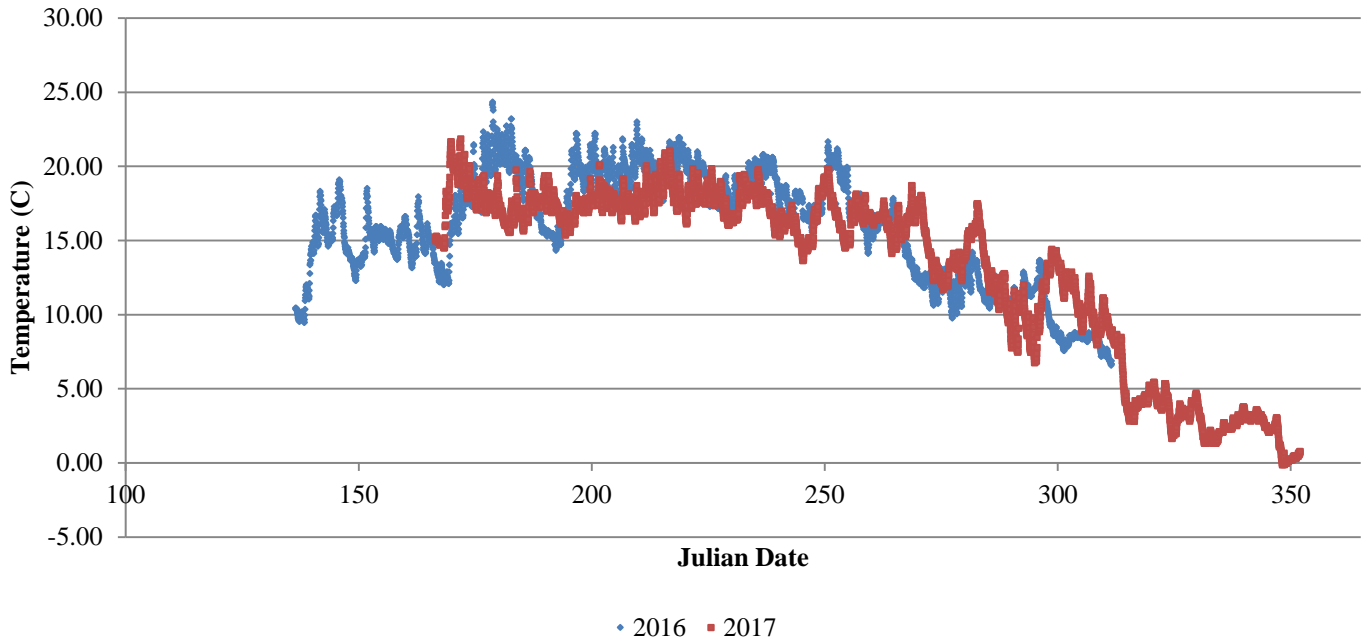
Seasonal Temperature Regime @ Hardy Mill Pond Outlet 2016 vs 2017 As measured by WRTBWA

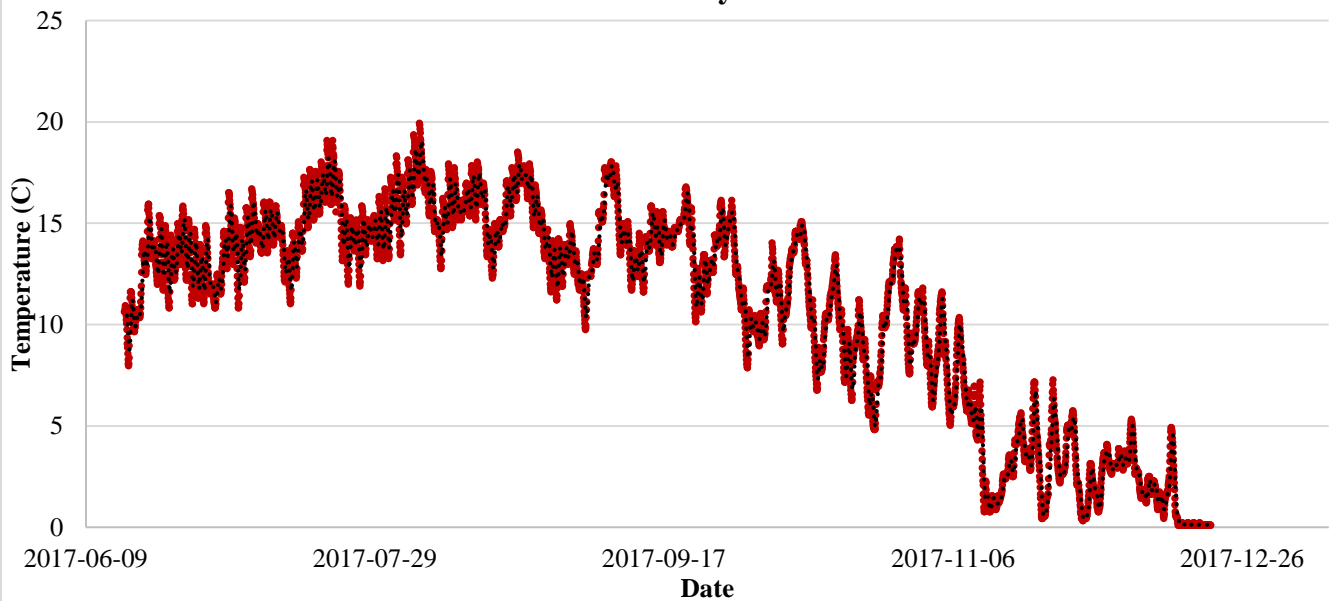
Seasonal Temperature Regime of the Union Branch As measured by WRTBWA

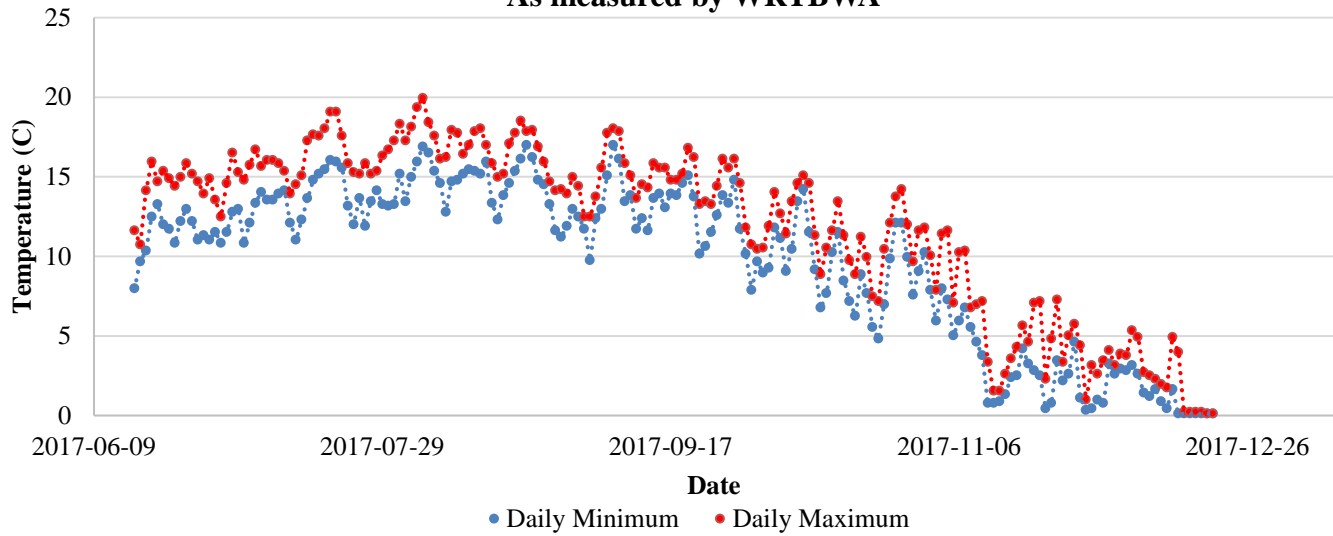
Daily Temperature Regime of the Union Branch As measured by WRTBWA

Temperature (°C)	Date
Maximum	19.948	2017-08-05
Average	10.865	
Minimum	0.121	2017-12-14

Percentage of hourly temperature measurements
Optimal Growth for Brook trout (11-18 °C)	60.142%
Tolerant Brook trout range (0-20 °C)	100%
Stress Zone (>20°C)	0%
Longest # of Hours in Stress Zone: 0

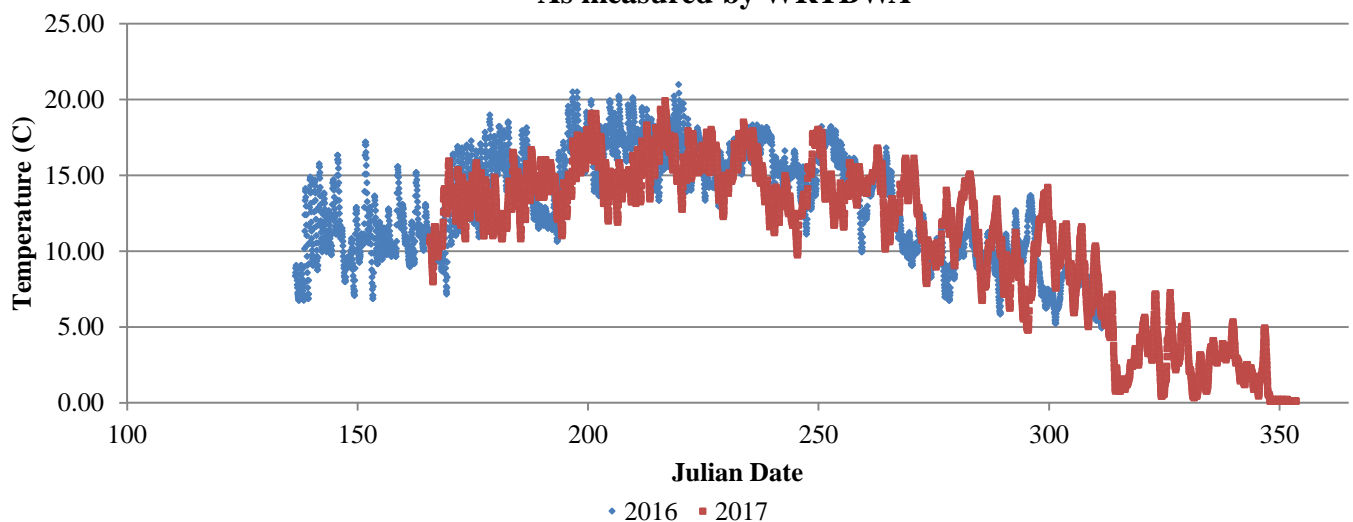
Seasonal Temperature Regime of the Union Branch 2016 vs 2017 As measured by WRTBWA

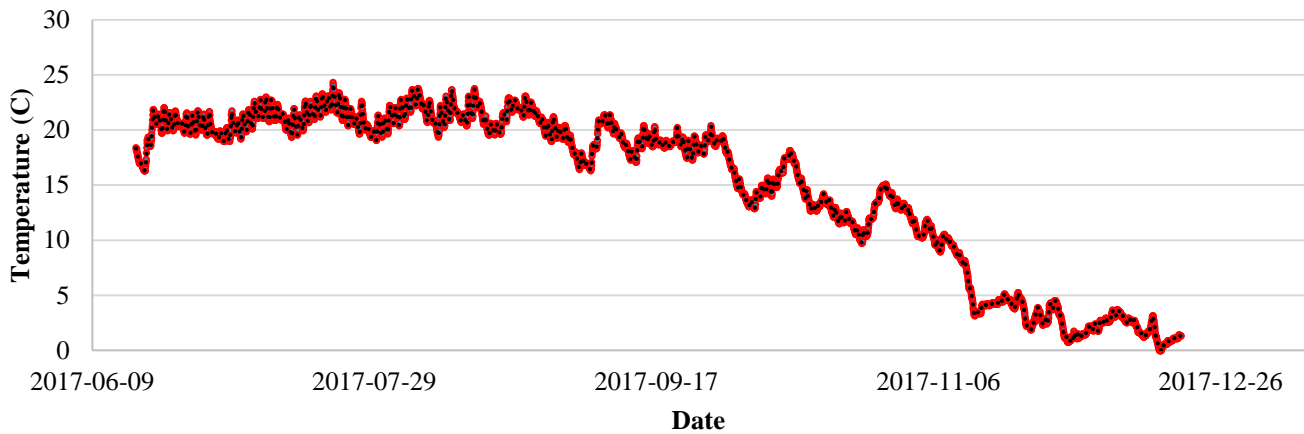
Seasonal Temperature Regime @ Officers Pond Outlet
As measured by WRTBWA

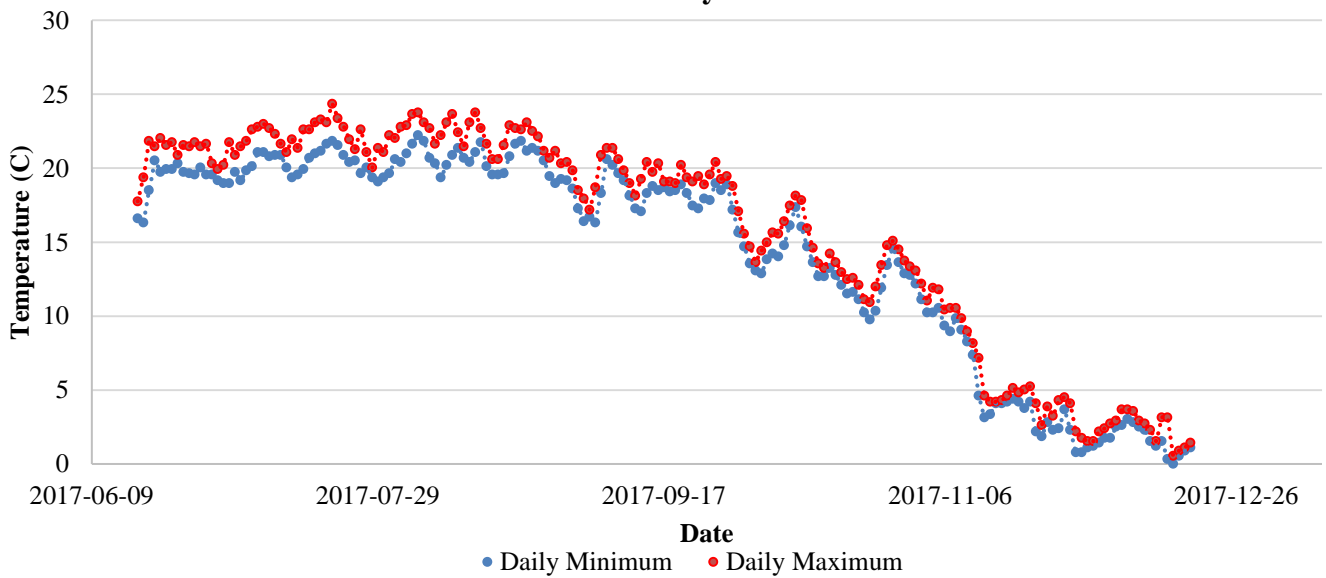
Daily Temperature Regime @ Officers Pond Outlet
As measured by WRTBWA

Temperature (°C)	Date
Maximum	24.351	2017-07-21
Average	15.074	
Minimum	0.01	2017-12-15

Optimal Growth for Brook trout (11-18 °C)	21.453%
Tolerant Brook trout range (0-20 °C)	65.033%
Stress Zone (>20°C)	34.967%
Longest # of Hours in Stress Zone: 236

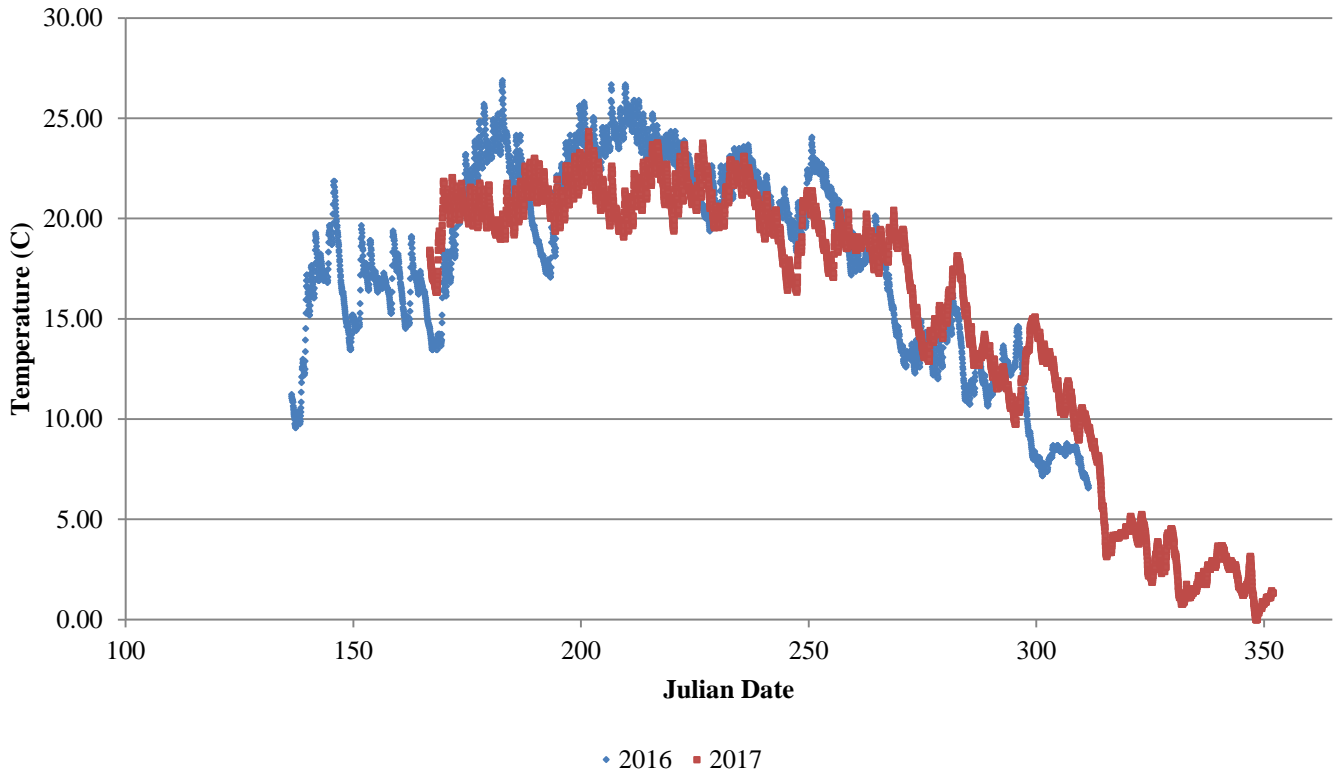
Seasonal Temperature Regime @ Officers Pond Outlet 2016 vs 2017 As measured by WRTBWA

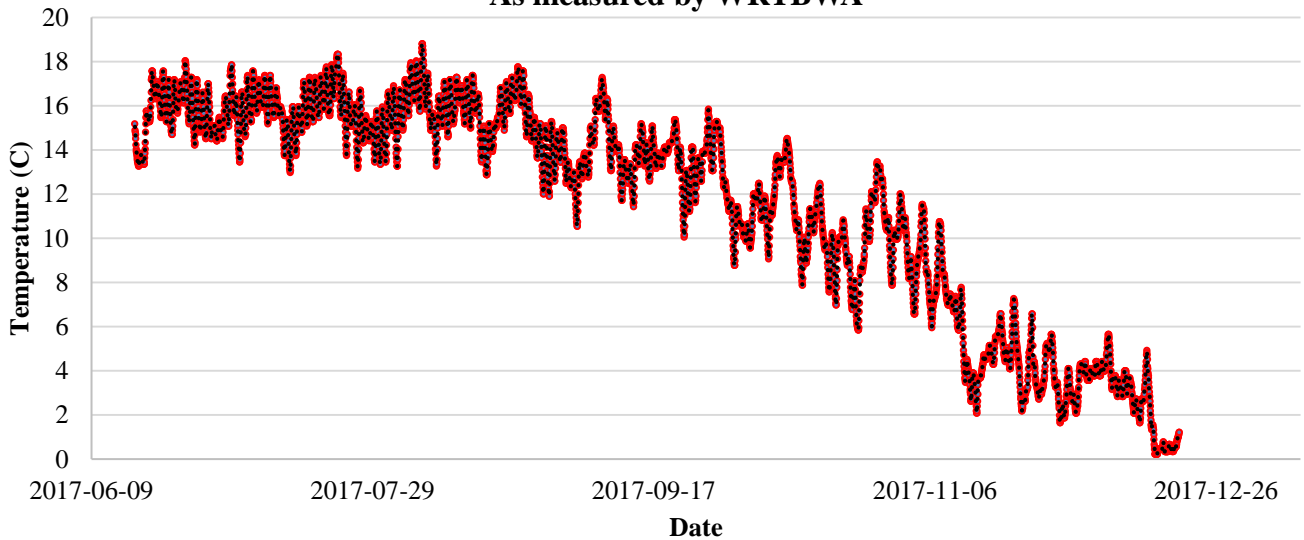
Seasonal Temperature Regime @ Tim's Creek Outlet As measured by WRTBWA

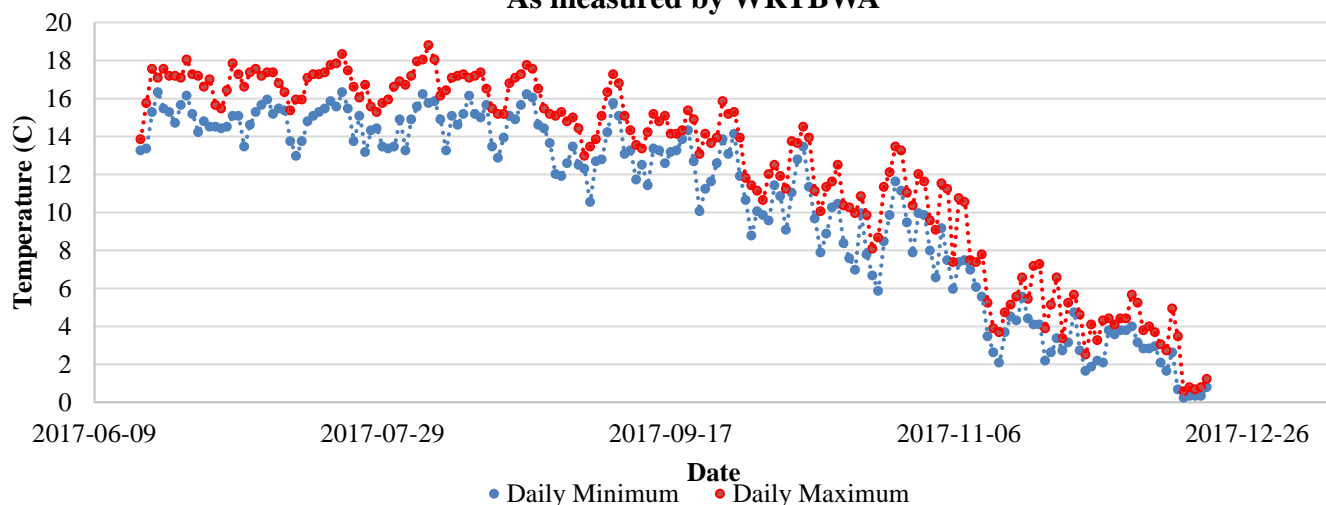
Daily Temperature Regime @ Tim's Creek Outlet As measured by WRTBWA

Temperature (°C)	Date
Maximum	18.806	2017-08-06
Average	11.554	
Minimum	0.232	2017-12-15

Percentage of hourly temperature measurements
Optimal Growth for Brook trout (11-18 °C)	62.996%
Tolerant Brook trout range (0-20 °C)	100%
Stress Zone (>20°C)	0%
Longest # of Hours in Stress Zone: 0

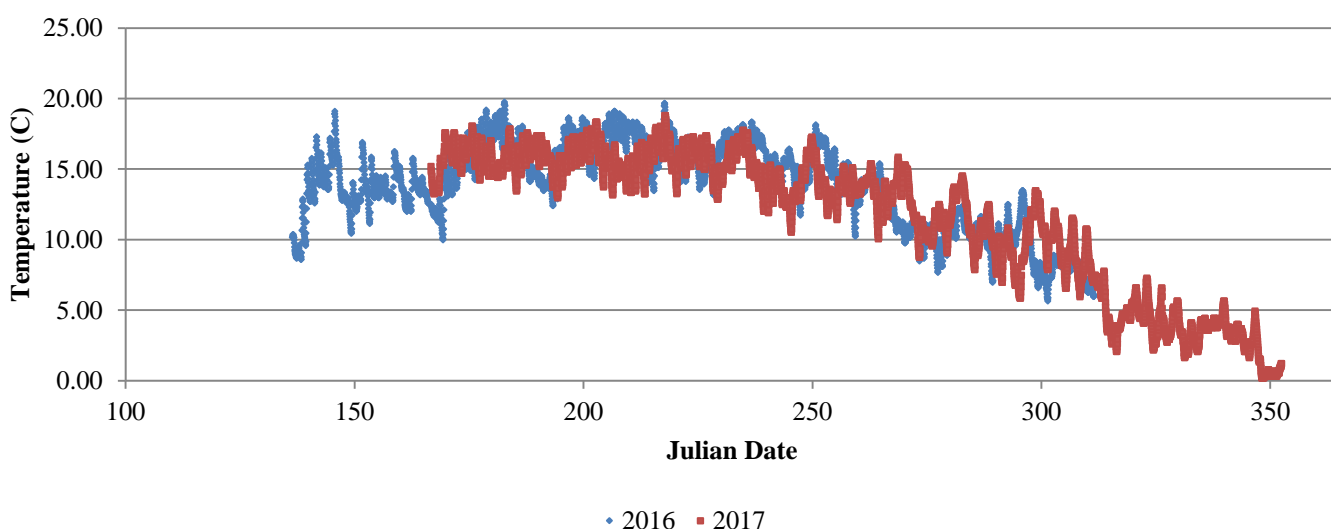
Seasonal Temperature Regime @ Tim's Creek Outlet 2016 vs 2017 As measured by WRTBWA

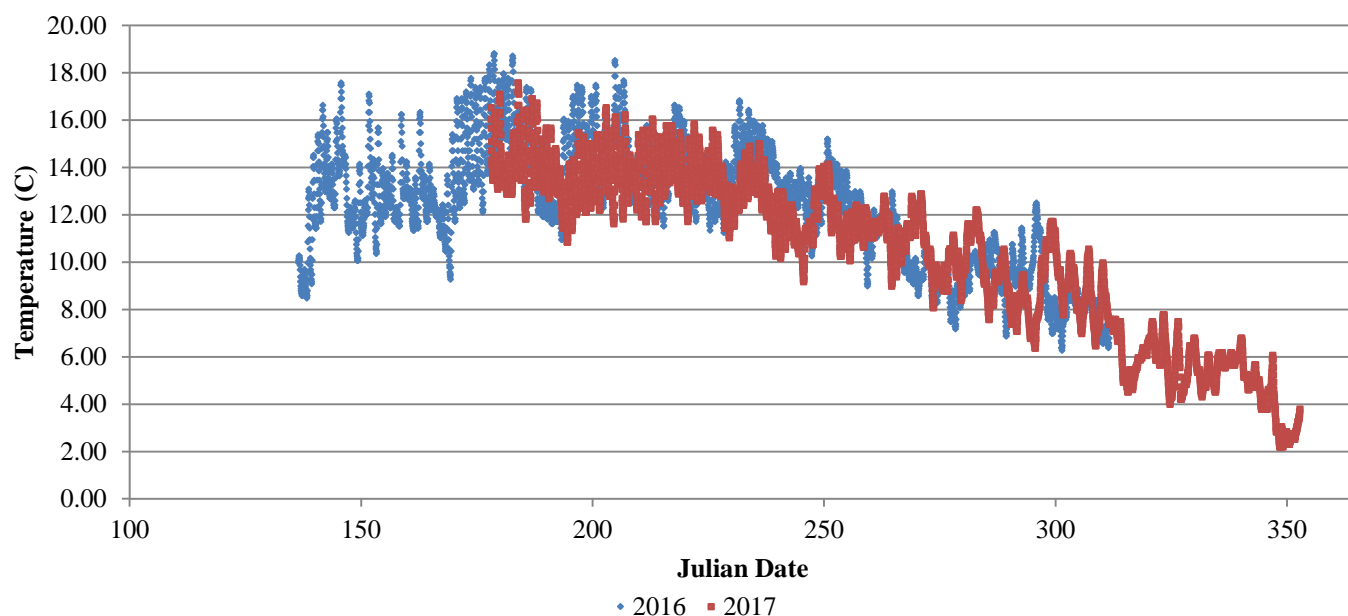
Seasonal Temperature Regime @ The "Apple Orchard" 2016 vs 2017 As measured by WRTBWA
