WINTER RIVER - TRACADIE BAY WATERSHED ASSOCIATION

Final Report 2017-2018 Work Year

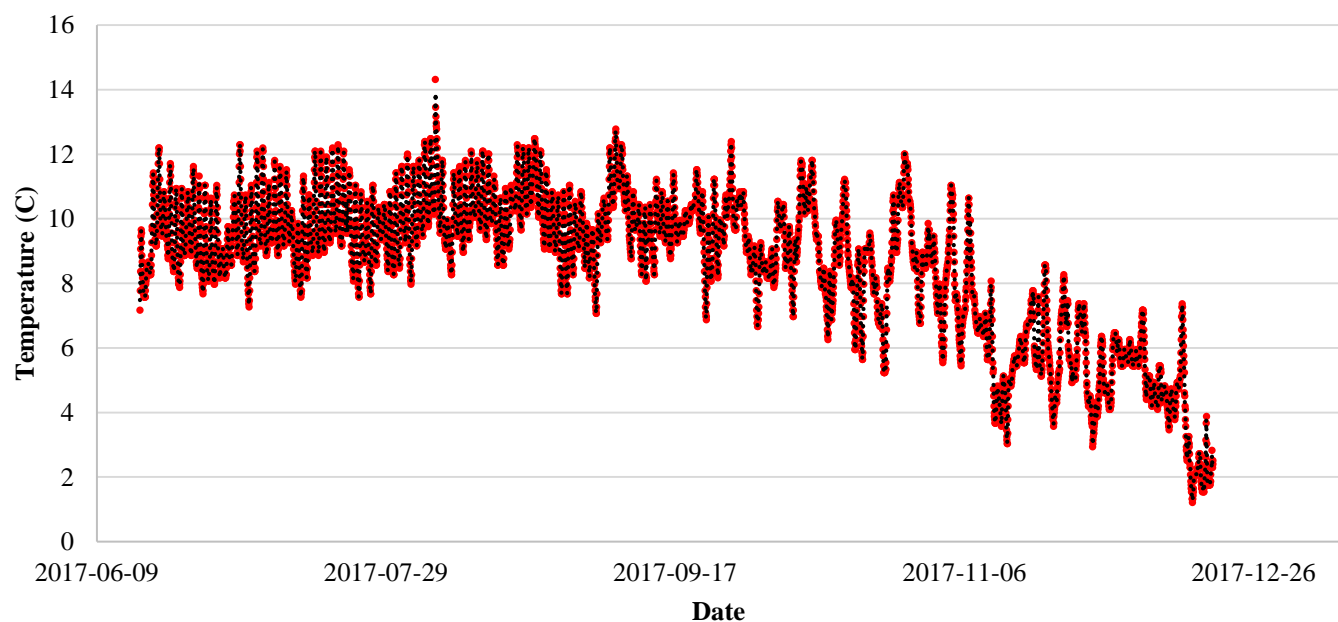
Seasonal Temperature Regime @ Friston Branch As measured by WRTBWA

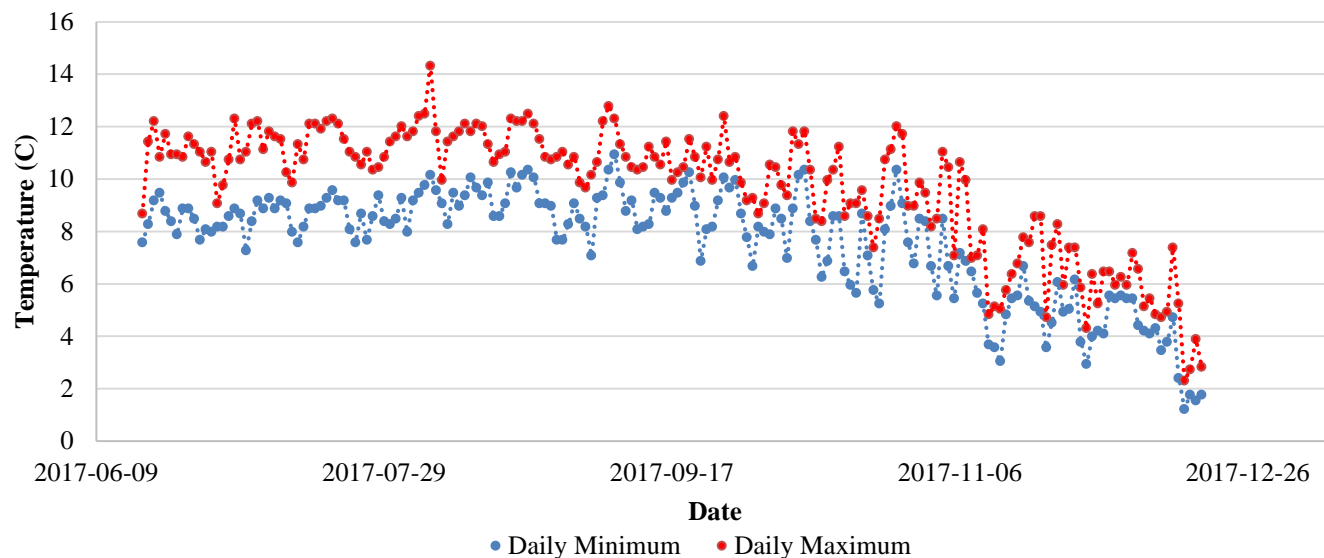
Daily Temperature Regime @ Friston Branch As measured by WRTBWA

Temperature (°C)	Date
Maximum	14.325	2017-08-06
Average	8.595	
Minimum	1.221	2017-12-15

Percentage of hourly temperature measurements
Optimal Growth for Brook trout (11-18 °C)	10.463%
Tolerant Brook trout range (0-20 °C)	100%
Stress Zone (>20°C)	0%
Longest # of Hours in Stress Zone: 0

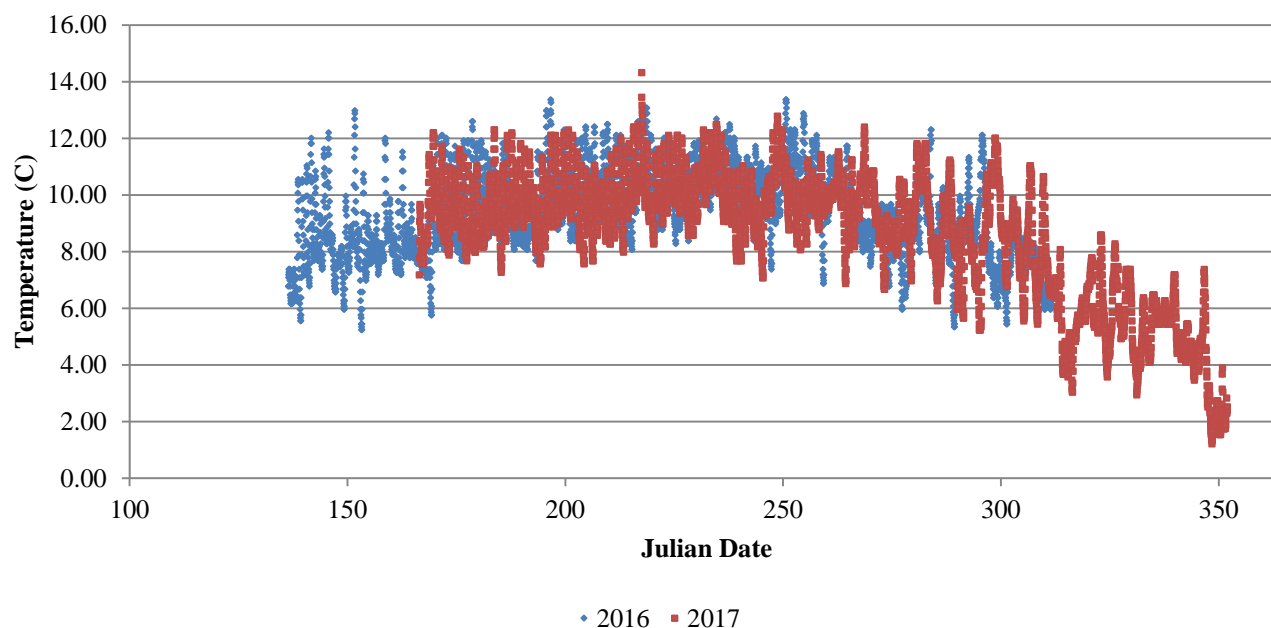
Seasonal Temperature Regime @ Friston Branch 2016 vs 2017 As measured by WRTBWA

Friston	Percentage of hourly temperature measurements	
	2017	2016
Optimal Growth for Brook trout (11-18 °C)	13.464%	17.887%
Tolerant Brook trout range (0-20 °C)	100%	100%
Stress Zone (>20°C)	0%	0%
Longest # of Hours in Stress Zone	0	0

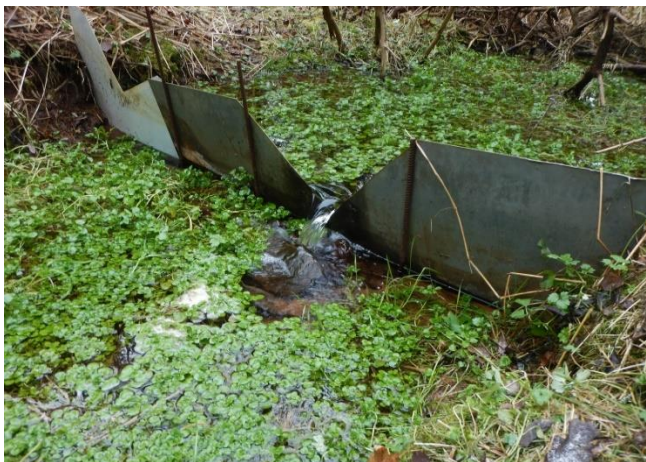
Figure 82. A spring with flow at the Cudmore Branch.

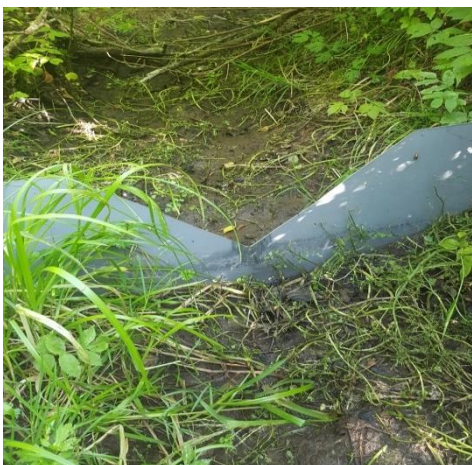
Figure 83. A dry spring at Brackley.

they need repair. The Brackley springs followed the same pattern as previous years; going dry towards the end of July. The exception was Brackley #7, in which flow remained until the middle of August. Water was not found in the Brackley springs again until spring 2018. The Vanco weir was dry from early September until mid-December, and Cudmore #6 also went dry from mid-October to early December.

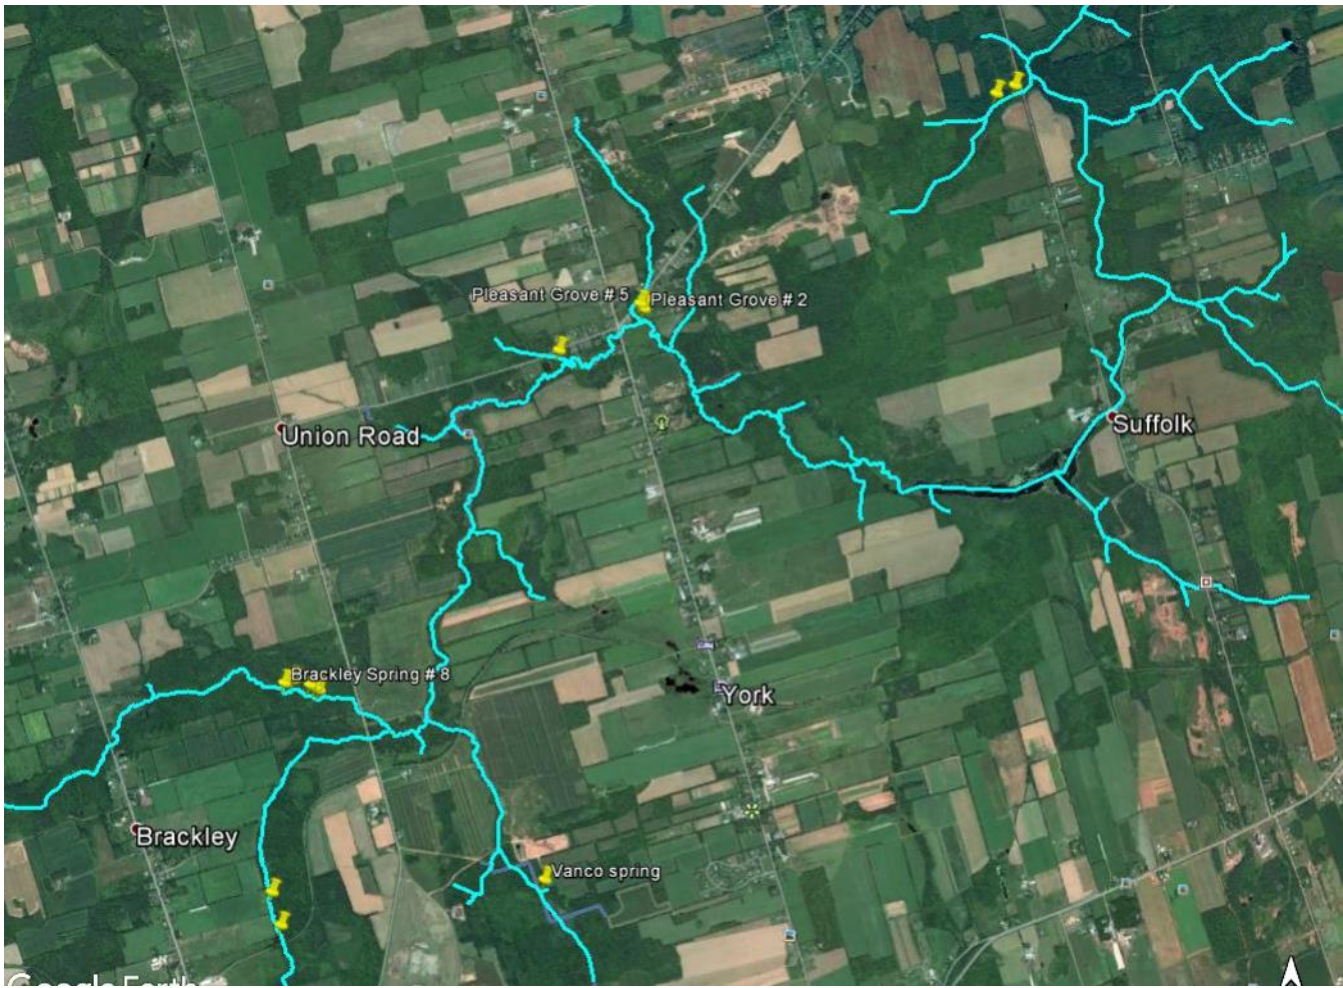
Figure 84. V-notch weir locations for the 2017 monitoring season.

This year, the v-notch weirs were installed in early June and monitored until mid-December. Measurements were taken using a ruler to measure the height of water trickling over the v-notch in centimeters. This measurement was then correlated to John te Raa's Excel file to determine the flow coming from the spring in litres per second.

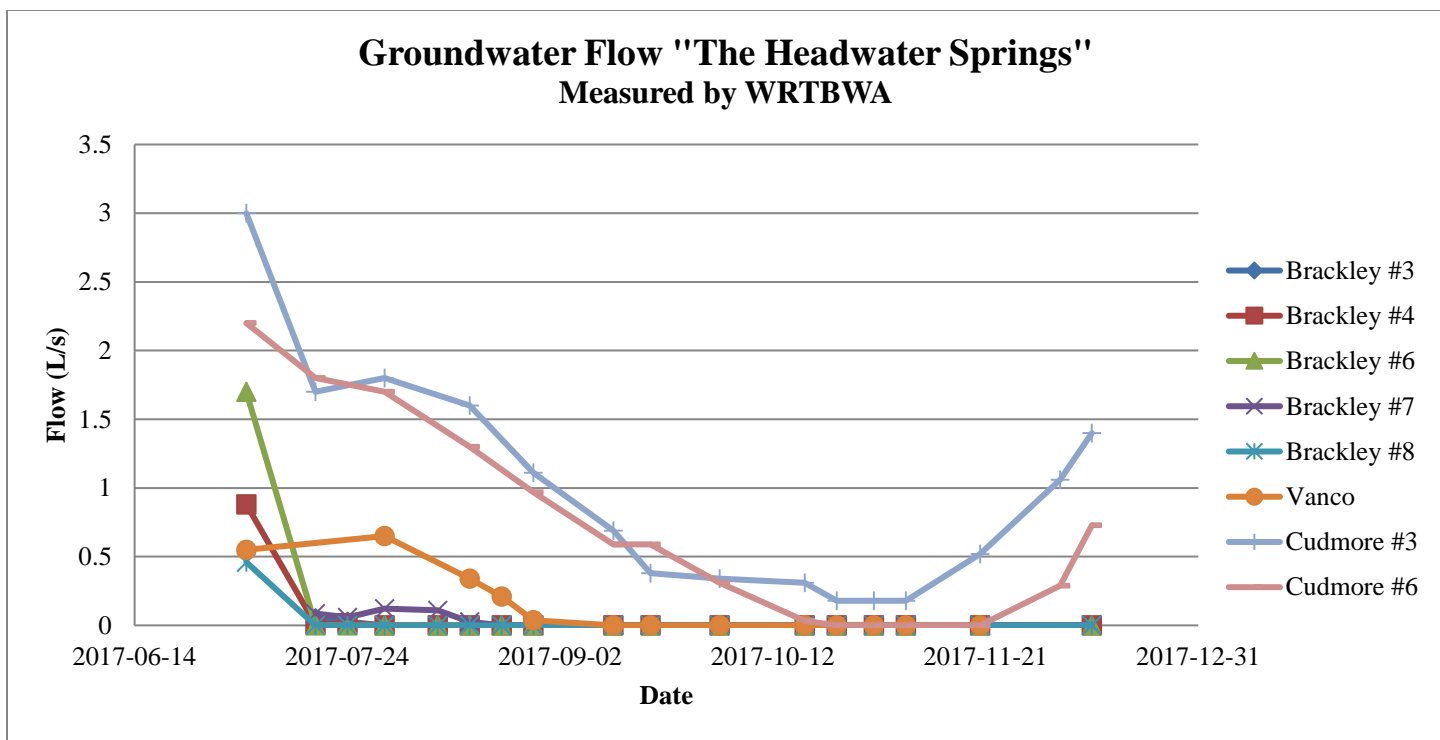
Figure 85. Flow measured from the headwater springs over the 2017 season.

*Note: The following trend graphs have a degree of error with weather impacts from rain and snow, although best efforts were made to take measurements at least a few days after a precipitation or snow-melt event. Daily variation from morning to late afternoon must also be factored in because of evaporation from increased air temperatures in the summer months. This is a trend-line visualization of seasonal groundwater fluctuations from selected springs to show how the increase in water extraction affects the springs and stream base flow (as shown from the water-level loggers) of Winter River.

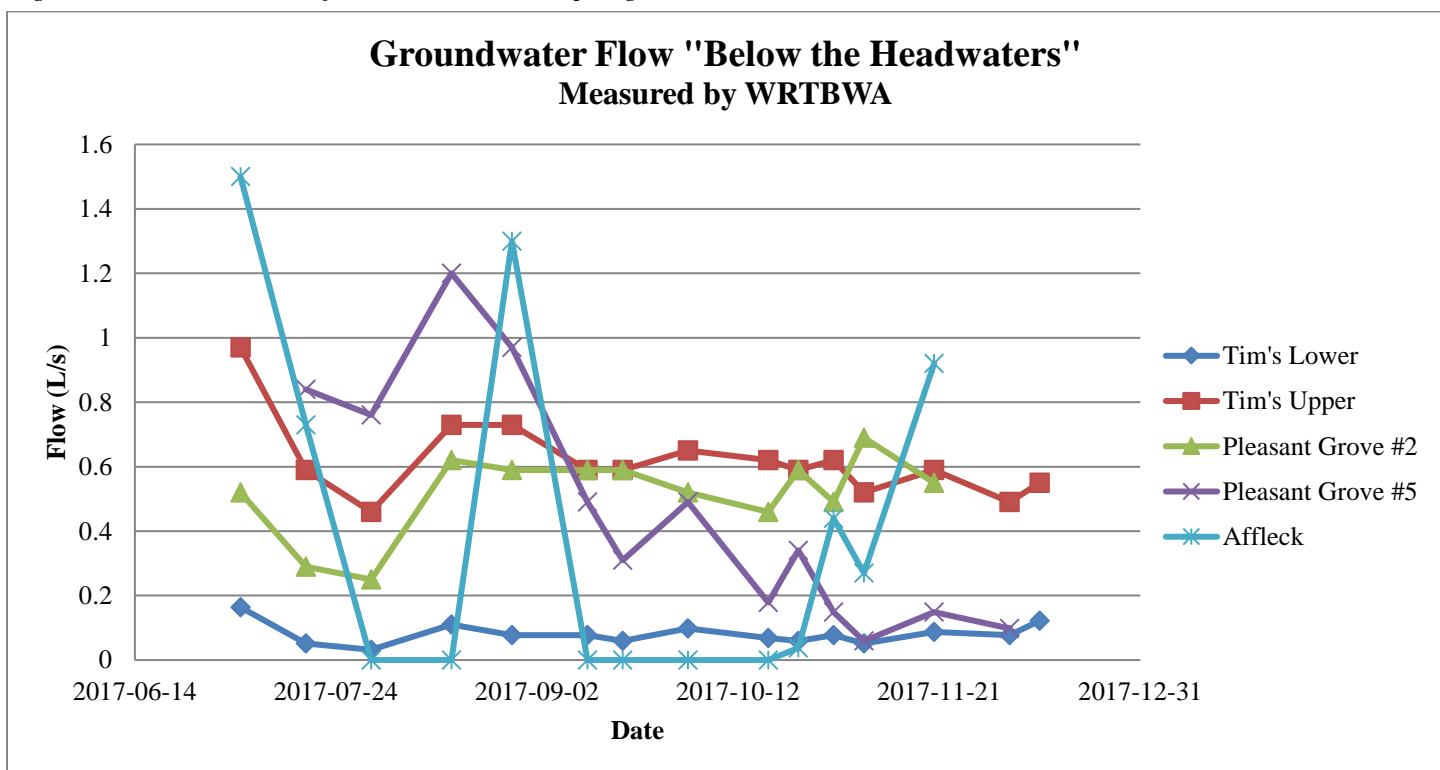
Figure 86. Flow measured from the springs below the headwaters over the 2017 season.

Weirs located at Pleasant Grove #5, Affleck, and Vanco had issues with leaks throughout the season due to highly erodible banks and stream beds, which accounts for their abnormal flow patterns. For this reason, it is recommended that a shovel, long gloves, and silt fencing material (and possibly rock/gravel) be brought along while checking weirs in case

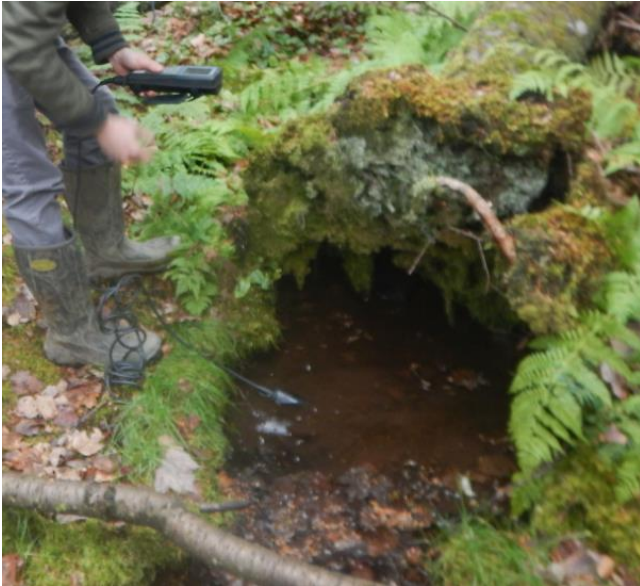
Figure 87. A crew member checking the water chemistry of a spring using the YSI.

Early in the season, various crew members were sent out to walk sections of the streams, marking out spring locations and testing the water chemistry with the YSI meter. The stream itself was also tested with the YSI approximately once every 200 m, to compare spring water to the regular channel. Nitrates were the parameter of most interest, but other data including temperature, dissolved oxygen, pH, and conductivity were also recorded.

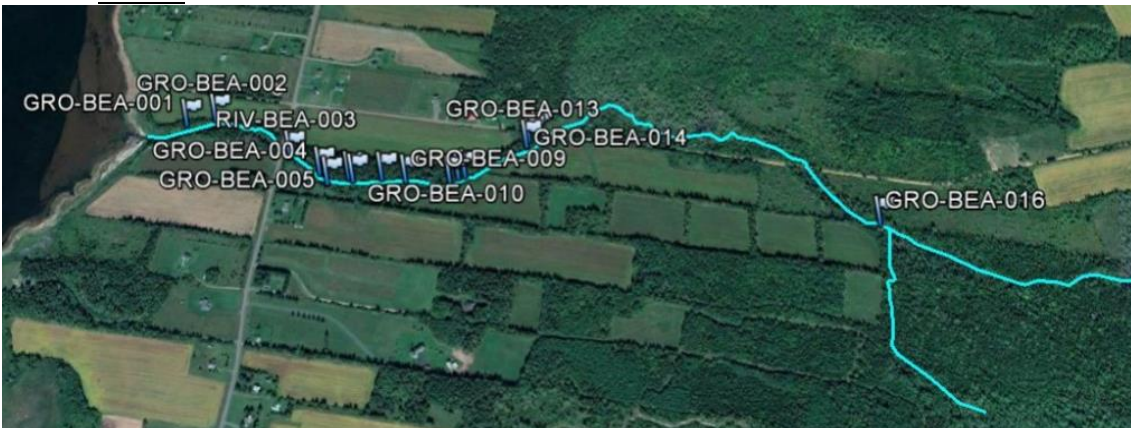
Figure 88. Beaton's Creek groundwater and surface water monitoring locations 2017.

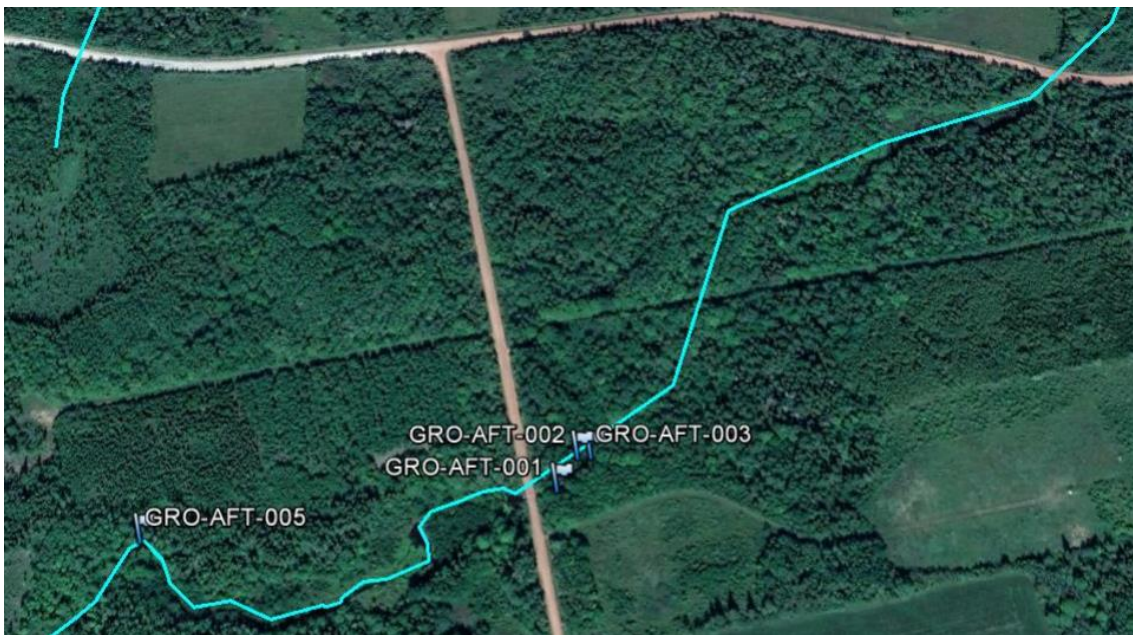
Figure 89. Afton groundwater monitoring locations 2017.

Out of all the sites checked this year, Black River, MacAulay's Creek, Friston North, and Afton had the highest levels of nitrates present. For this reason, it is recommended these areas be checked again in the following year. Black River was checked in early July, and showed to have very high nitrates, but when checked again in the fall the nitrates were not nearly as high. It would be beneficial to check this location at the same times during the following year to determine if there is a pattern in the fluctuating nitrate levels. Friston North had higher nitrate levels at the first three springs which, as seen in the map above, are closer to an agricultural field. MacAulay's Creek had similar issues, with the 5th and 6th spring having higher nitrates while also being closer to an agricultural field. These areas may benefit from tree planting to reduce runoff from these fields. The first two springs of the Afton location showed to have higher nitrate levels, but the rest of the springs were dry and unable to obtain a reading. It is recommended that these springs be checked earlier than early July in the following year so that there may still be spring flow present.

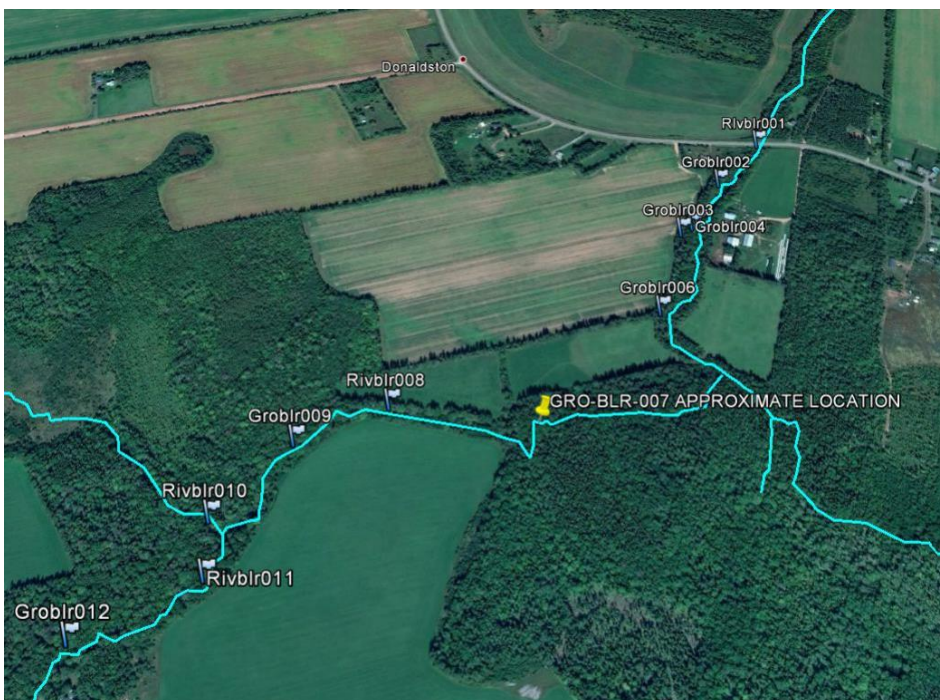
Figure 90. Black River groundwater and surface water monitoring locations 2017.

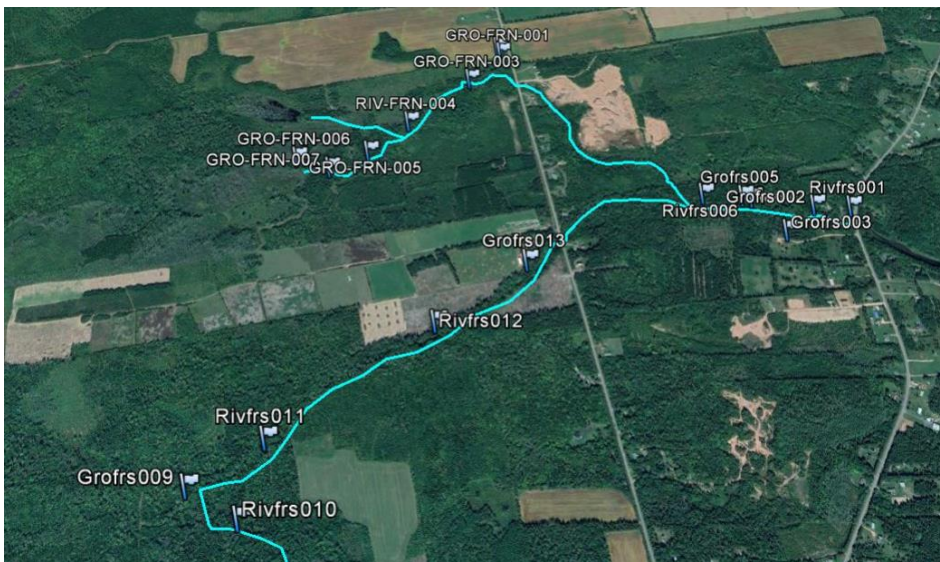
Figure 91. Friston groundwater and surface water monitoring locations 2017.

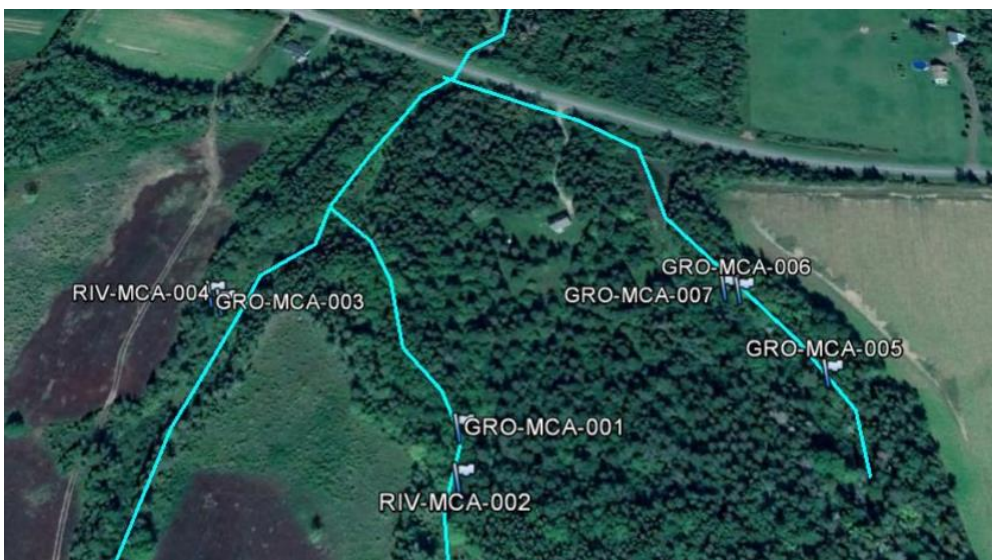
Figure 92. MacAulay's groundwater and surface water monitoring locations 2017.

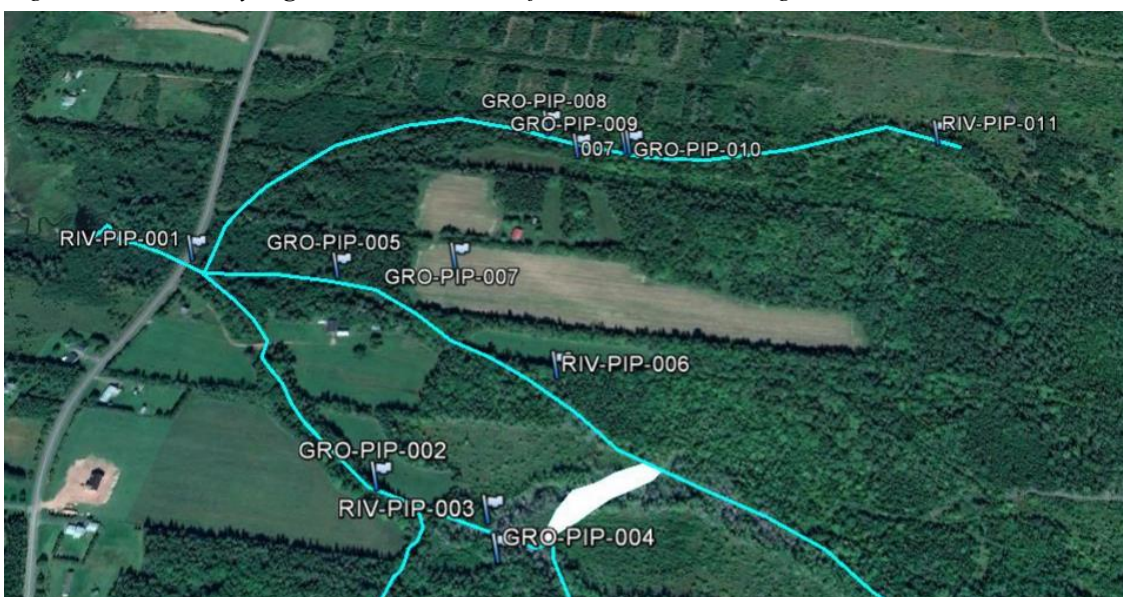
Figure 93. Piper's Creek groundwater and surface water monitoring locations 2017

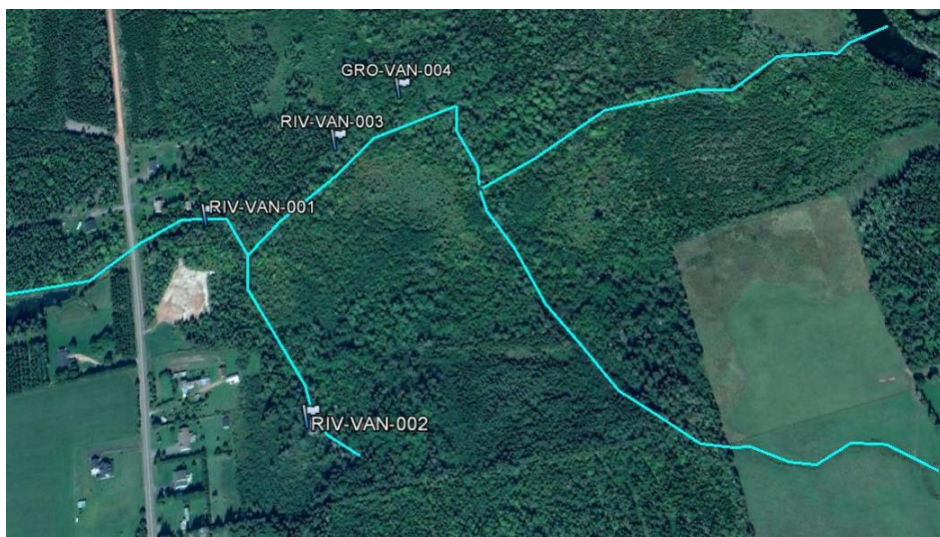
Figure 94. VanWesterneng groundwater and surface water monitoring locations 2017

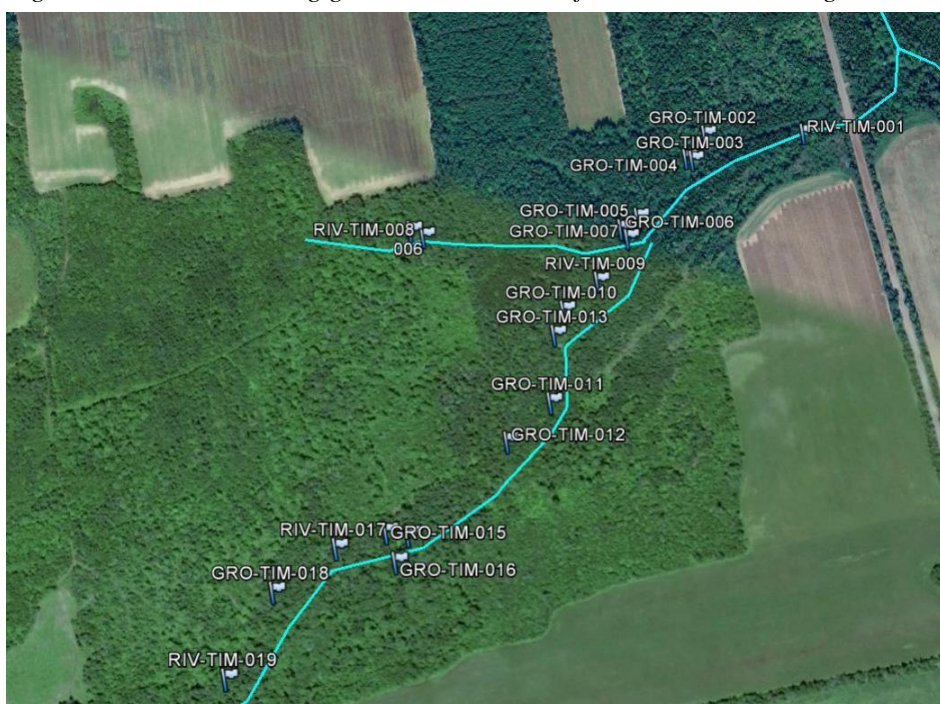
Figure 95. Tim's Creek groundwater and surface water monitoring locations 2017.

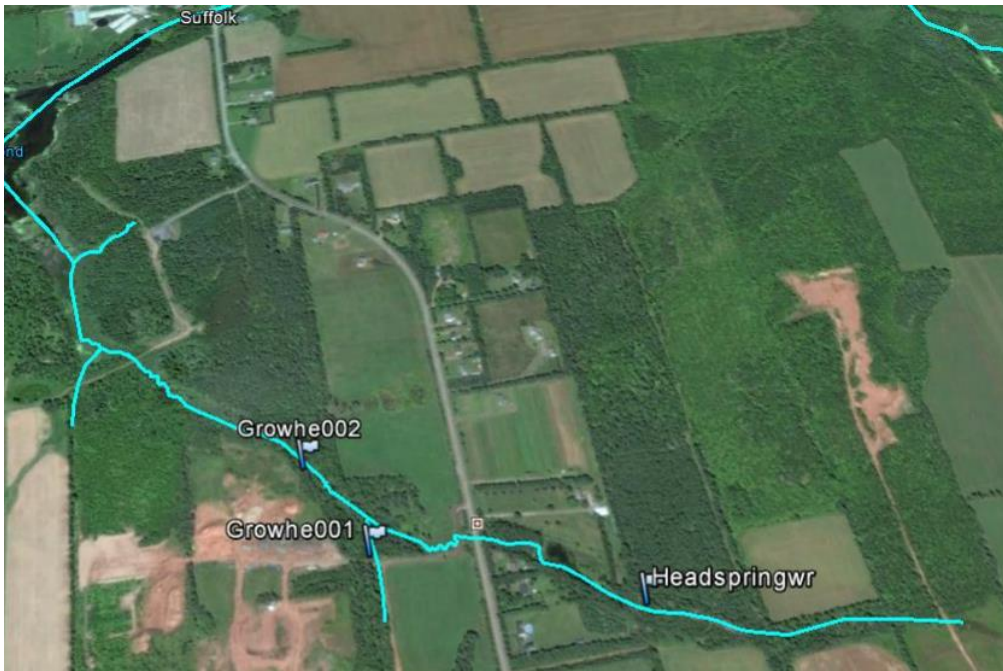
Figure 96: Wheatley groundwater monitoring locations 2017.

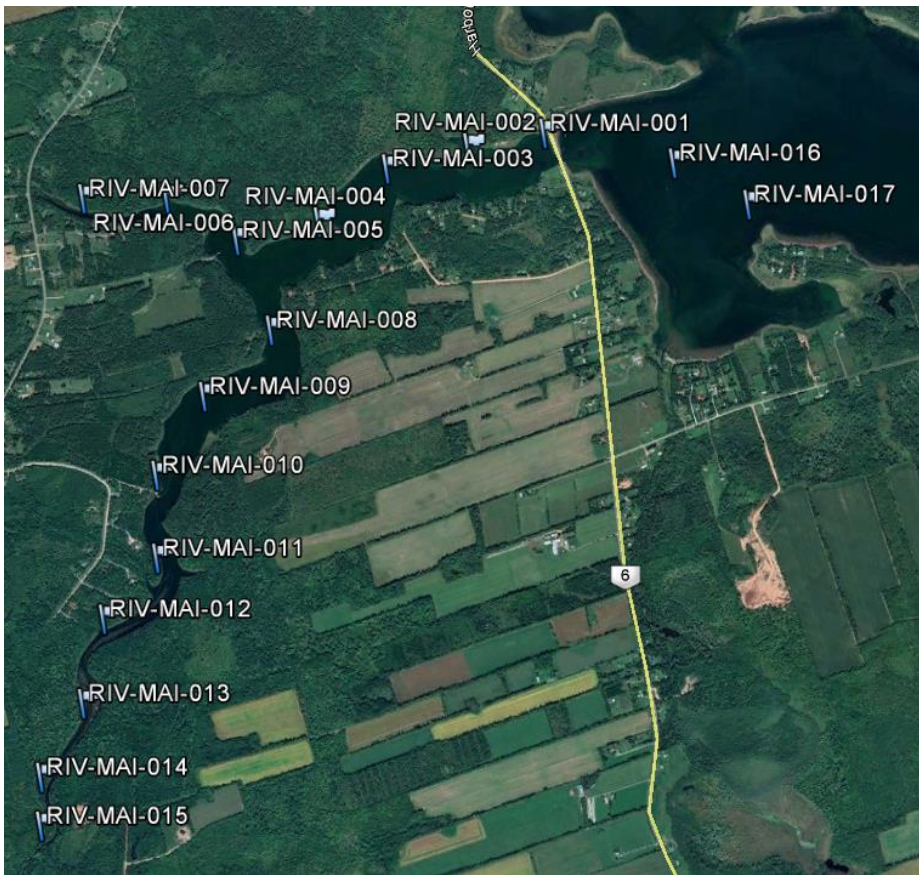
Figure 97. Estuary watch scoring locations 2017.

As soon as it was reported that the Winter River had gone anoxic, the crew began conducting an estuary watch survey once every two weeks to determine the severity of the anoxic conditions. The survey involved canoeing the estuary from the Corran Ban bridge near Tracadie Bay, to the end of tidal influence upstream. Every 200 m, conditions such as water clarity, water color, sea lettuce coverage, sea lettuce condition, and odor were scored according to the Estuary Watch Log sheet (Appendix 2). Water chemistry data was also recorded at each point using the YSI meter (nitrate probe must be removed due to salt water). The scores of each condition were then added up to determine the overall quality of the water at that section of the estuary.

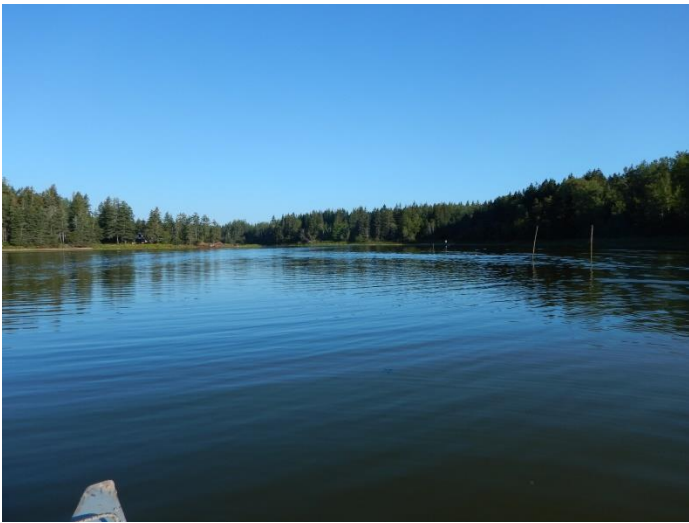
Figure 98. The estuary with healthy oxygen levels.

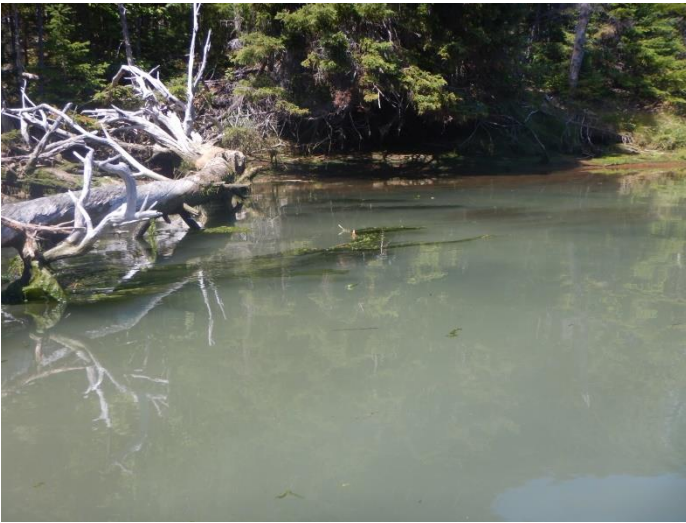
Figure 99. Anoxic conditions in the Winter River estuary.

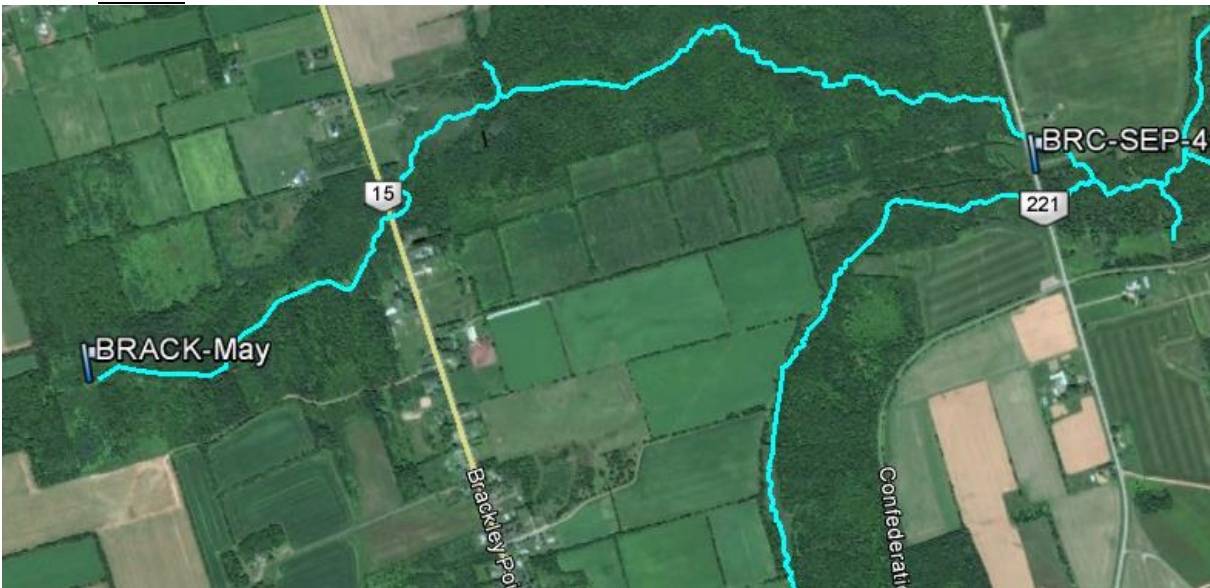
Figure 100. Brackley headwater survey 2017, 3.27 km became dry.

It appears the streams which are located closer to high capacity wells have a longer portion of stream becoming dry. For example, Brackley has 9 high capacity wells located within 1 km of the stream and had 3.27 km go dry, whereas Tim's Creek only has 5 high capacity wells within 3 km and was not found to go dry. The Pleasant Grove branch was found to have 0.18 km go dry and has 10 high capacity wells within 3 km (none of which were within 1 km).

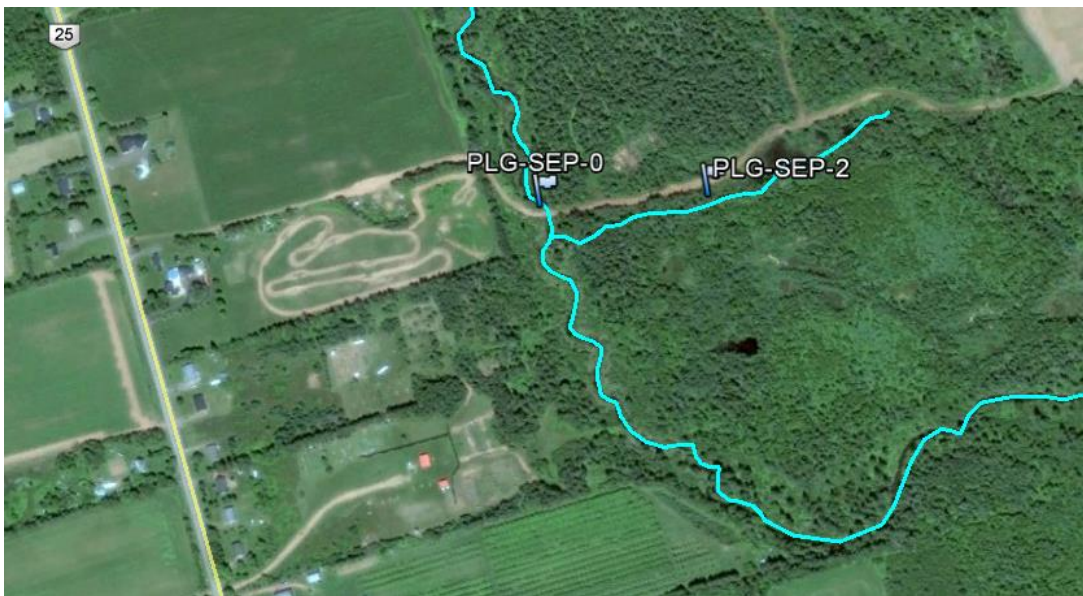
Figure 101. Laken Lewis Branch (by BMX park) headwater survey September 2017, 0.18 km became dry.

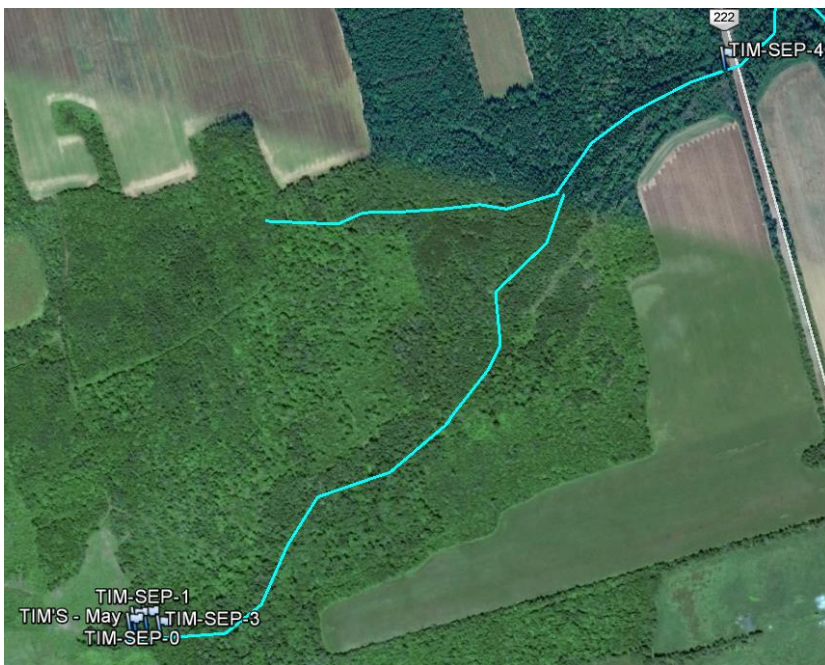
Figure 102. Tim's Creek headwater survey 2017, 0 km dry.

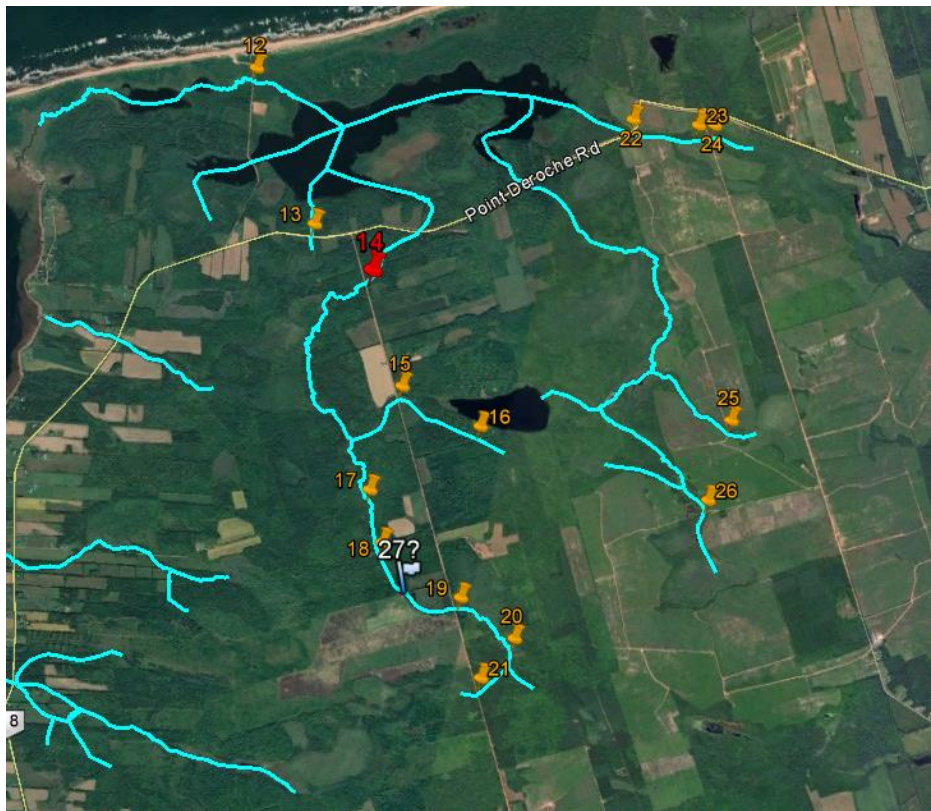
Figure 103. Locations of culverts assessed in 2017 east of Tracadie Bay.

Various culverts were assessed throughout the Winter River – Tracadie Bay watershed, beginning in August and continuing into the fall. Each culvert was assigned an ID, and the stream name, road name, and GPS coordinates were noted. The culvert was then checked for its type, baffles, armor, bottom material, fill line, rust line, diameter, obstructions, undercutting, overtopped, hanging, and crushed percentage. Road information was also noted, along with bridge

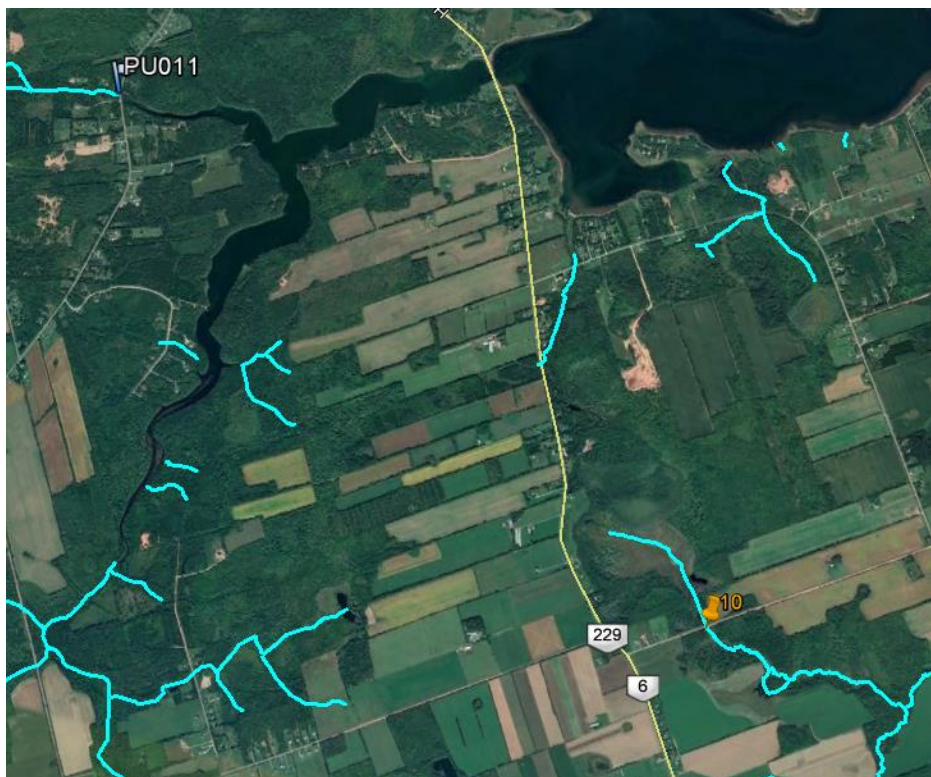
Figure 104. Location of culverts assessed in 2017 south of Tracadie Bay.

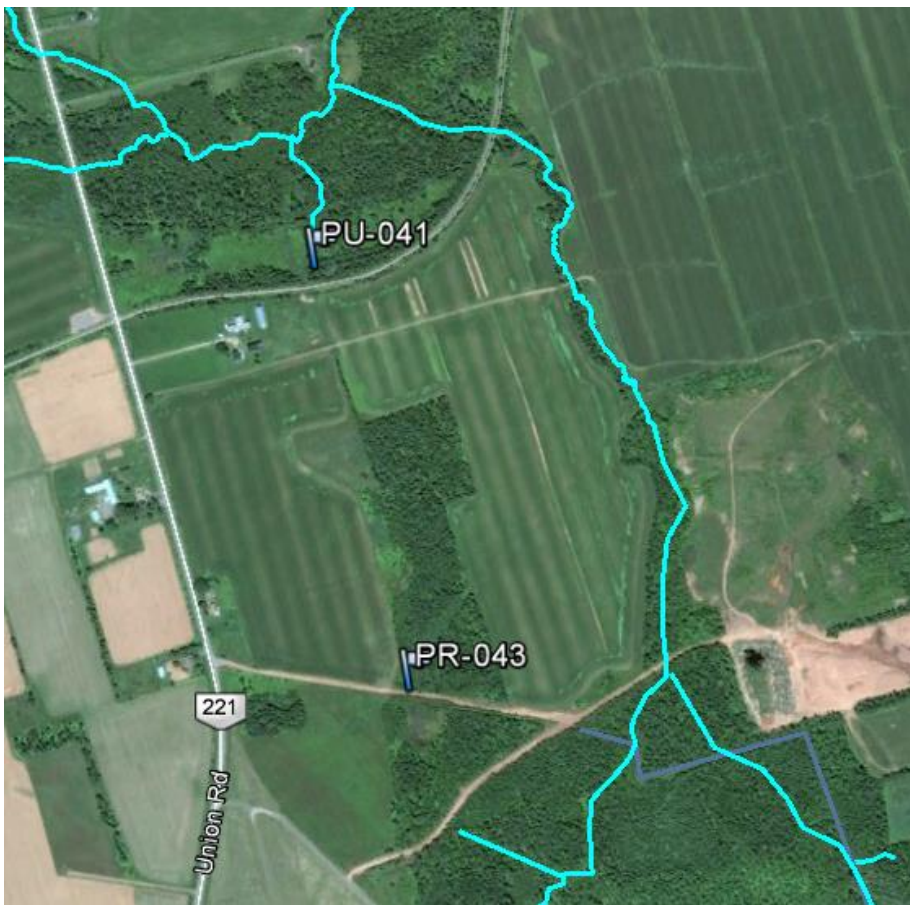
Figure 105. Location of culverts assessed in 2017 near the Vanco drainage ditch.

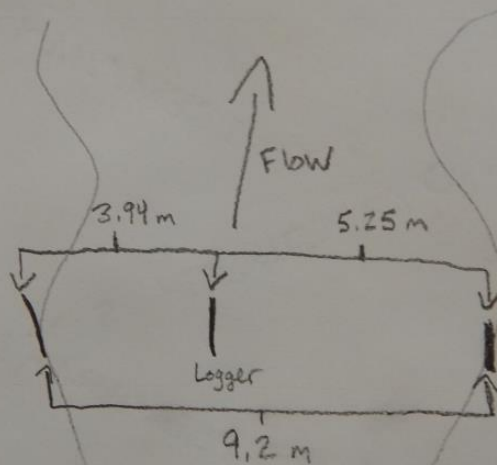
Officer's:

In case of the loss of a depth logger's rebar over the winter, measurements were taken to enable future staff to replace this rebar in the same location. Some rough sketches are shown below:

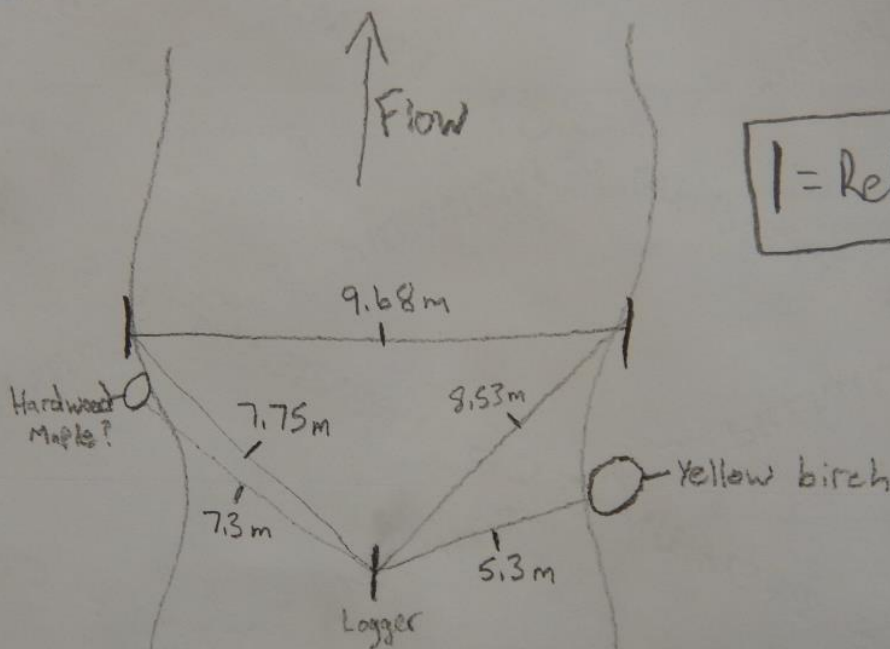
Tim's:

| = Rebar
