Winter River – Tracadie Bay Watershed Association

2016 Field Report

Hilary Shea
2017-01-09

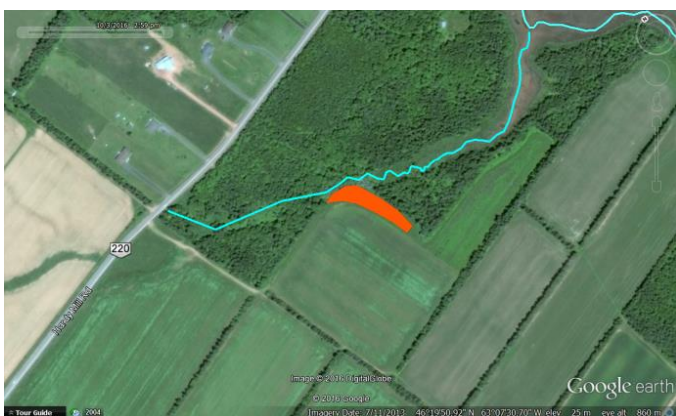
Figure 3: Pater branch, Winter River

The native planting site is adjacent to the headwaters springs of the Pater Branch on Winter River and below an active agricultural field. In the spring, this area was surveyed and found a large amount of sediment runoff within the buffer zone. This summer, approximately 60 trees and shrubs were planted within the buffer zone including: Green Ash, Blue leaf Birch, Red Maple, Larch, Black Spruce, White Spruce, Bayberry, Pussy Willow, and Winterberry. In addition, the watershed group installed a 200m long sediment fence to mitigate the sediment runoff for an effective short-term solution.

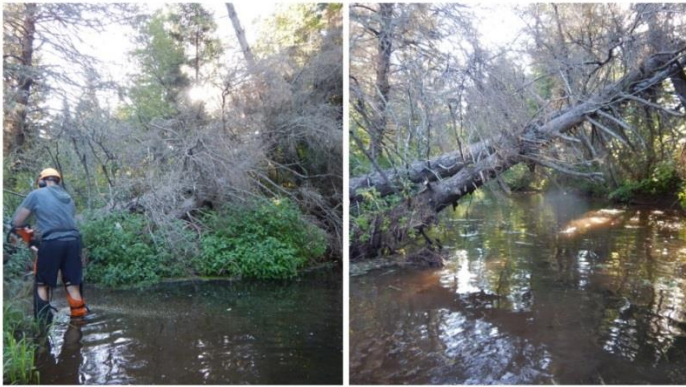
Figure 21: Black River – before and after debris removal.

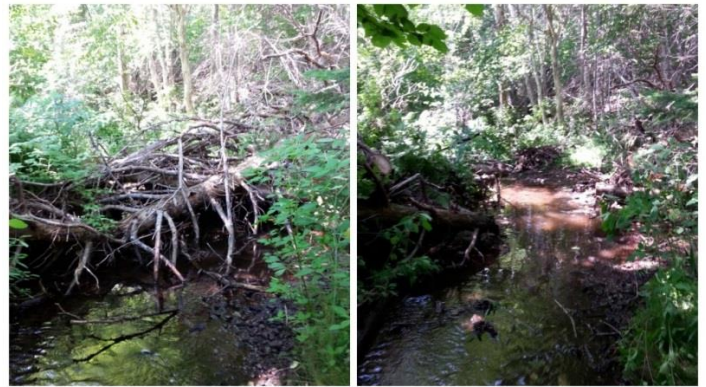
Figure 22 : Black River – before and after debris removal.

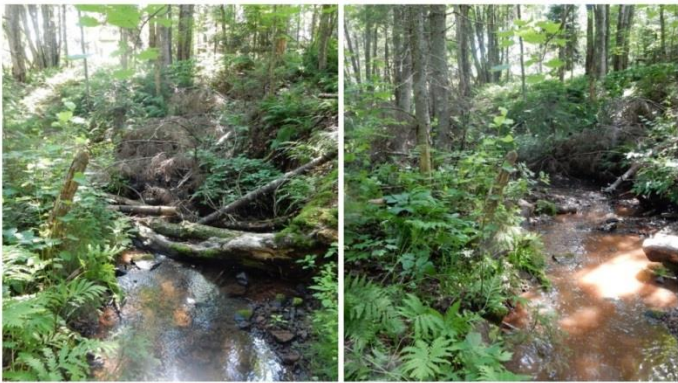
Figure 23: Vanwesterneng Branch – before and after debris removal.

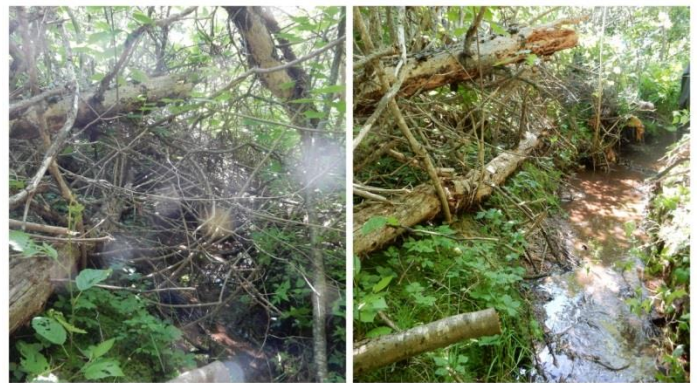
Figure 24: Vanwesterneng Branch – before and after debris removal.

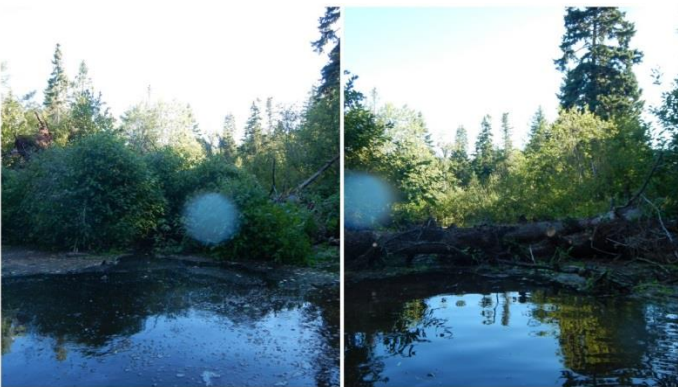
Figure 25: Winter River, Above Officers Pond – The stream at this location was 6 feet deep; the chainsaw operator was only able to remove the debris above and around the blockage. In a fall assessment, the water level is now well below this blockage and a chainsaw operator in 2017 should be able to take the rest of it out.

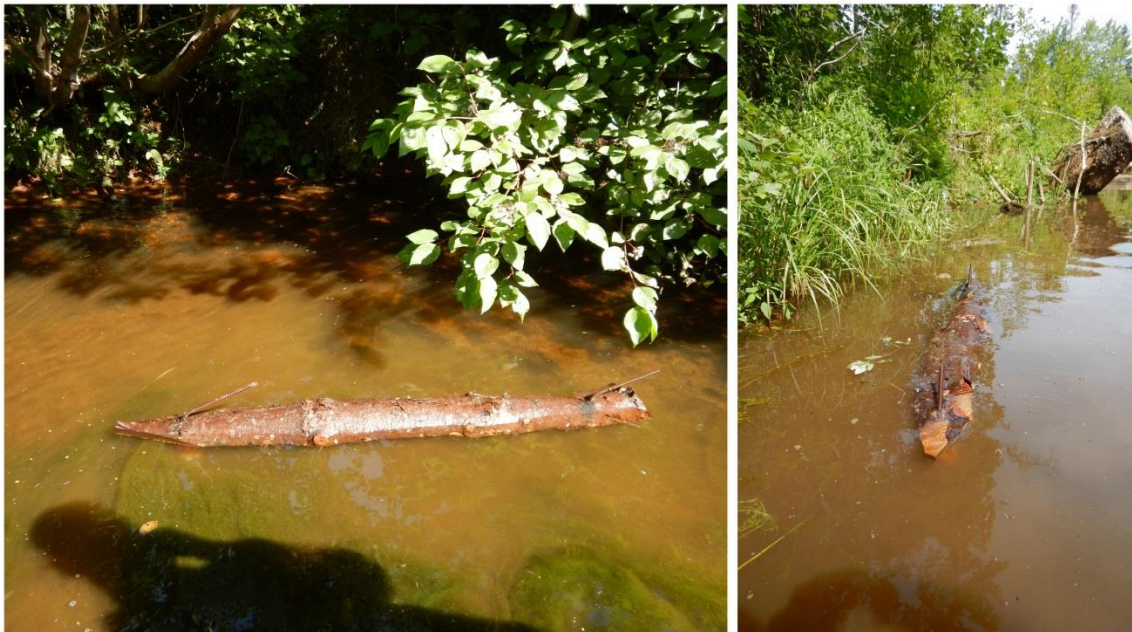
Figure 37: Cover logs along the main stem of Winter River

The crew installed 15 cover logs along Winter River in areas that lack woody debris cover and shade from vegetation.

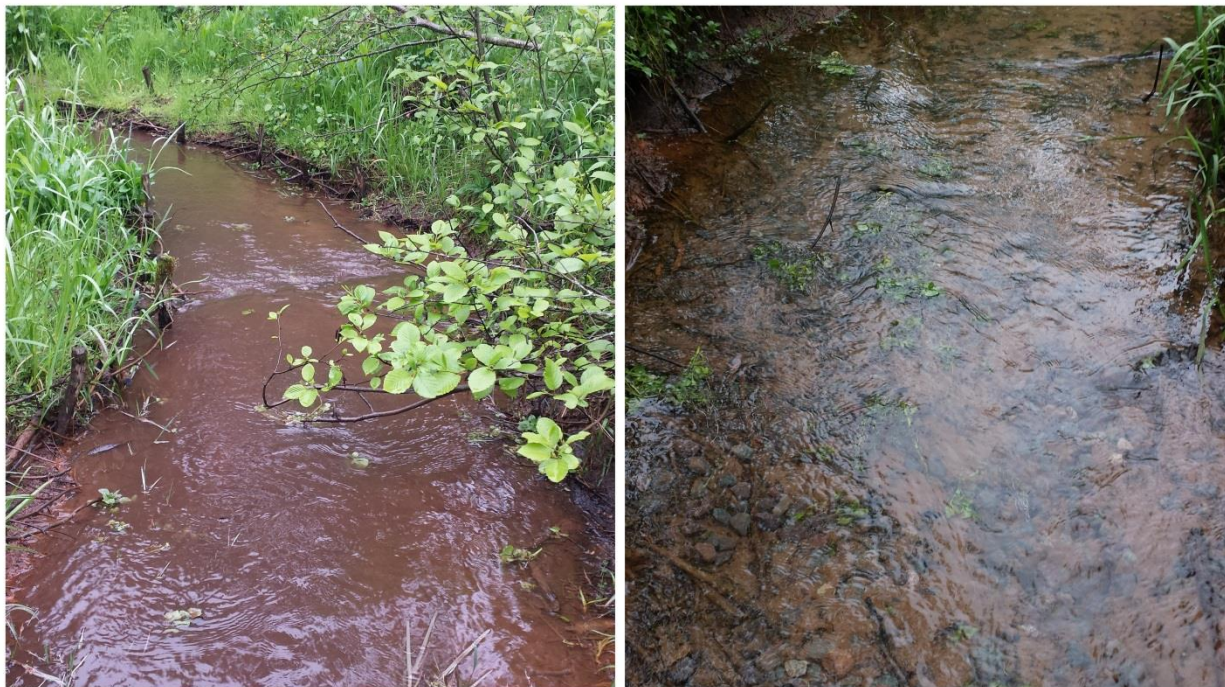
Figure 41: A before and after picture of pebble enhancement in the springs on the MacLauchlan Branch, Winter River

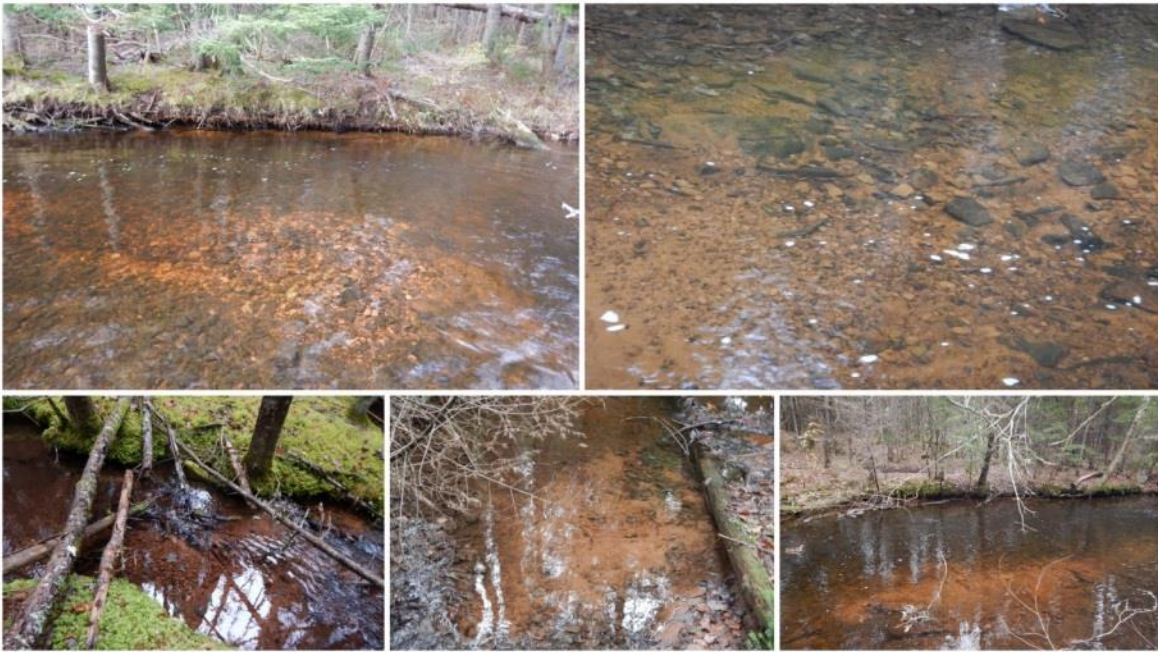
Figure 60: Brook trout redds of Winter River

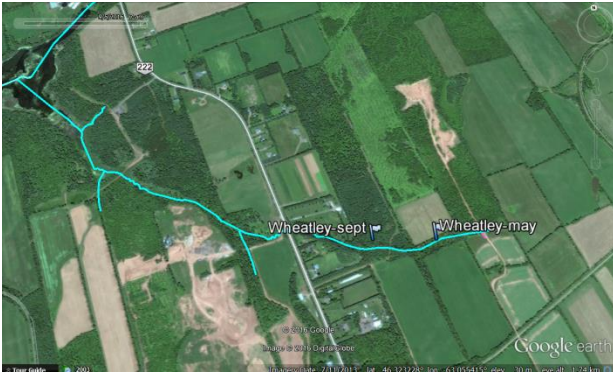
Wheatley Branch

Distance - ~220 metres

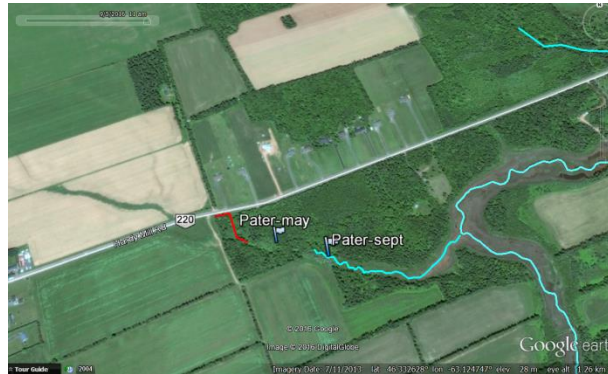
Pater Branch

Distance - ~125 metres

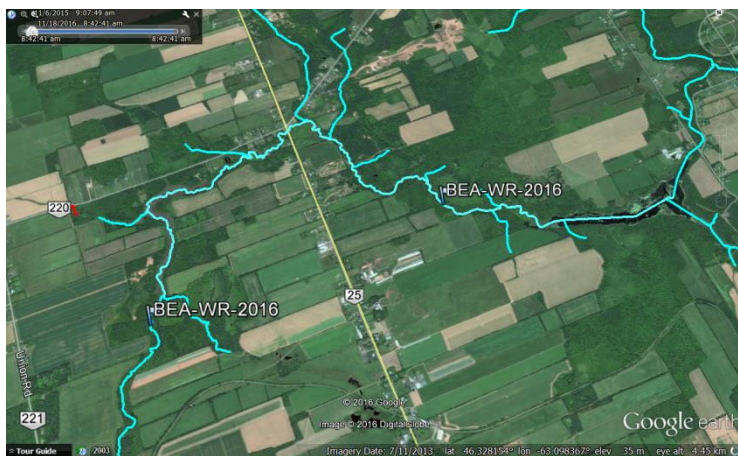
Figure 63: Beaver Activity - Winter River
