WINTER RIVER - TRACADIE BAY WATERSHED ASSOCIATION

Work Report for 2019-20

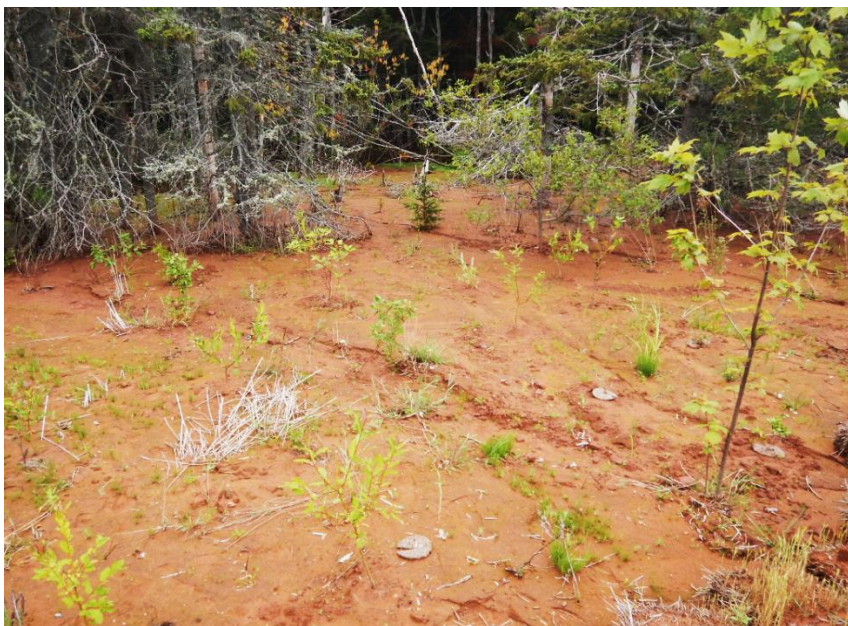
Figure 29. Planting completed at erosion control site.

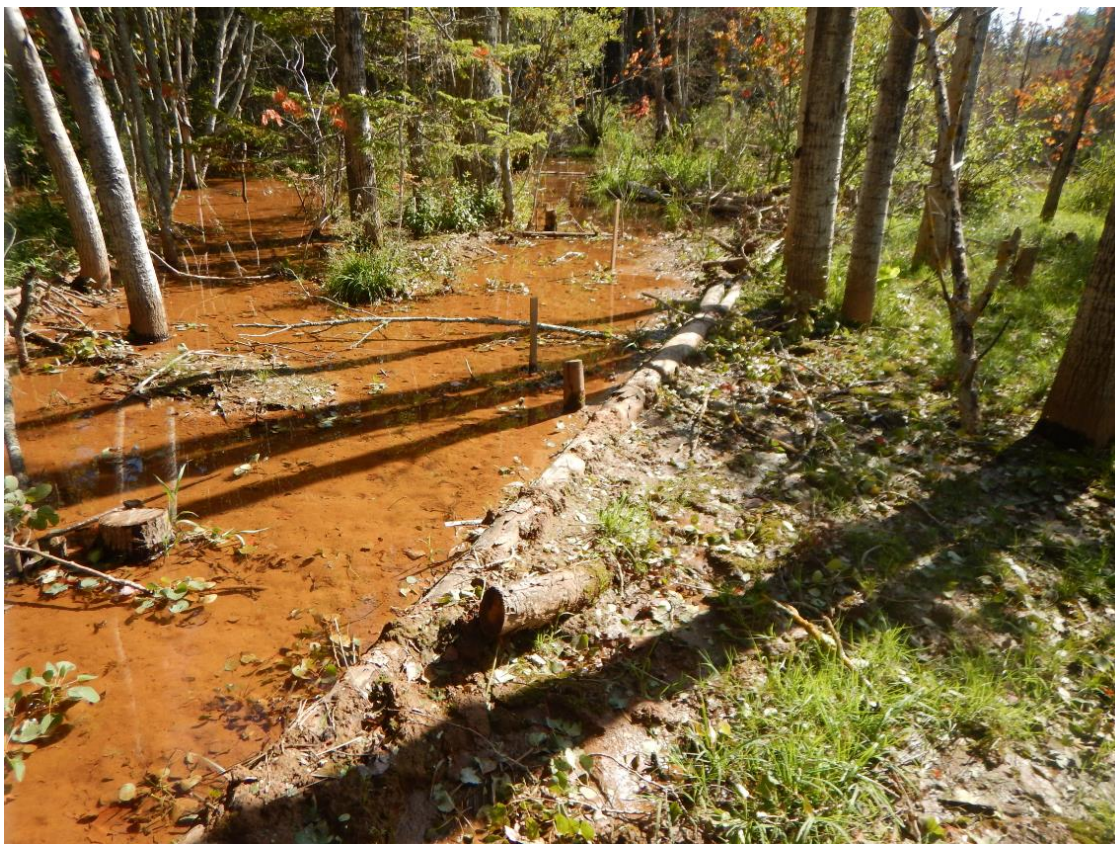
Upon checking the site in spring 2019, it was found that a large section of the riparian zone on either side of the stream had been covered in silt. There were several trenches formed and sediment was running directly into the stream. The straw bales had been pushed out of place from the force of the water coming off the field, and silt completely covered the straw bales in some areas. The stream in this section (approximately 50 m) looked more like a wetland covered in silt than a stream.

Figure 35. Rail inserted at stream edge at the soil erosion site.

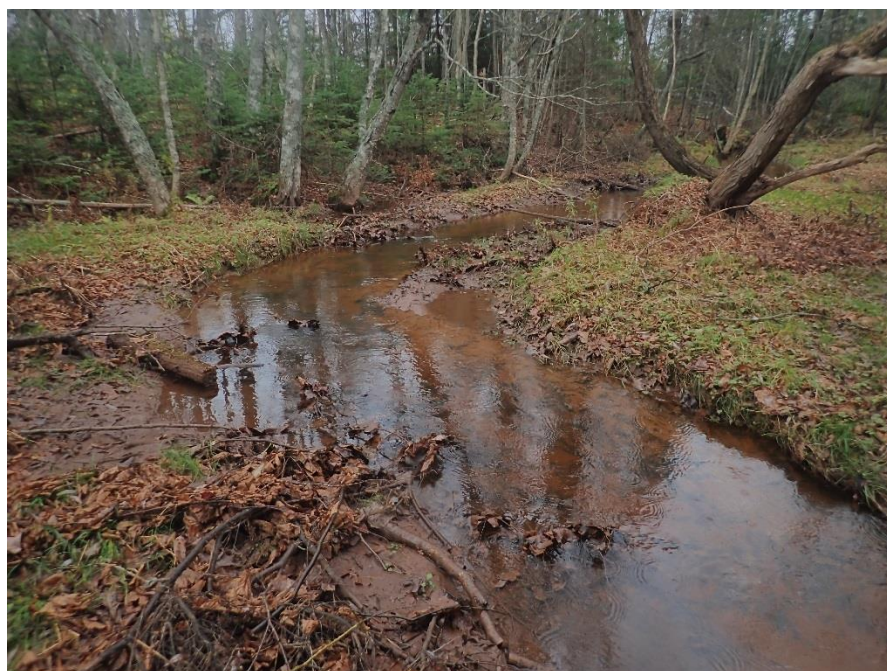
Figure 44. Stream assessment along Vanco Branch in November 2019.
